OPERATIONAL ASSESSMENT REPORT

LION'S HEAD MARINA

LION'S HEAD, ONTARIO

Planmac Ref. No. 1728

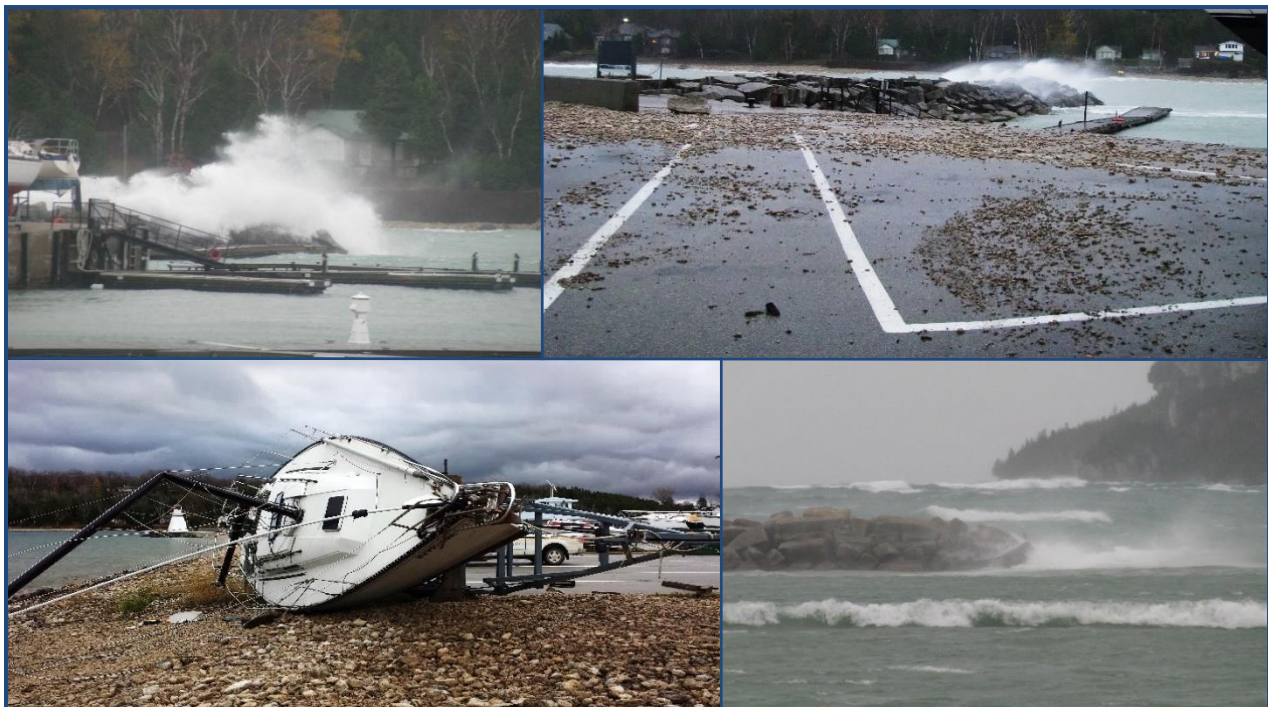
While the location and positioning of Lion's Head on the Bruce Peninsula allows the marina to be partially sheltered from most weather, the harbour is extremely exposed to weather originating from the north/northeast. Storms originating from these directions can produce very large and strong waves, which build over a fetch of between 85 and 110 km before reaching the harbour. These conditions overpower the harbour's armour stone breakwater wall, and bring strong winds, high waves and lakebed materials into the marina. These weather events also produce hazardous currents through the harbour mouth. These storms have caused damage to the vessels in the marina, both in and out of the water, as well as the marina's facilities, including its parking facilities, floating docks, lighthouse and breakwater (see Figure 3-2, below). These storms hit the marina a few times per year, and have become a costly hazard.

Figure 3-2: Weather and Damage During Storms at Lion's Head Marina

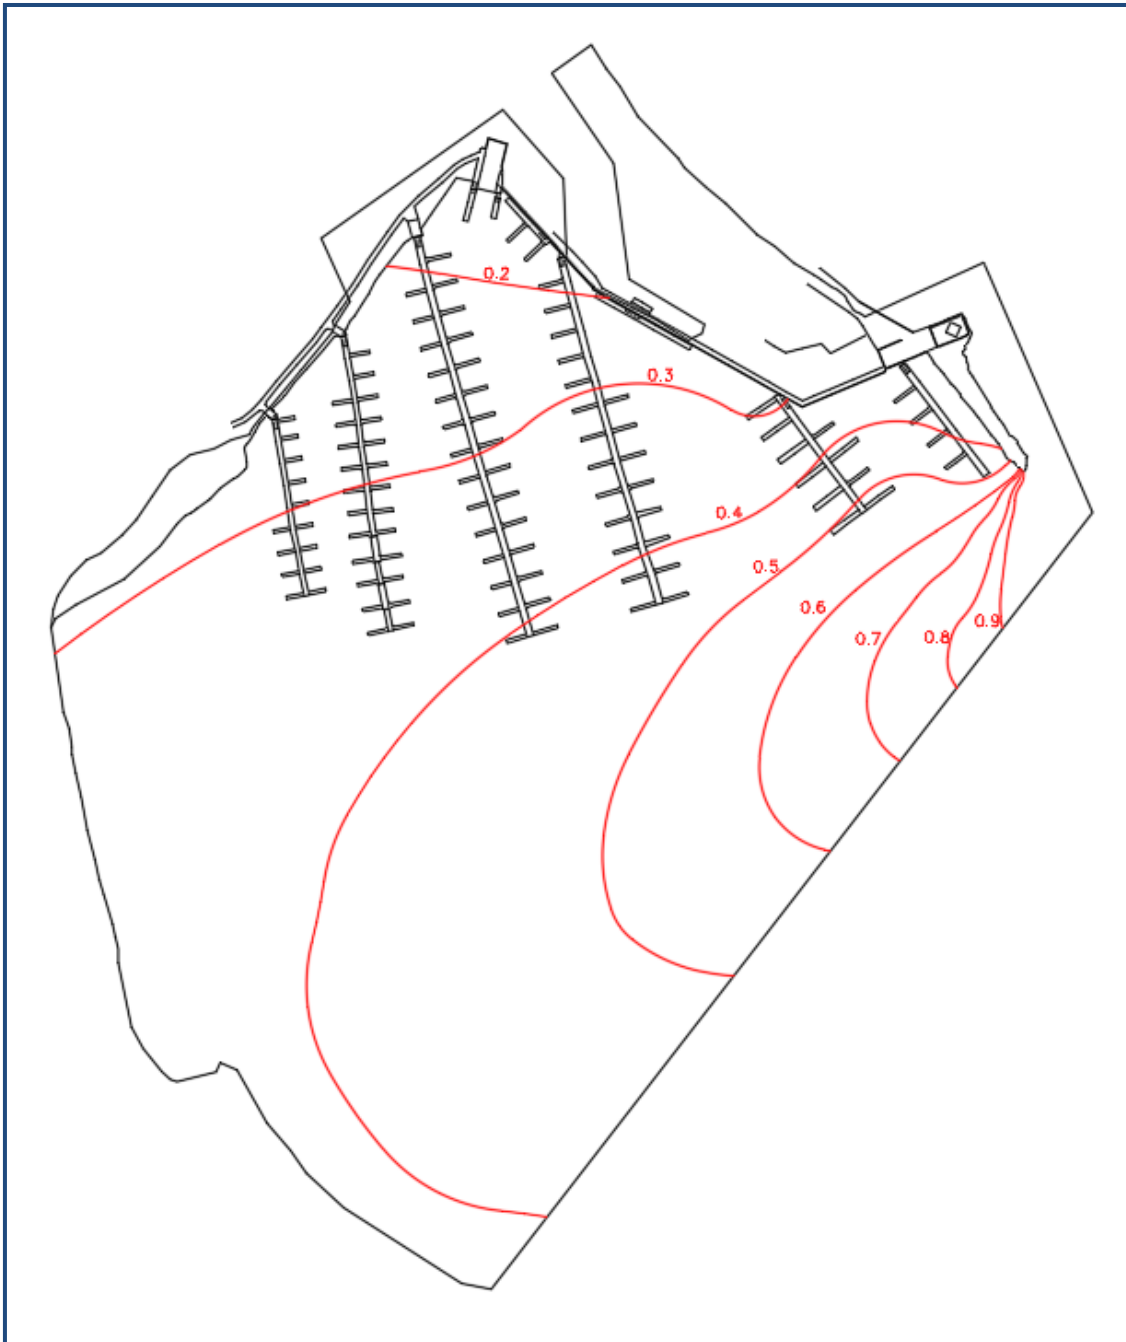
Although the area of the harbour currently occupied by Dock A and Dock B is behind the breakwater wall, it still experiences very rough conditions during storms. While some larger waves are able to overtop the wall, most of the damage is caused by the proximity of the end of the wall to these docks. Because of its positioning, the wall is not able to properly diffract and de-power the waves before they hit enter this area. Instead, it diffracts large and high-powered waves directly into the harbour wall, which reflects the waves back into the area, causing even larger waves. For a contour map of wave heights within the marina's property limits during typical storm events, expressed in fractions of incident wave height, see Figure 6-2, below. This diagram is representative of the height, period and speed of waves observed in on-site footage

and data taken during storm events and provided by marina staff. The results of this wave diffraction modeling demonstrate why the outermost fingers of Dock A and the last segment of Dock B often sustain the heaviest damage during extreme weather events.

Figure 6-2: Contour Map of Wave Heights During Typical Storm Events

These results can be improved through realigning and repositioning the breakwater structure. The structure's angle of incidence with the waves has a great affect on the strength and path of diffracted waves within the harbour. Also, increasing the distance between a point in the harbour and the edge of the breakwater will decrease the size and strength of the waves. Another consideration is that if a new breakwater structure were built to the east of the existing armour stone wall, it could be extended northward to provide additional protection to other exposed regions of the marina, such as the lighthouse base, the beach, and the parking area south of the marina buildings.

We recommend that the existing breakwater structure be removed, and, where possible, salvaged and rebuilt into a new armour stone breakwater structure. This new structure would be taller than the existing structure to more adequately shelter the marina from Lion's Head's strong winds, and would be longer to provide more protection from diffracted waves. The new structure would be built to the east of the existing structure to provide more useable space within the marina.

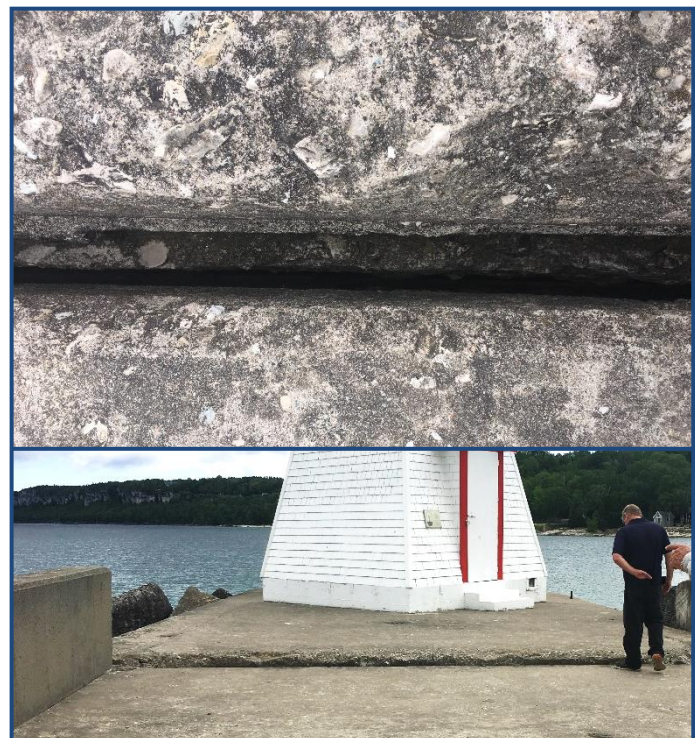
At the site meeting, we observed an elevation gap that had developed between the marina pier and walkway and the concrete slab supporting the Lion's Head Lighthouse (see Figure 7-1 for top and side view of separation). The lighthouse base has risen when compared to the concrete wharf, and has also shifted to the east, away from the wharf. Water is visible in the gap produced between the two concrete structures, and waves coming in from Georgian Bay can be seen to continue through this gap, toward the armour stone breakwater structure on the south side. The slab's other edges are protected by armour stone. This stone barrier has deteriorated slightly, to a similar degree as the neighbouring breakwater structure. The lighthouse base was originally poured onto rocks and fill material, which has washed out, creating a void underneath. This has caused the slab to rotate and slant to the east.

Figure 7-1: Separation of Concrete Lighthouse Base Slab from Concrete Wharf

The existing concrete slab supporting the Lion's Head Lighthouse has rotated and shifted due to erosion of fill materials. To remedy this, Planmac recommends the existing slab be demolished and replaced, with the addition of a protective sheet pile wall (as per Section 7.2.3.). This will provide long-term durability and strength to the lighthouse foundation.

This option involves boring holes through the slab, through which cementitious grout would be injected. This would fill the voids under the slab that have caused it to displace, and would help prevent further deterioration.

This option involves the removal and replacement of the existing slab. After demolishing the existing slab, granular fill materials would be added to the

base to replenish the fill that has been washed away. Once the granular base is refilled and compacted, the new concrete slab would be poured directly onto it. Similarly to Option 1, the armour stone protection would need repair as part of this work in order to prevent future deterioration.

This option is similar to Option 2 in that it involves the demolition of the existing slab and temporary relocation of the lighthouse. However, in this option, a sheet pile wall would be built around the new slab to better protect the fill material in its foundation from future deterioration.

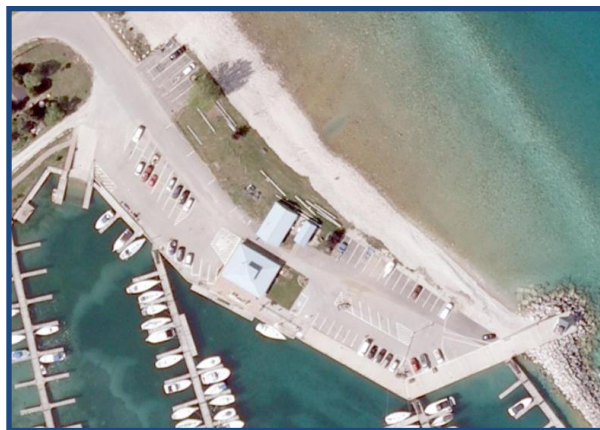
Figure 8-1: Parking Facilities at the Lion's Head Marina.
**Please note that this satellite image is out of date and the marina parking layout has since been rearranged slightly.*

Therefore, the existing parking facilities at the Lion's Head Marina are inadequate. Note that should a larger portion of the slips be used commercially, the demand for parking will increase.
