MUNICIPALITY OF NORTHERN BRUCE PENINSULA

# 2022 STRUCTURE INSPECTION REPORT

FINAL  
PROJECT NO.: 201-01605-00  
DATE: APRIL 03, 2023

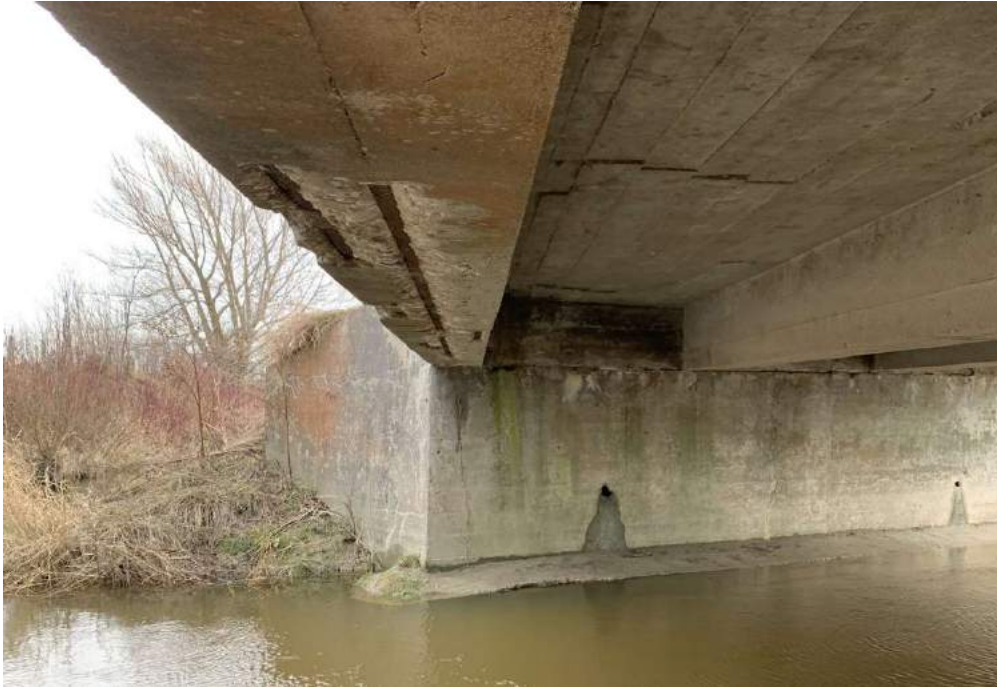
Photo 1-2: South abutment, soffit and exterior girder.

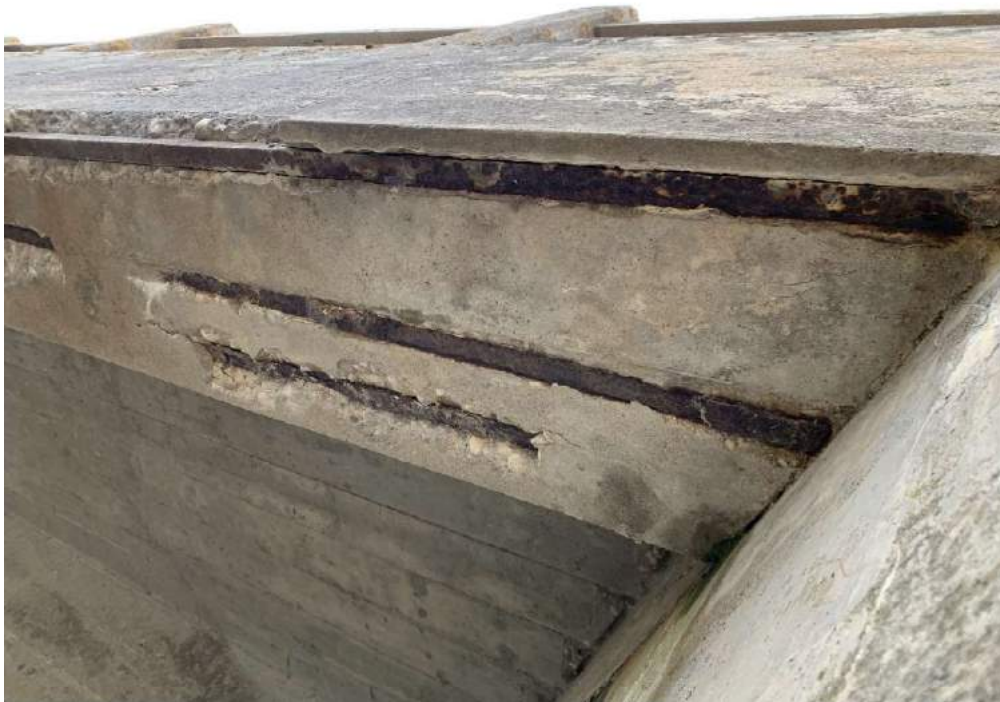
| <b>Comments:</b> | Exterior soffit concrete loss with exposed rebar was observed. | | | | | | |

Photo 1-3: North abutment, girders and soffit with spalling and delamination

| | Remove delaminated concrete, clean steel and replace concrete. | | | | | | |

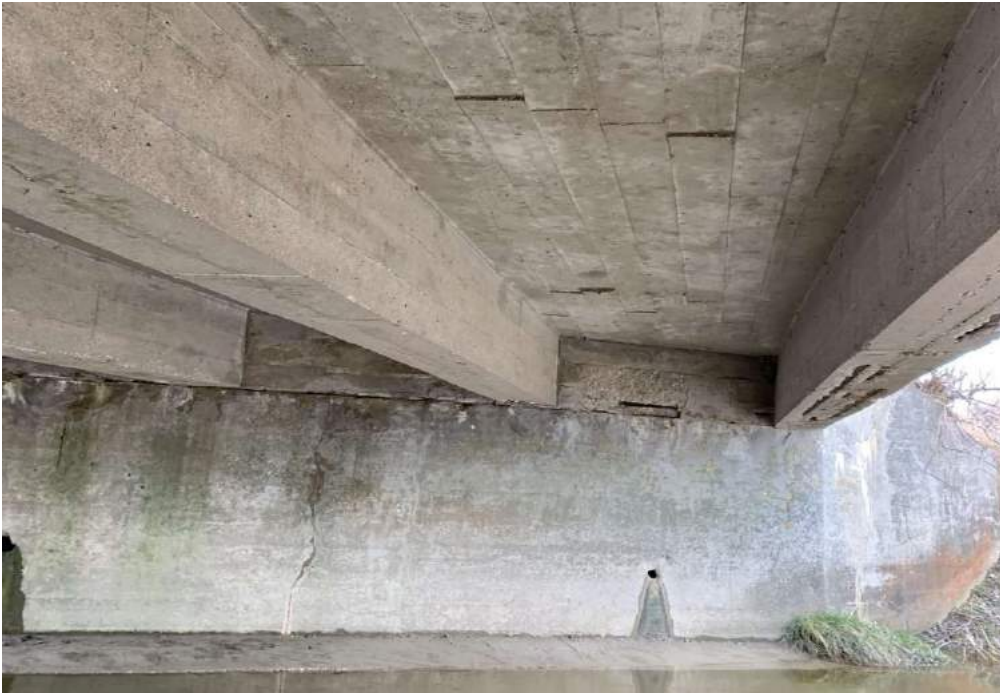
Photo 1-4: South abutment wall, soffit and girders

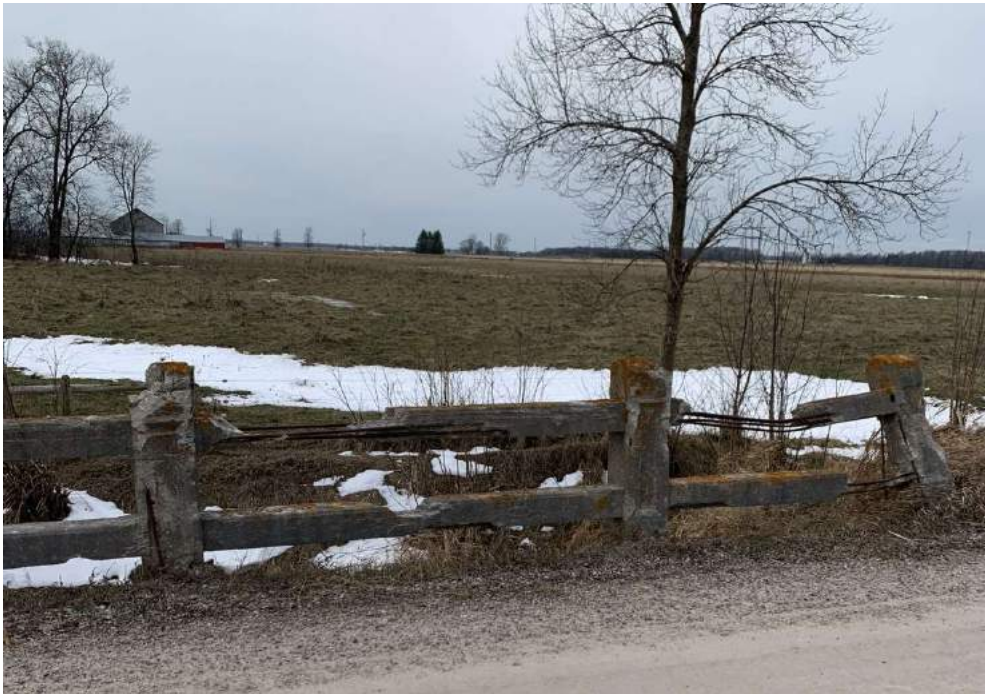
| <b>Comments:</b> | Limited inspection of the top deck condition due to cover with granular wearing surface. | | | | | | |

Photo 1-6 - Structure barrier and excessive granular fill on deck

| | Grade out excess gravel and inspect the condition of the concrete deck top. | | | | | | |

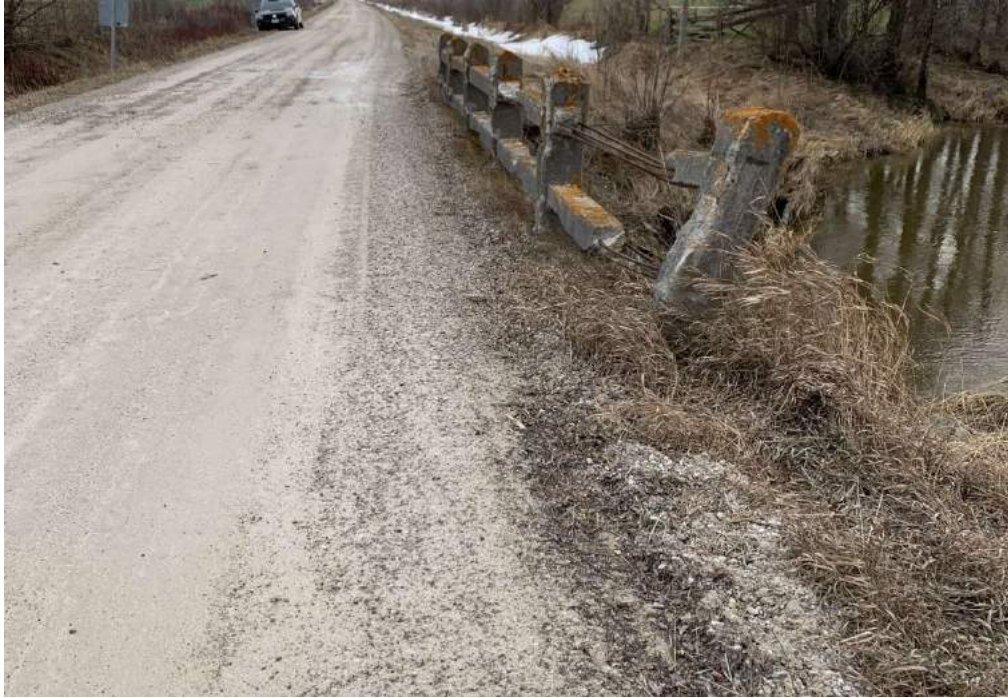
| <b>Comments:</b> | Shoulder vegetation has started to encroach on the roadway. | | | | | | |

Photo 1-8 - Vegetation and debris accumulation along shoulders, potholes in wearing surface

| <b>Recommended Work:</b> | None 6-10 Years 1-5 Years <input checked="" type="checkbox"/> < 1 Year Urgent<br>Grade the shoulders and clear the encroaching vegetation. | | | | | | |

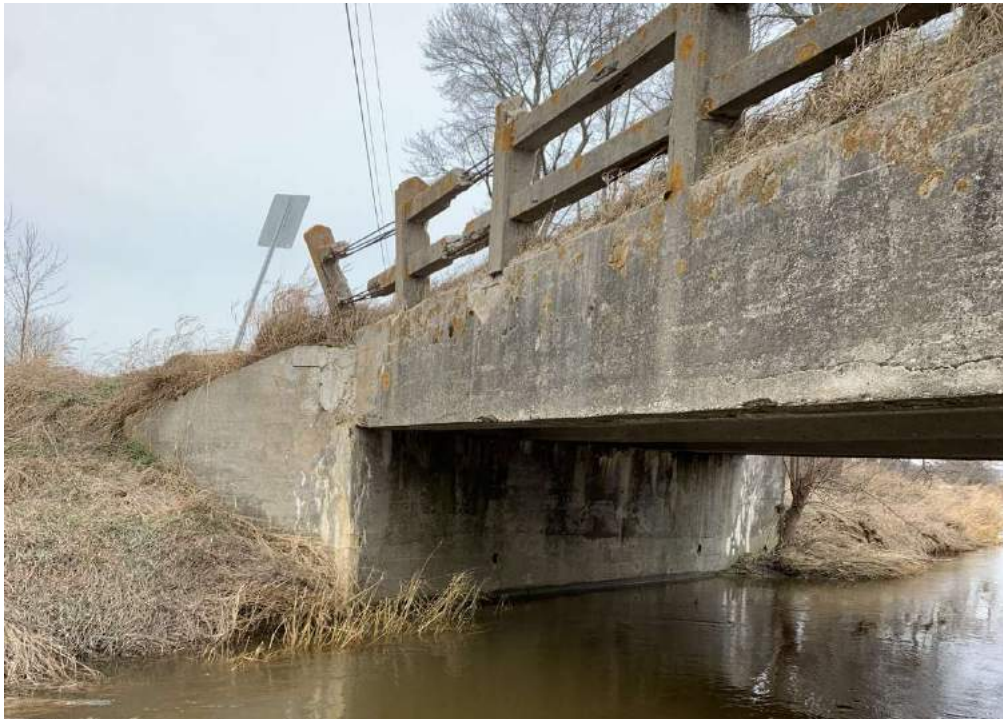
Photo 1-9 - Structure elevation, exterior soffit, curb and barrier

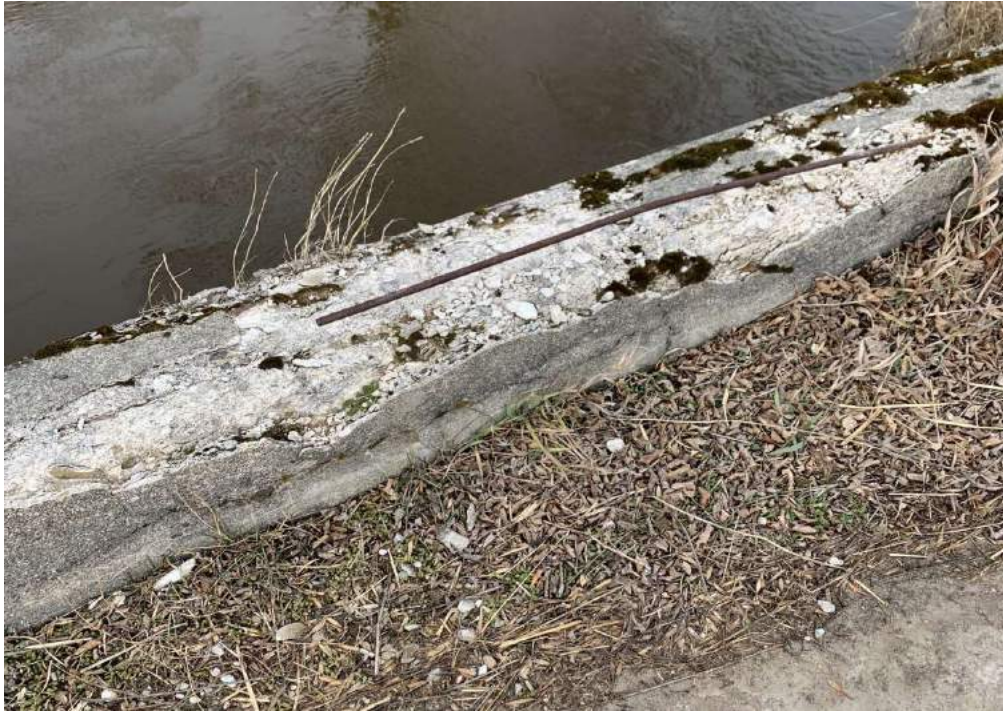
Photo 2-2: Spalling of exterior curb

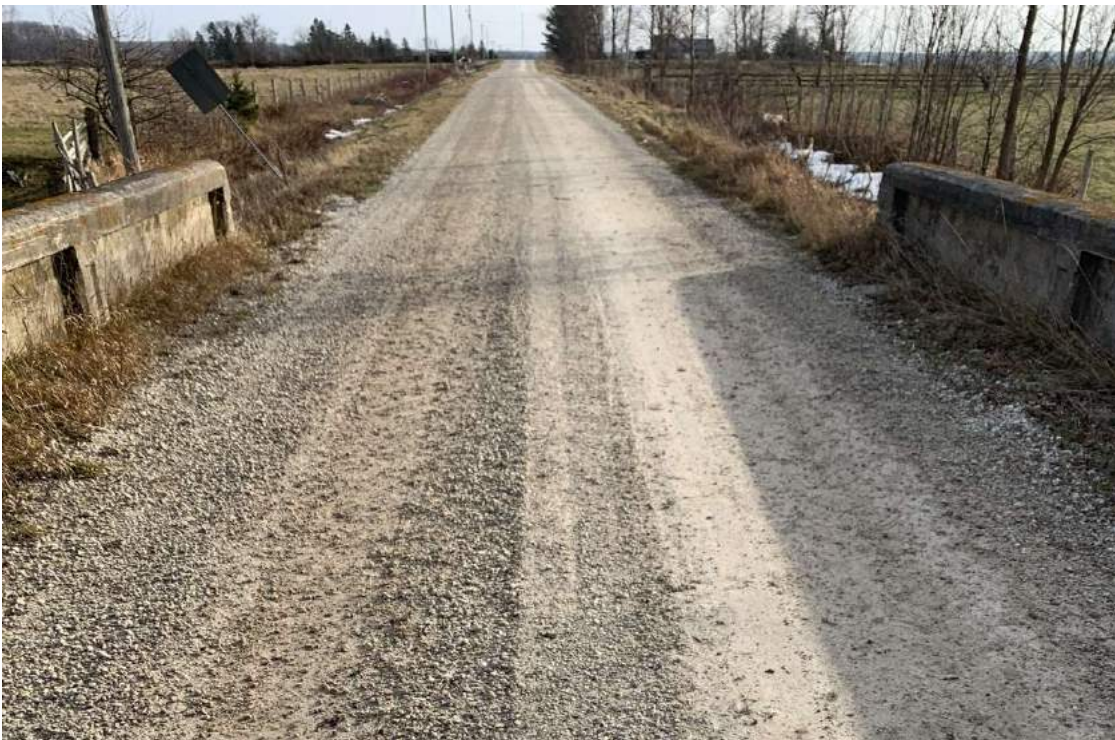
| <b>Comments:</b> | Heavy (grass) vegetation on shoulders should be cleared to improve drainage. | | | | | | |

Photo 3-5: Structure and approach wearing surface with wheel path rutting and encroaching vegetation

| <b>Recommended Work:</b> | None    6-10 Years    1-5 Years <input checked="" type="checkbox"/> < 1 Year    Urgent<br>Grade the shoulders annually to promote positive drainage. | | | | | | |

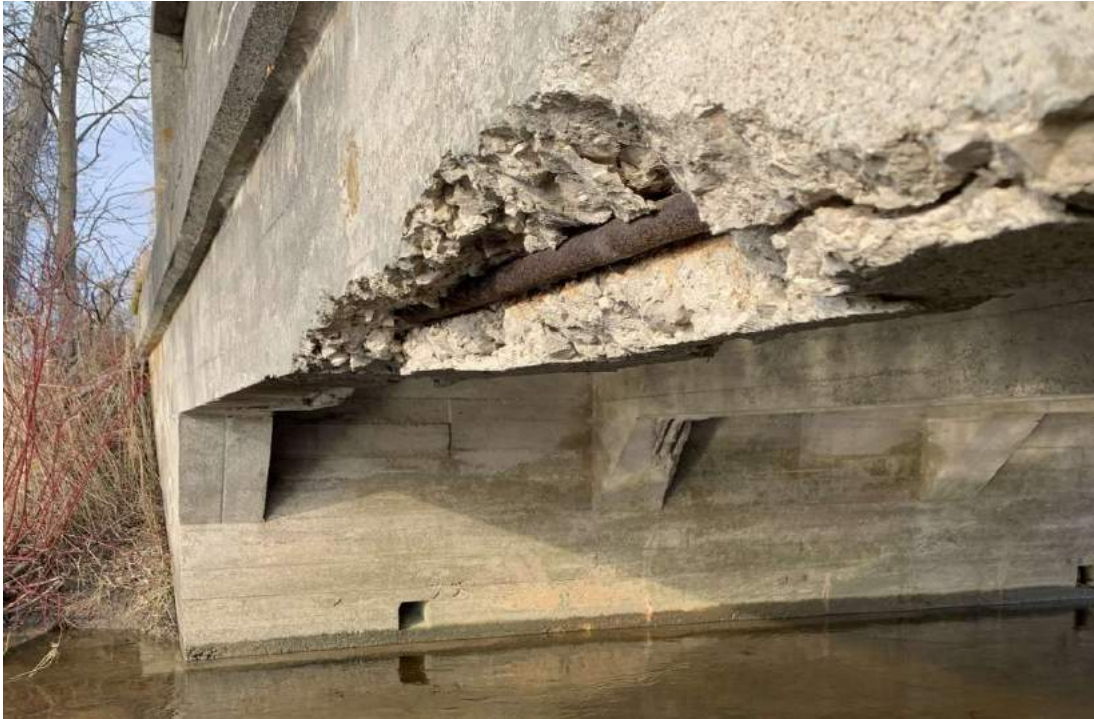
Photo 3-8: Exterior girder delamination and spalling

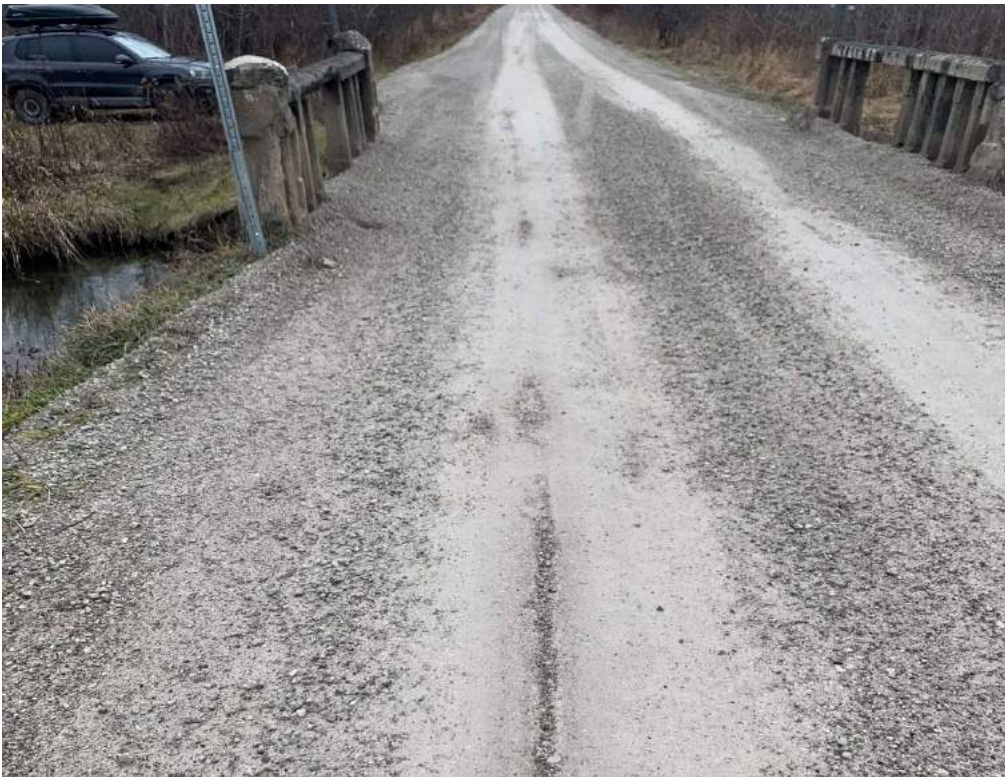
Photo 4-5: Wearing surface deterioration

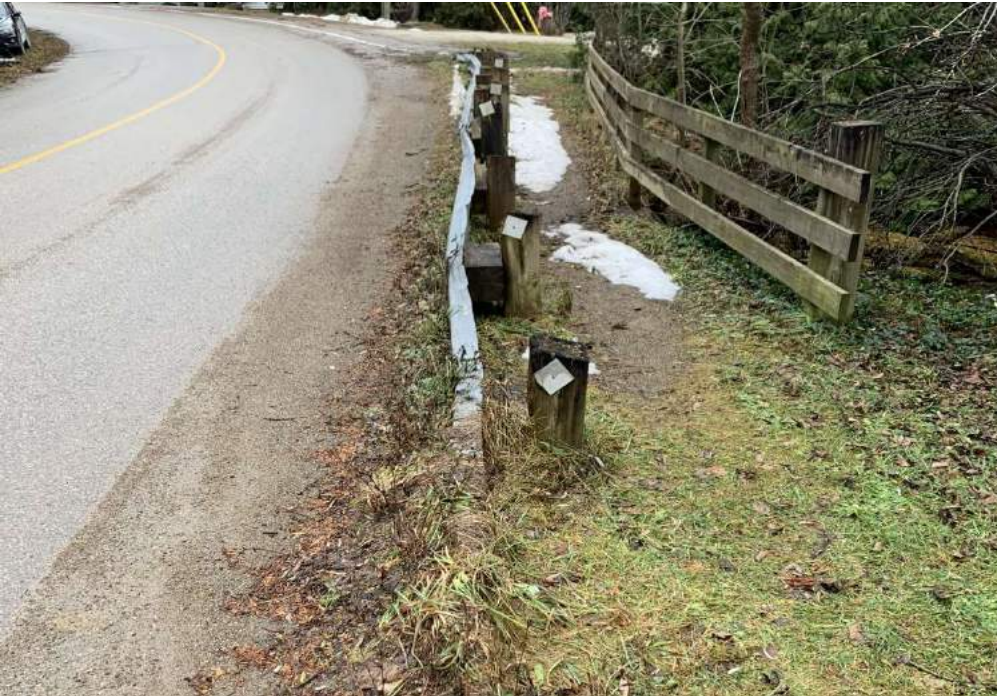
Photo 5-3: Impact damage to southeast barrier protection

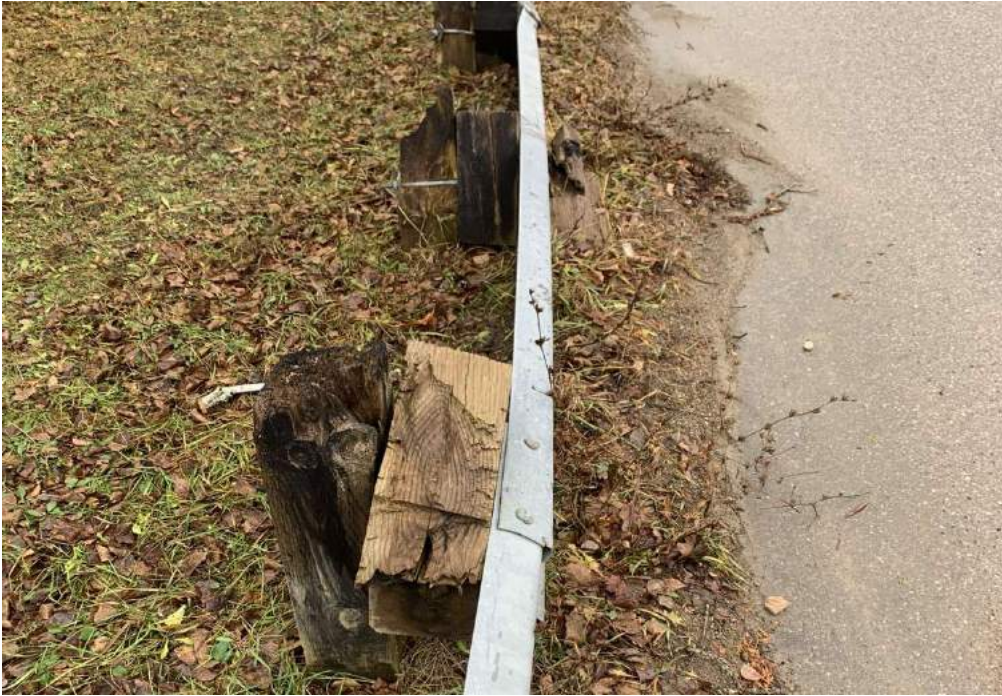
Photo 5-4: Wooden barrier post rot (typical)

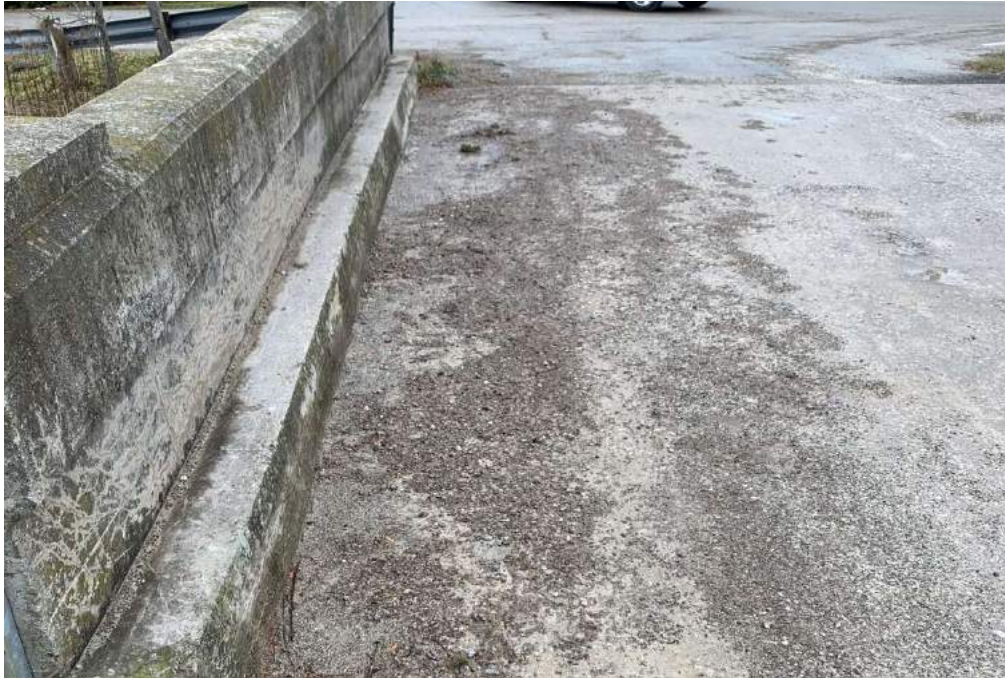
Photo 6-2: View of structure deck with delamination

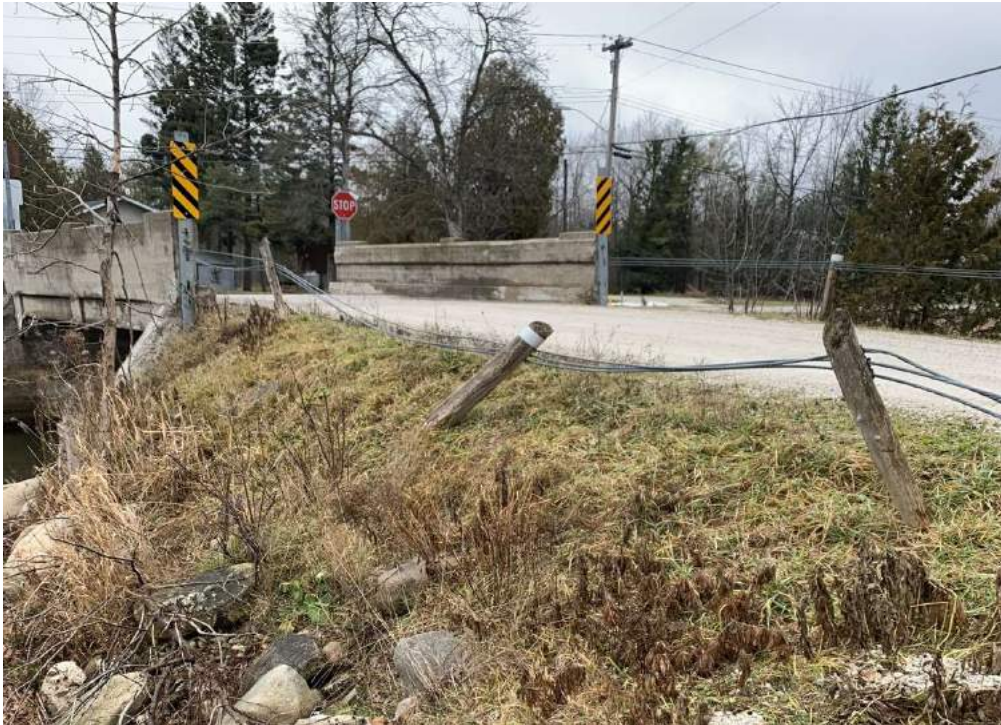
| <b>Comments:</b> | The configuration of the flex beam on the north side of the structure does not meet Code. There are missing intermediate posts, improper connections to the structure parapet walls, and lack end protection. The 3-cable guiderail on the south approach is set too high, the cable is loose, several posts are broken, and the structure connection is not to code. | | | | | | |

Photo 6-12: Embankment and deficient barrier protection

| <b>Recommended Work:</b> | None    6-10 Years    1-5 Years <input checked="" type="checkbox"/> < 1 Year    Urgent<br>Upgrade the north approach barrier protection and structure connection to meet current code. Replace the 3-cable south side barrier with flex beam. | | | | | | |

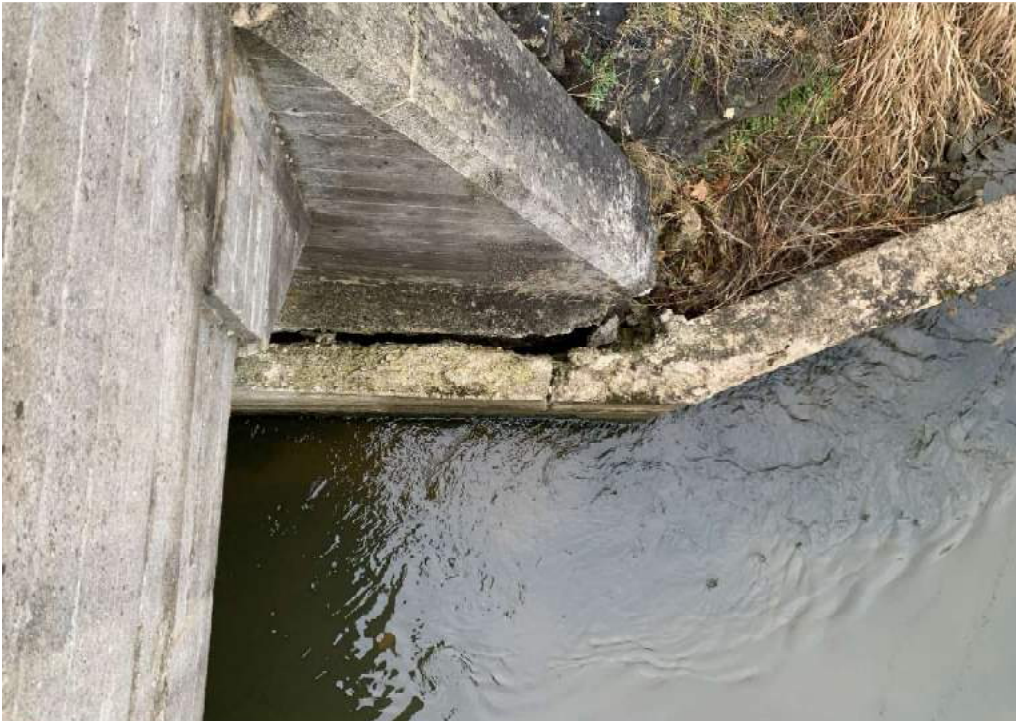
Photo 6-13: Wingwall and footing separation.

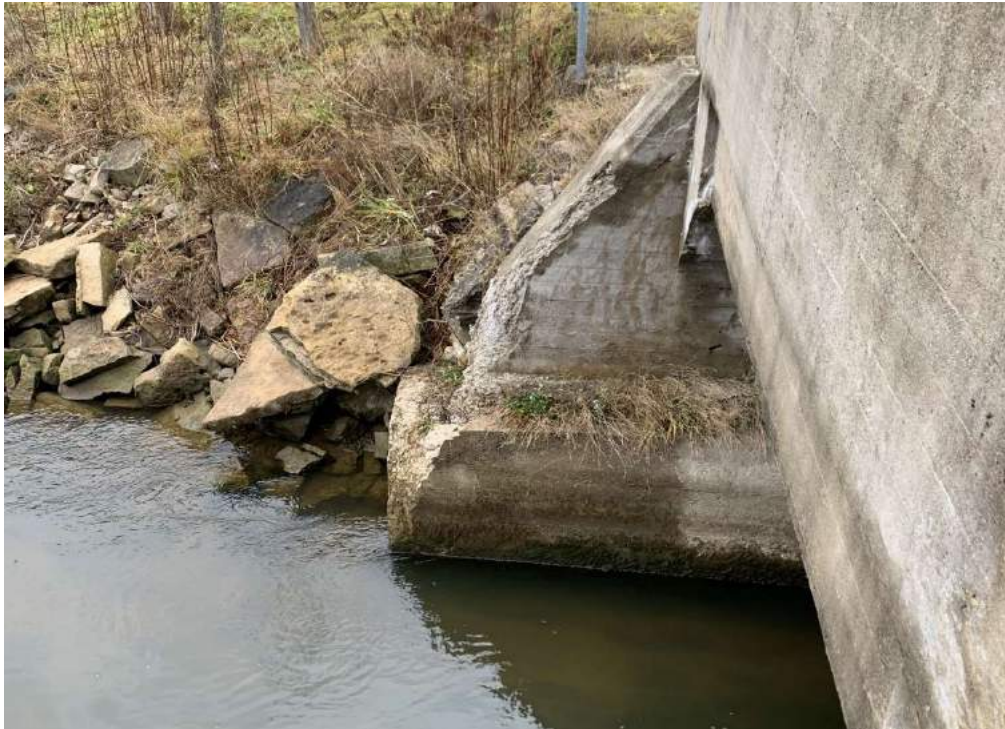
Photo 6-15: View of abutment wall and footing spalling.

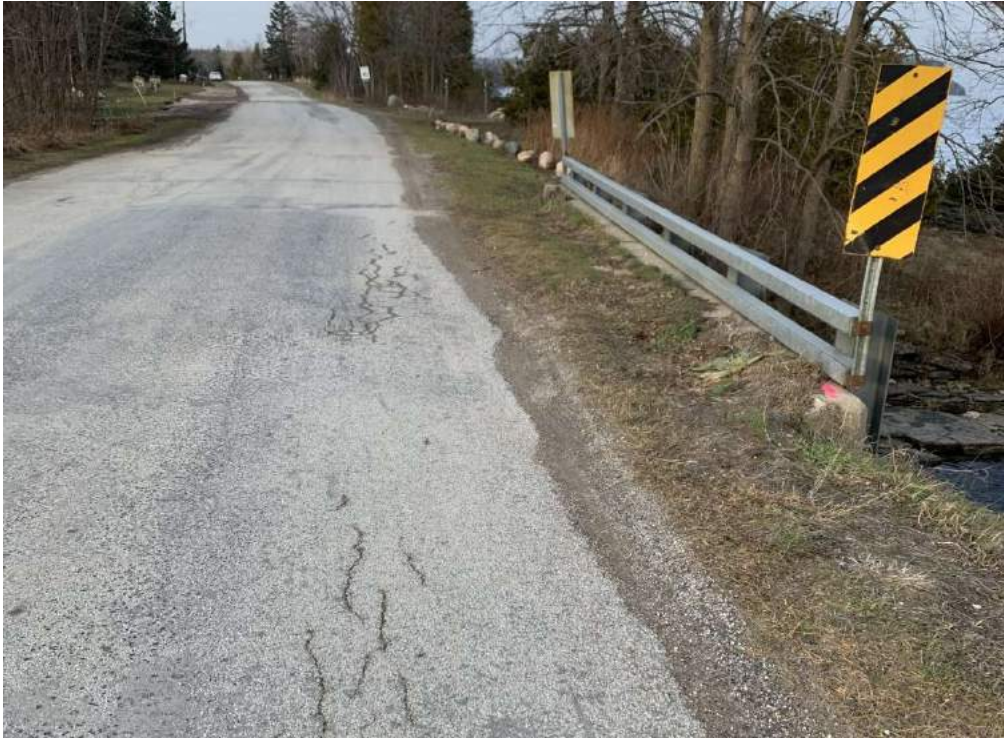
Photo 8-4: Deficient barrier termination and hazard signage

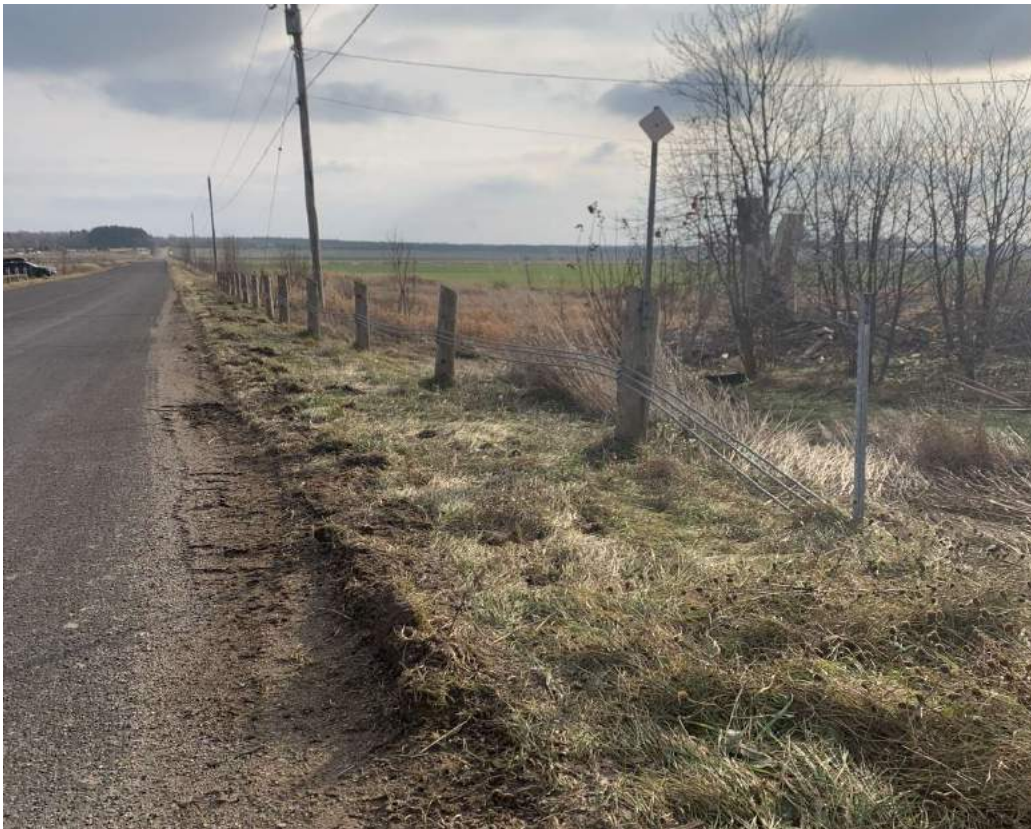
Photo 9-5 - View of 3 cable guiderail barrier protection with loose cable

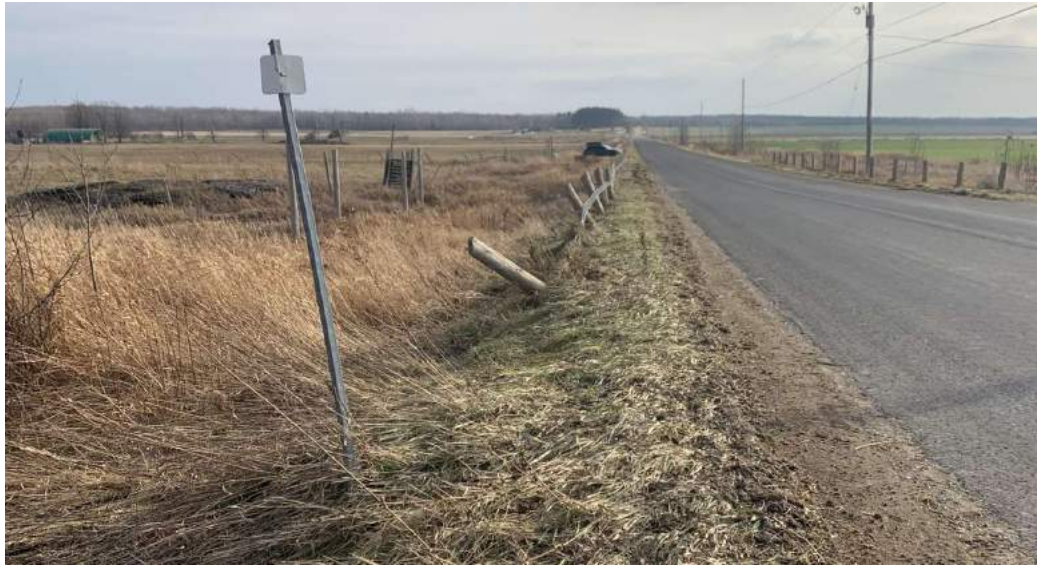
Photo 9-8 - View of northeast deficient section of 3 cable guiderail (impact damage)

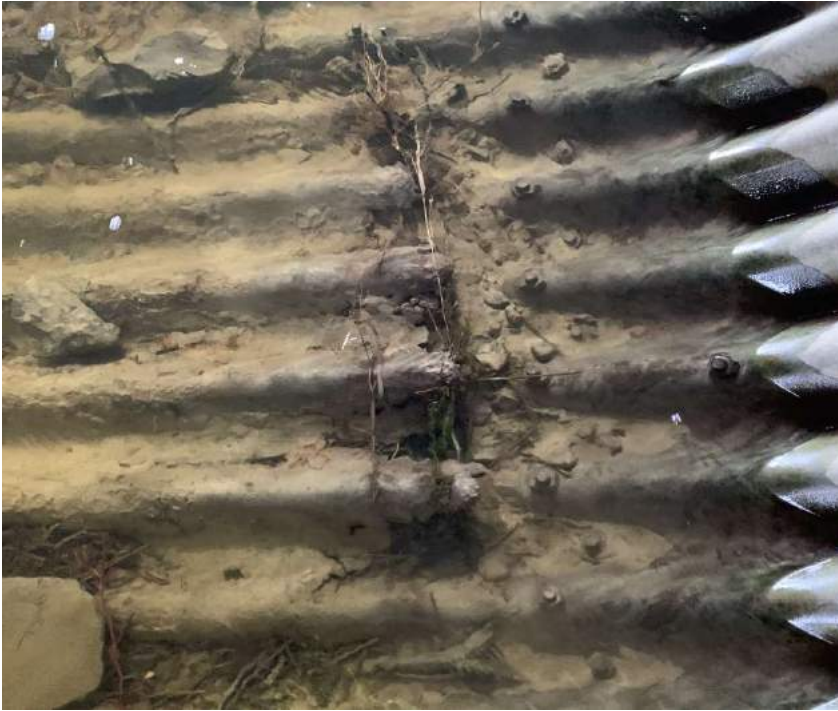
Photo 10-6: Localized failure with complete section loss in base of culvert.

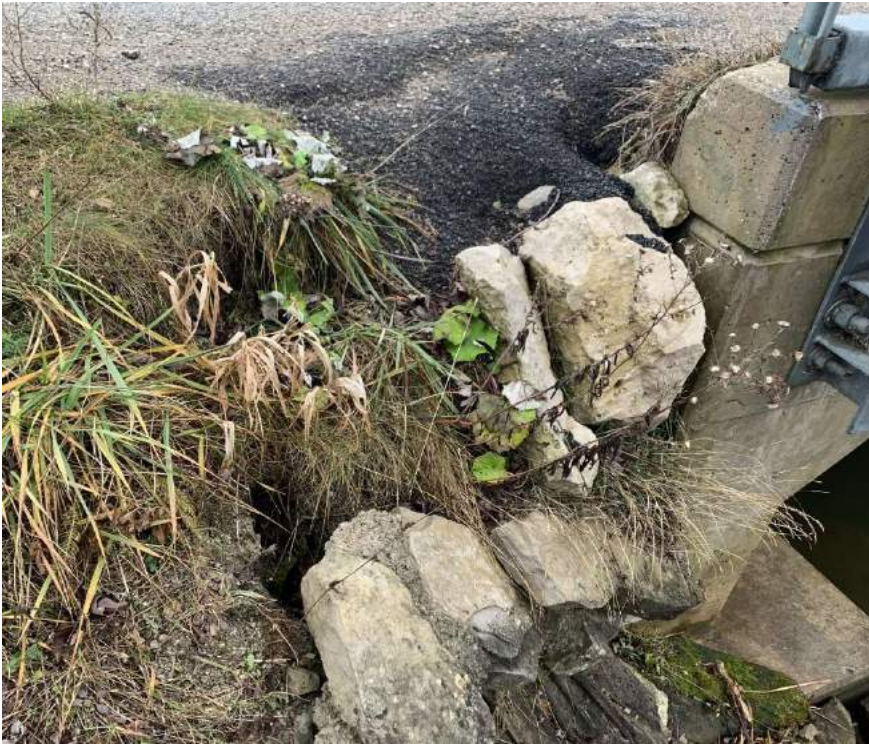
11-5: Rock slope protection and geotextile failure at the southeast quadrant

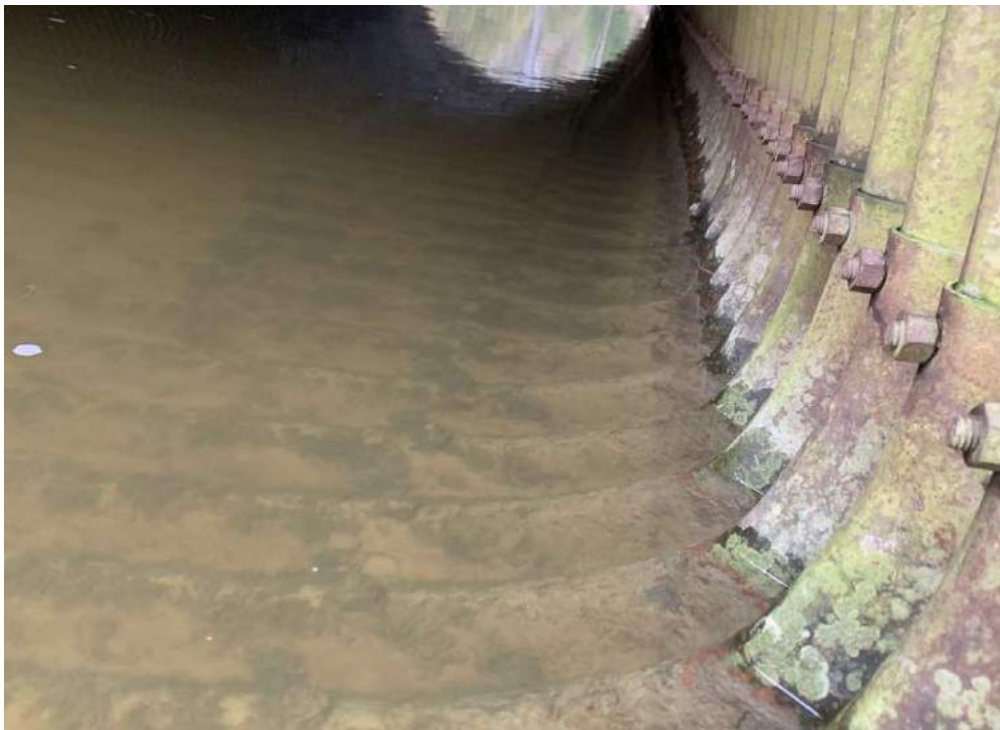
Photo 12-9: View of culvert barrel corrosion at the waterline (typical)

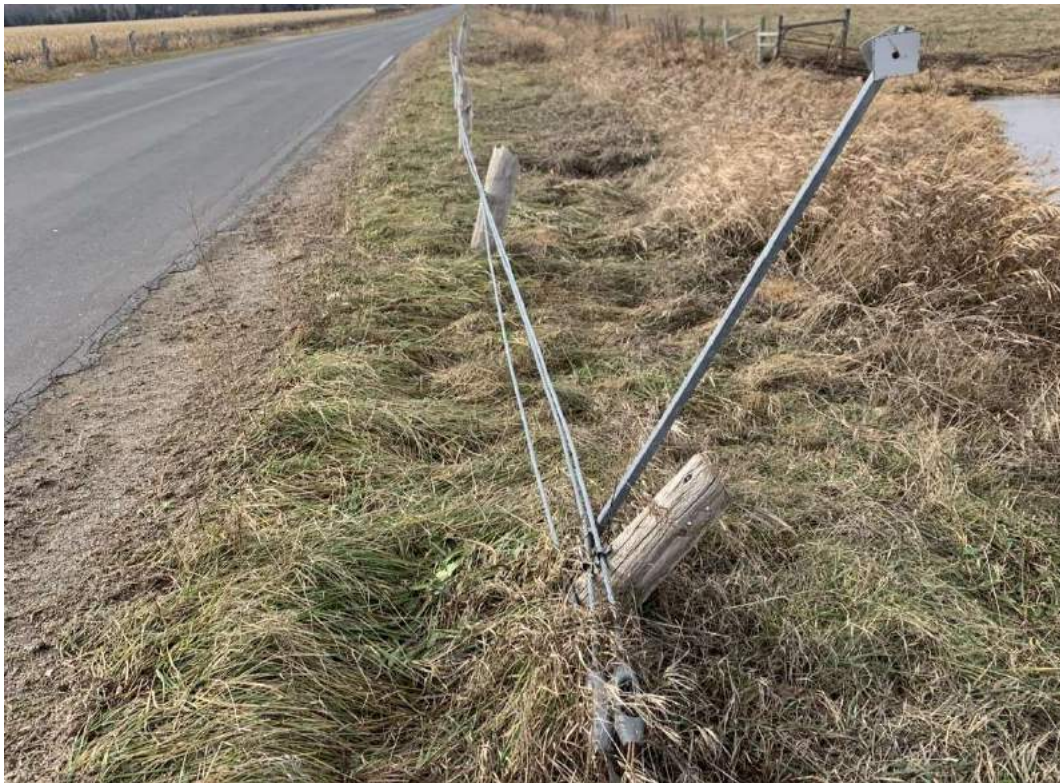
Photo 19-5: Impact damage to the northeast barrier protection post
