OPERATIONAL ASSESSMENT REPORT

LION'S HEAD MARINA

LION'S HEAD, ONTARIO

Planmac Ref. No. 1728

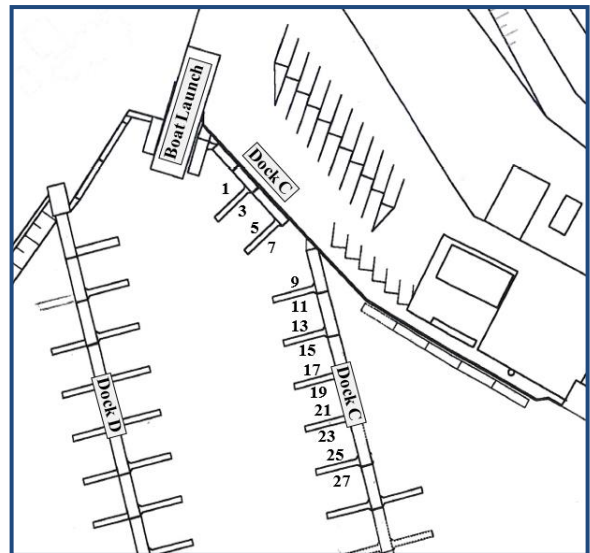
Figure 0-1: Proposed Location of Commercial Zone in Lion's Head Marina

Should the marina staff wish to assign an area of the existing floating docks to commercial vessels, we recommend slips 1, 3, 5 and 7 of Dock C. Should commercial activity in the marina grow beyond the berthing area provided by these four 30 ft slips, this commercial zone could be extended to the odd-numbered slips from 9 to 27 on Dock C. See Figure 0-1 for a diagram showing the location of these slips.

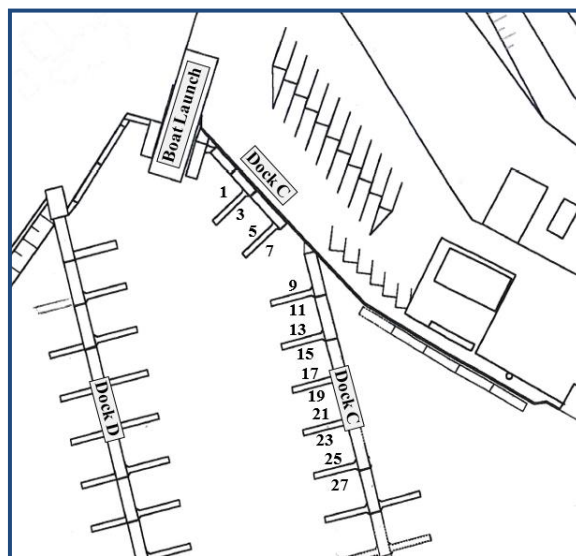
Figure 4-1: Proposed Location of Commercial Zone in Lion's Head Marina

Should commercial activities develop in the marina, Planmac recommends these vessels be assigned slips 1, 3, 5 and 7 of Dock C. These slips are located along harbour wall adjacent to the boat launch ramp, separate from the main length of Dock C. This area consists of four 30' slips on the two finger docks. Should commercial activities grow, this zone could be extended to slips 9 through 27 on Dock C. This is the portion of Dock C closest to the parking lot, where the dock's fingers only extend to the west. This area would be preferable for commercial vessels due to its proximity to the marina's buildings and parking facilities, and because it is located on slips near dock access ramps. This is important for commercial vessels with large passenger capacities, such as sight-seeing tour boats, as it encourages passengers to stay on land while waiting to board their vessel rather than queue on the narrow and less stable floating docks.

Should the marina staff wish to assign an area of the existing floating docks to commercial vessels, we recommend slips 1, 3, 5 and 7 of Dock C. Should commercial activity in the marina grow beyond the berthing area provided by these four 30 ft slips, this commercial zone could be extended to the odd-numbered slips from 9 to 27 on Dock C. See Figure 4-1 on page 4 for a diagram showing the location of these slips.

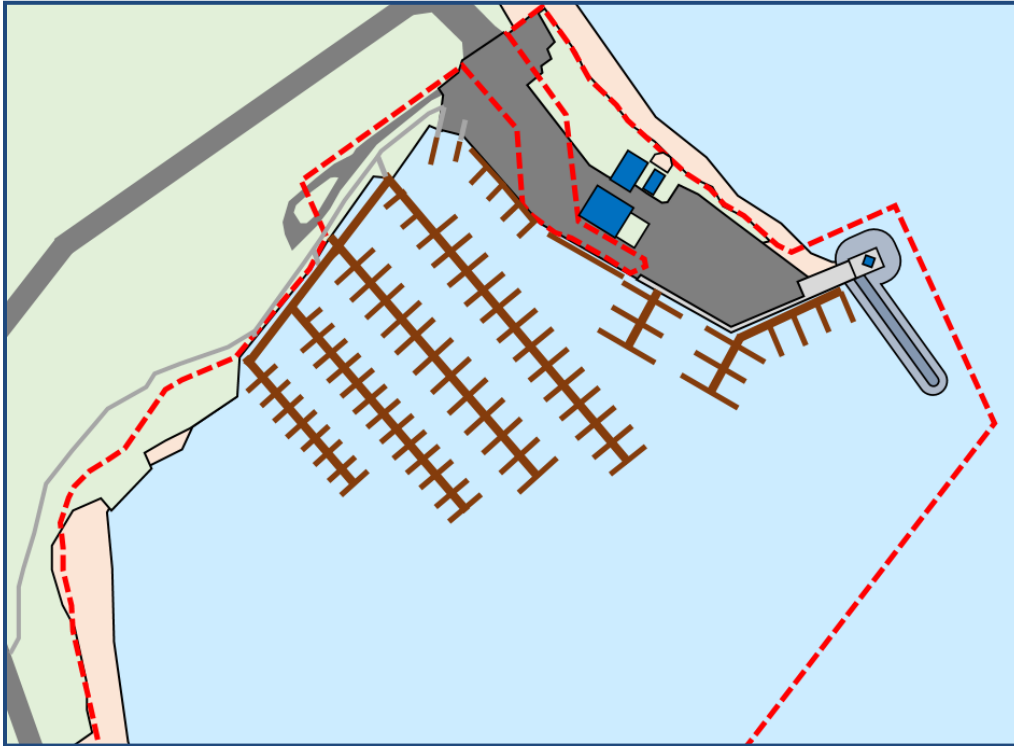
Figure 4-2: Dock Reconfiguration, Alternative 1

The first alternative dock reconfiguration involves moving Dock C to the west, next to Docks D-F, and rearranging the pieces of Docks A and B to form a new Dock B extending from marina wall south of the service docks, as well as a new Dock A running along the marina's south wall before extending out towards the southwest. See Figure 4-2, above, for a conceptual plan.

The downsides of this layout include the need to rearrange many of the docks, which can be time-consuming and costly. This new arrangement also increases walking time for private/residential boaters from the parking areas. Docks C-F would be placed closer together, but this would not significantly affect maneuverability.

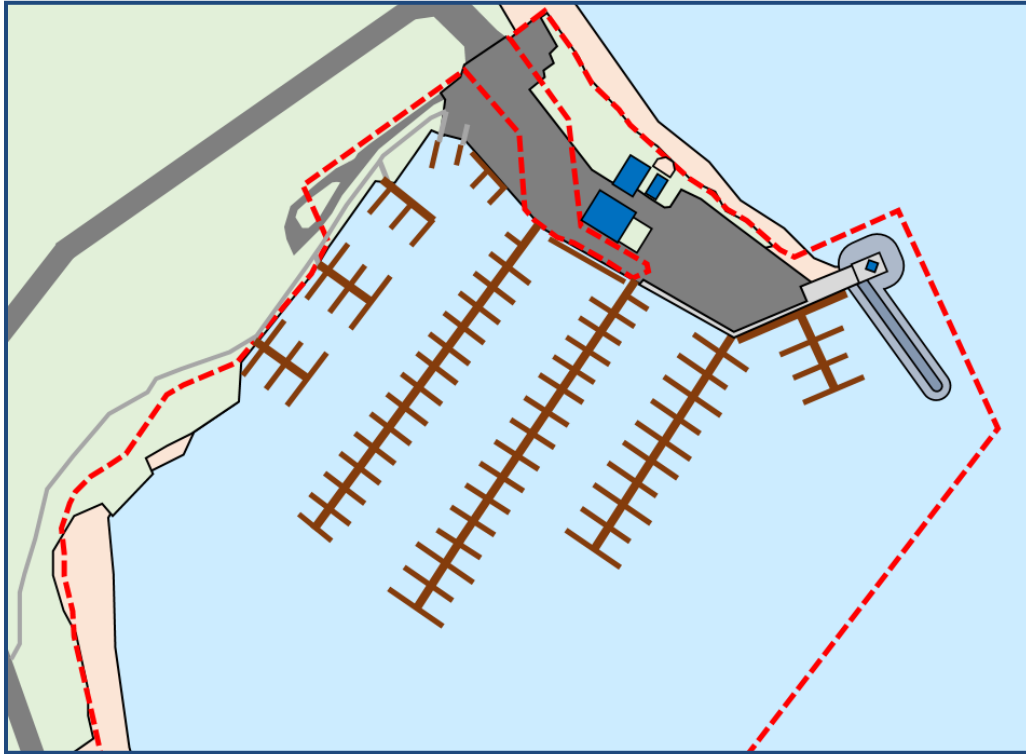
Figure 4-3: Dock Reconfiguration, Alternative 2

The second alternative reconfiguration involves rearranging the alignment of the docks to match that of the service docks and adjacent shoreline to the north. A new dock (new Dock C) can be added on the east side of the service docks. The existing Docks D-F (now Docks E-G) are shortened to become finger docks. See Figure 4-3, above, for a conceptual plan.

Benefits of this alternative include relocating Docks A and B to avoid the unprotected area behind the breakwater, providing immediate parking lot access to boat users from the parking lots to the vast majority of slips, and wide spacing between the docks, providing improved maneuverability. Drawbacks of this alternative include the need to rearrange many of the dock sections, the lack of direct access between the service dock to the boat launch, and the need for boats to travel further in the harbour on average to get to Georgian Bay from their slip.

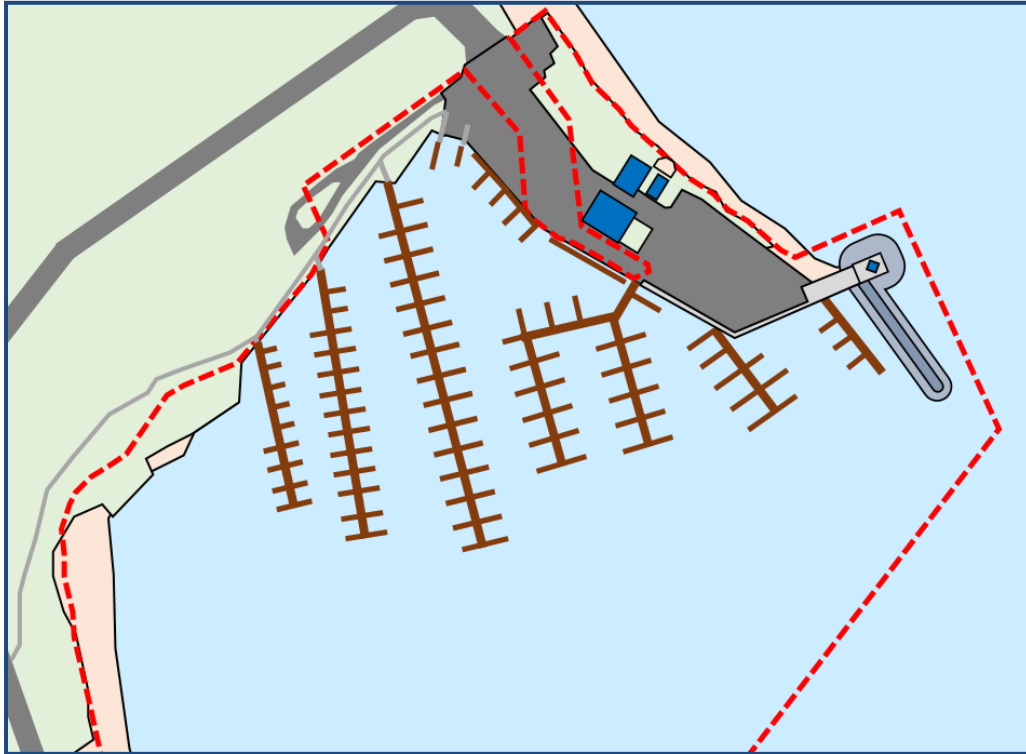
Figure 4-4: Dock Reconfiguration, Alternative 3

The third alternative reconfiguration primarily involves changes to Dock C. Its sections have been rearranged such that the new Dock C is accessed from a point immediately east of the service dock. This dock then branches into Dock C1, which extends southward, and Dock C2, which extends eastward before bending 90° to the south, after which it is aligned with Docks C2 and D. Docks A and B are shortened, and Docks D-F largely remain the same. See Figure 4-4, above, for a conceptual plan.

One main drawback of this alternative is the lack of sheltering from the harbour's rough weather conditions. While Docks A and B have been shortened slightly, the existing issues with damage from weather conditions will largely continue. Another drawback is that at times when the public boat launch ramp, service dock, mast crane and fuel pumps are all in use, the area of the harbour between Docks C and D will become very congested.

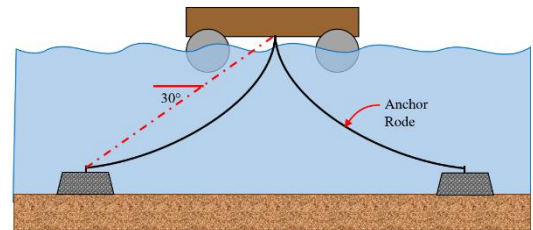
Figure 5.1: Deadman Anchoring Method

As mentioned in section 5.2.1, above, the floating docks in the Lion's Head Marina are concrete deadweight anchors. For the most part, these anchors are capable of holding their docks in place. However, due to the extreme and severe weather conditions acting on the floating dock system, the floating dock system fails. Planmac does not believe, however, that the failure of the docks during storms is a result of the anchoring method. The docks are subjected to such large forces during these events that if a stronger anchor were able to hold the docks in place, they would simply fall apart and detach. While past storms have caused anchors to shift and move, they have also caused welded steel joints to tear apart and anchor rodes to snap.
