MUNICIPALITY OF NORTHERN BRUCE PENINSULA

# 2022 STRUCTURE INSPECTION REPORT

FINAL  
PROJECT NO.: 201-01605-00  
DATE: APRIL 03, 2023

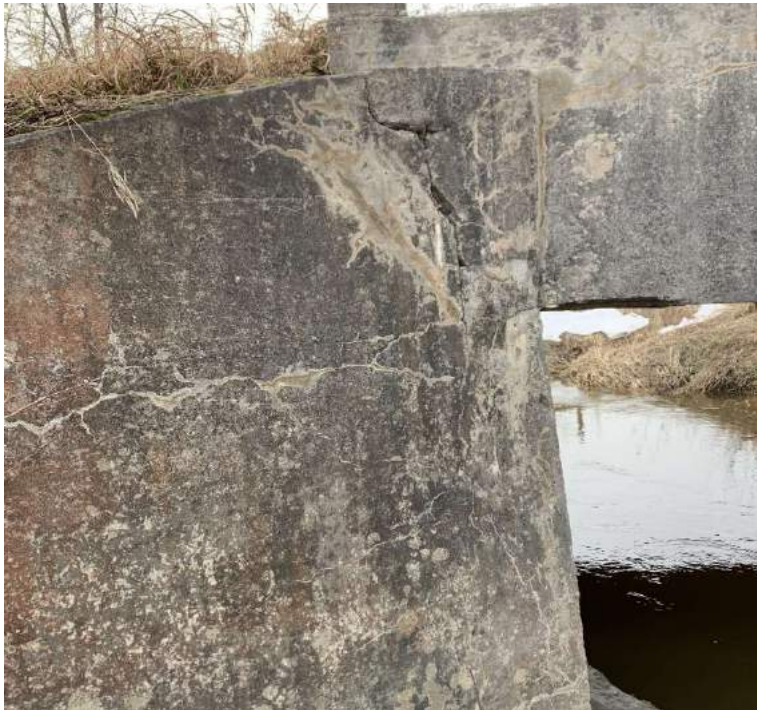
Photo 1-5: Wingwall deterioration (typ)

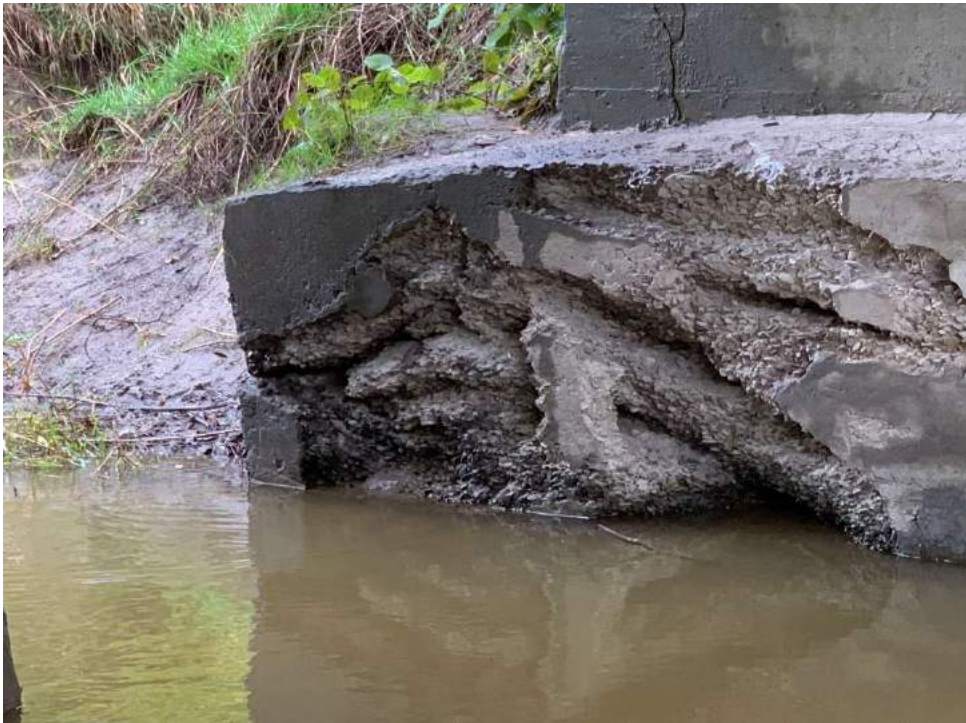
Photo 1-7 - Embankment erosion behind south footing and abutment (Sept. 24, 2020)

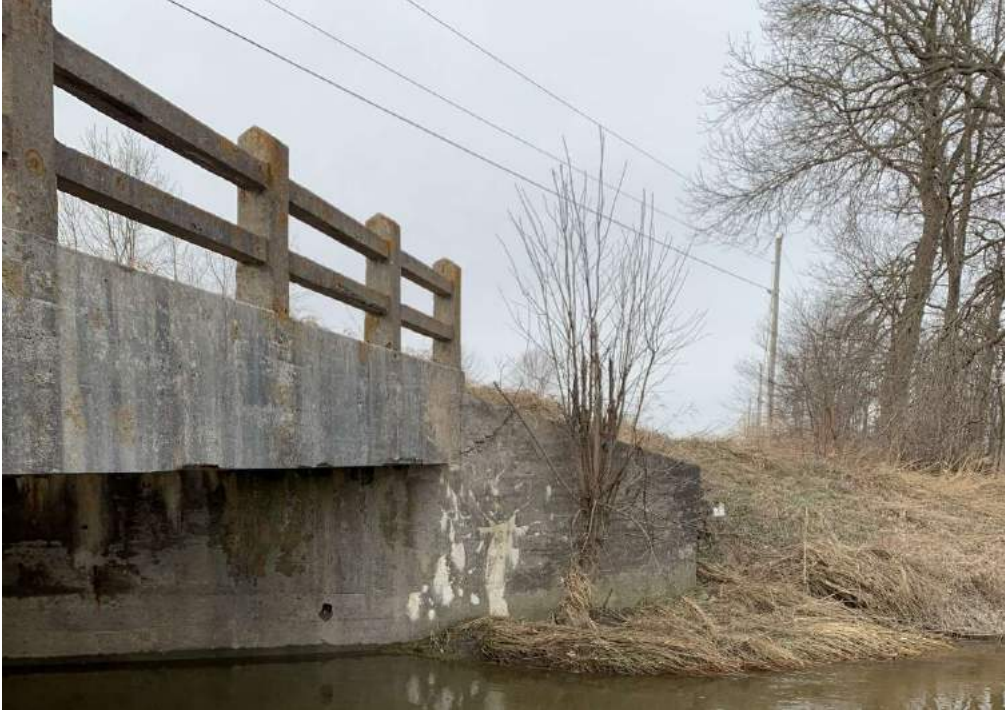
Photo 1-12 - Abutment wall drain and wingwall

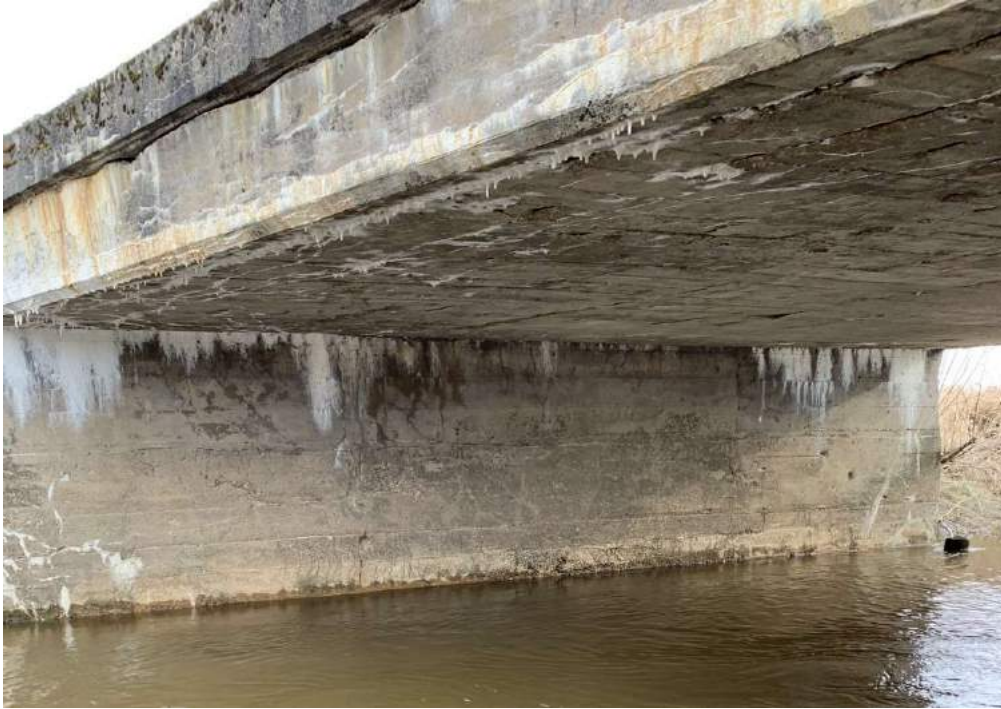
Photo 2-6: Extreme efflorescence at joints

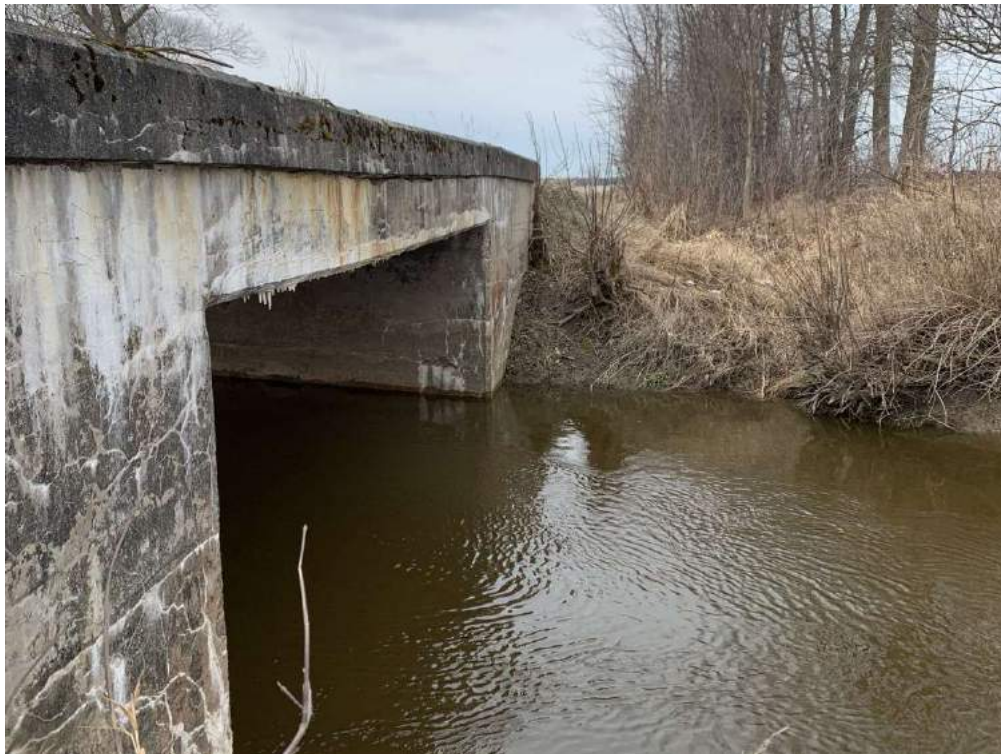
Photo 2-7: Erosion at structure footing, efflorescence of wingwall (typ)

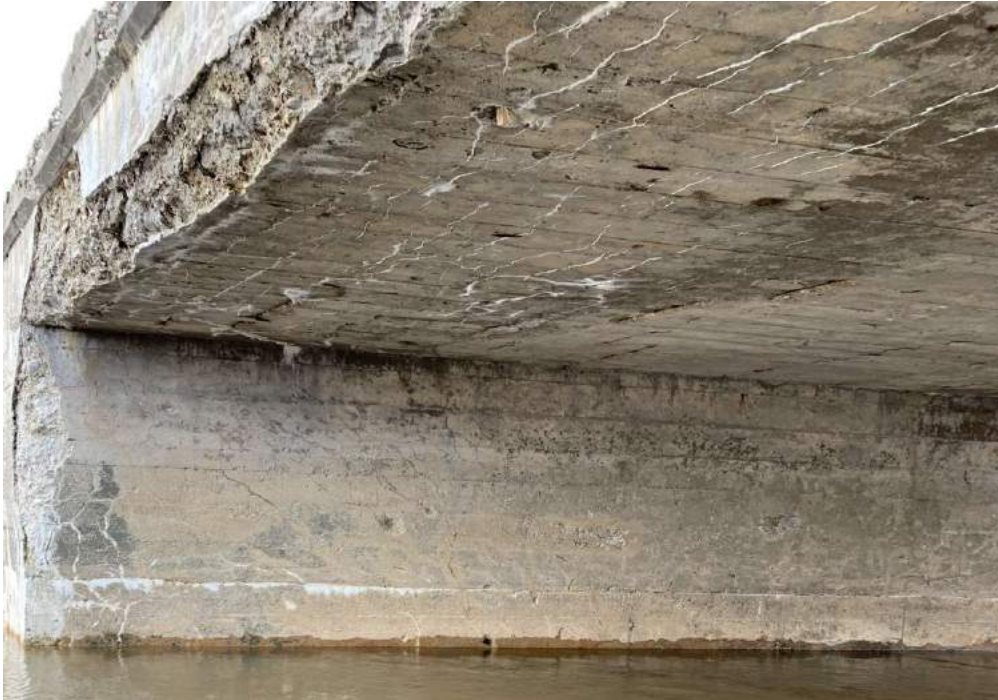
Photo 2-8: Delamination of soffit

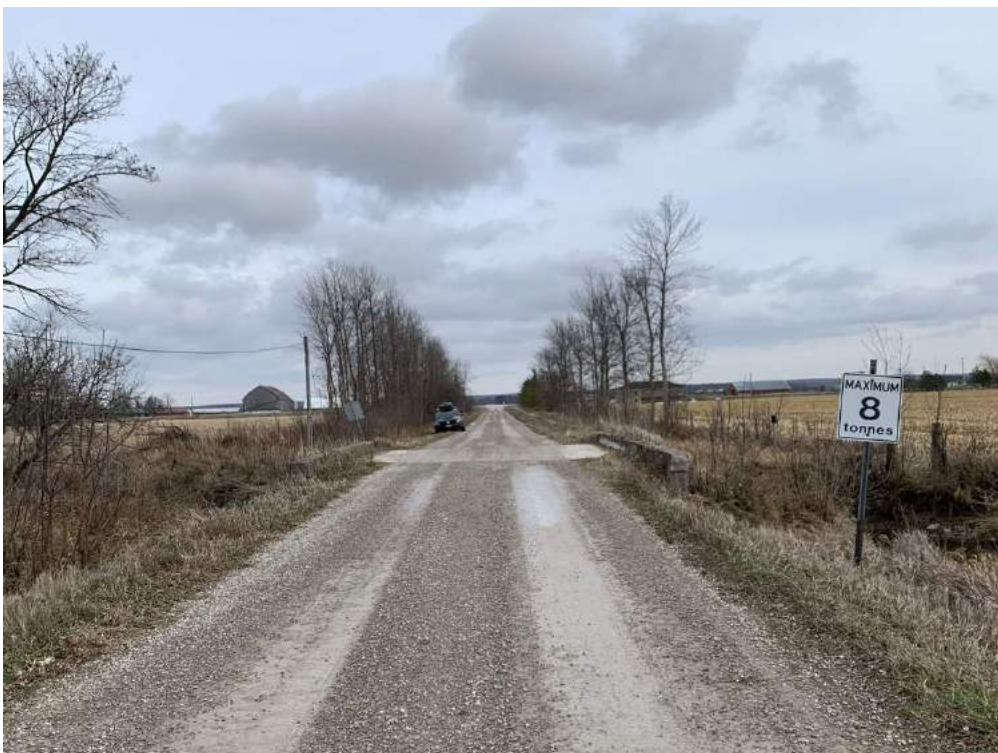
Photo 2-9: Load limit posting

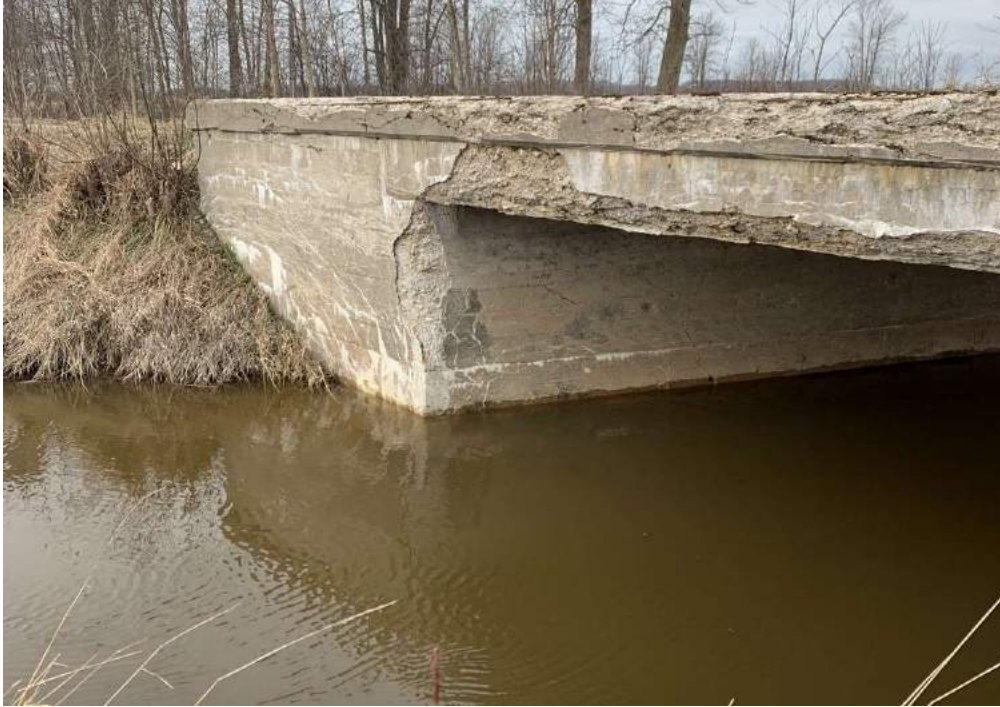
Photo 2-12: Wingwall, abutment wall and exterior soffit delamination.

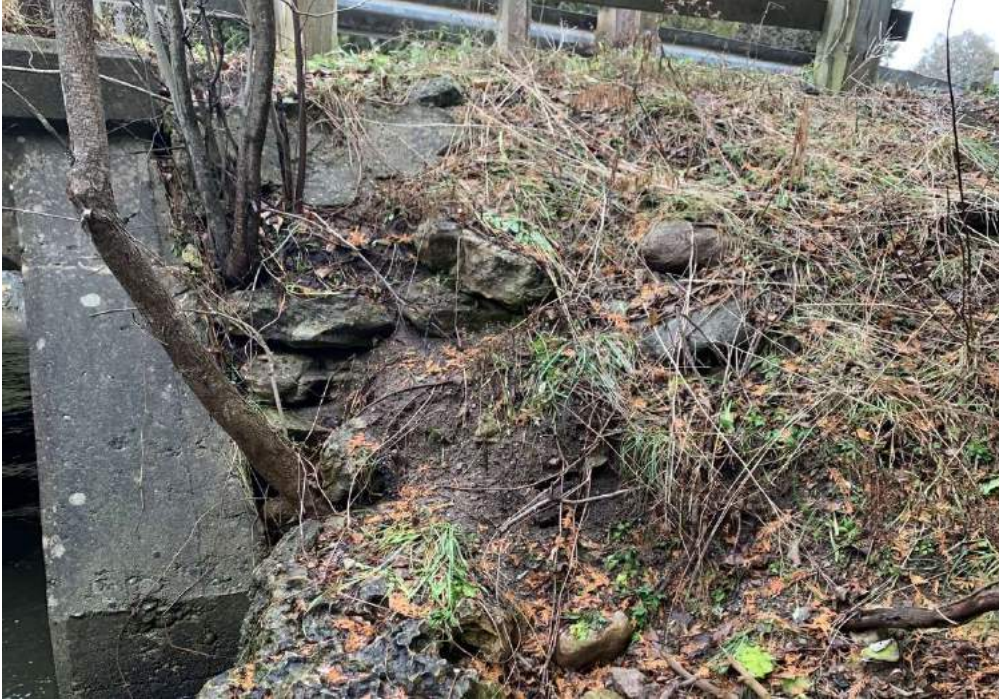
Photo 5-6: Southeast structure embankment erosion

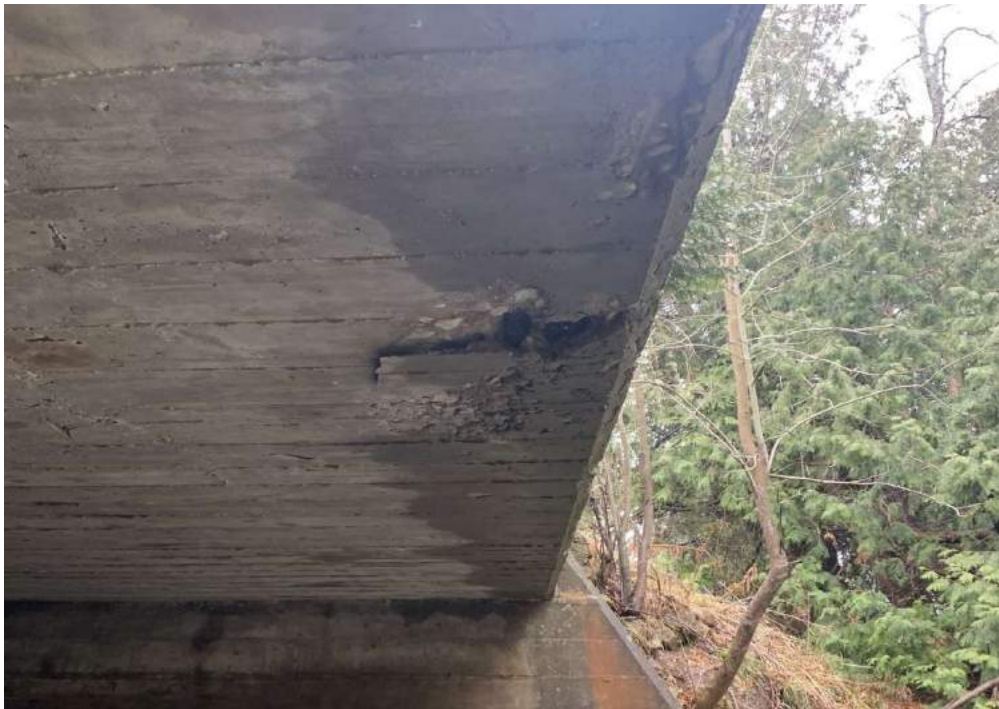
Photo 5-8: View of structure soffit

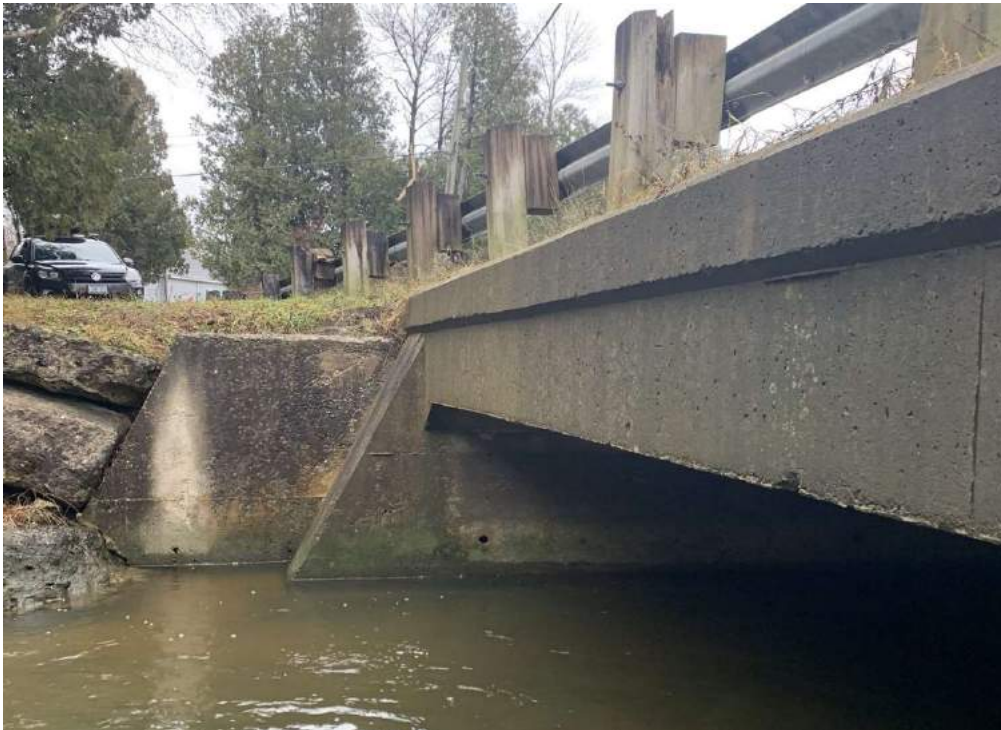
Photo 5-11: View of north structure elevation, exterior curb and soffit and northwest wingwall

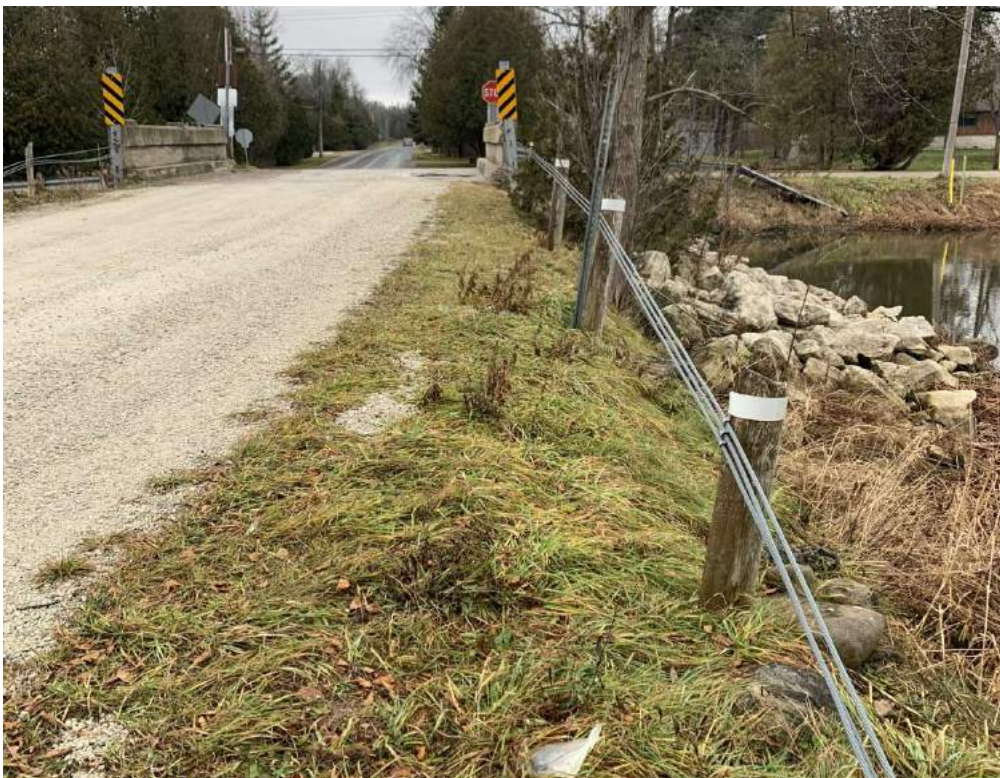
Photo 6-3: View of structure from south approach

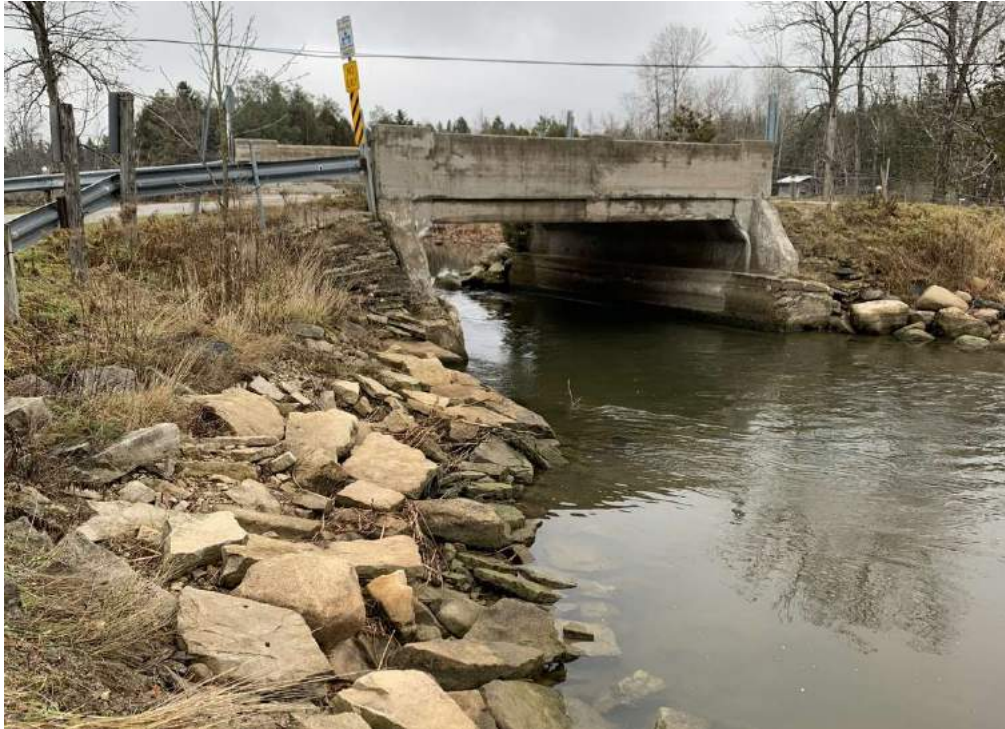
Photo 6-4: View of west structure elevation, slope protection and exterior of parapet wall

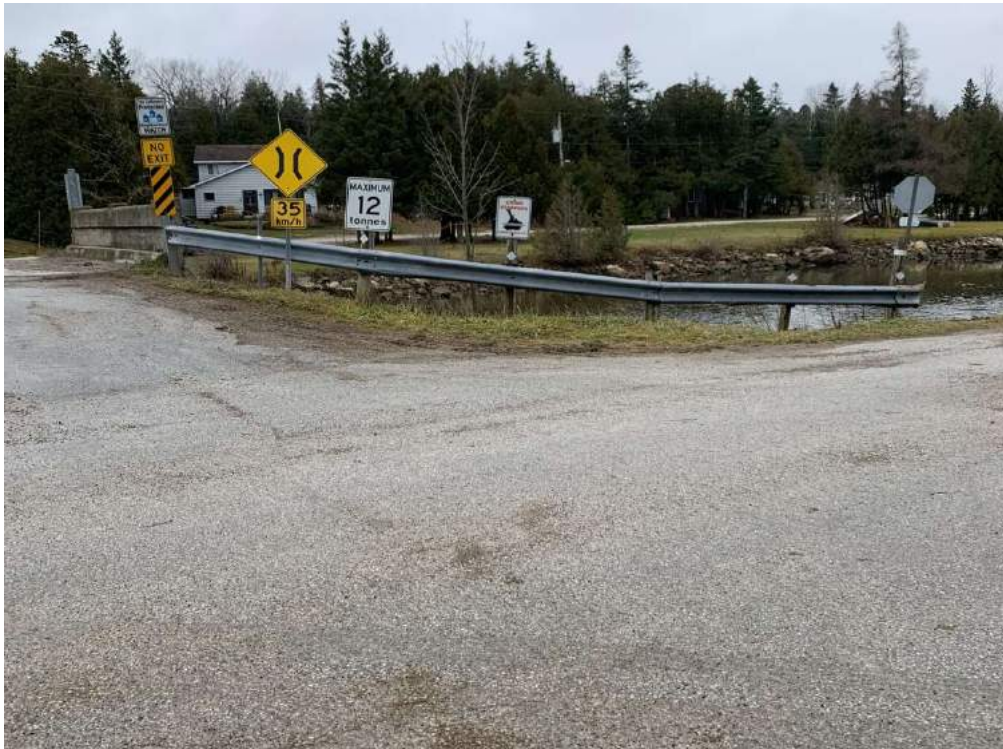
Photo 6-5: View of approach barrier flex beam and wood posts

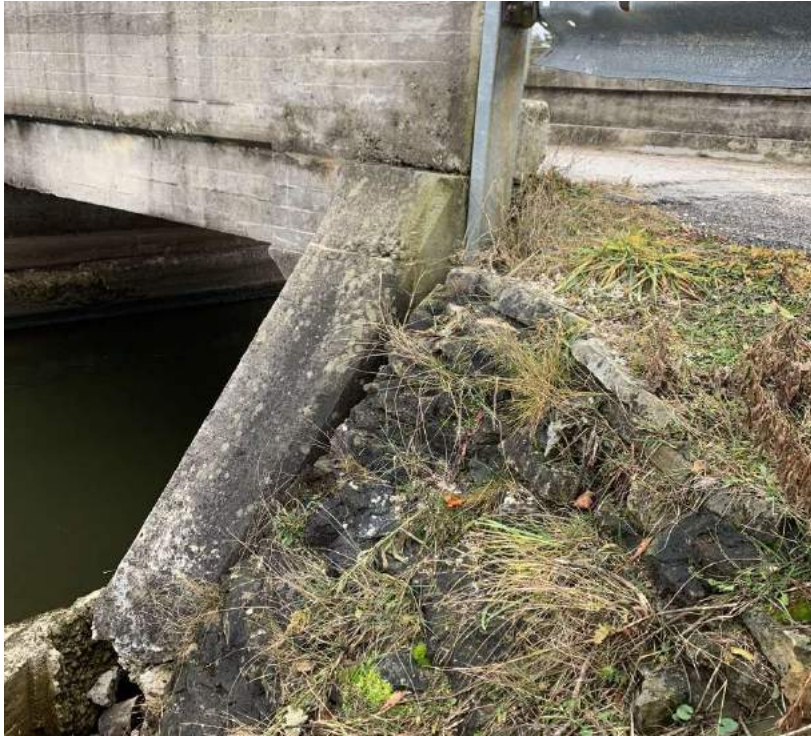
| <b>Comments:</b> | The northeast wingwall previously failed and was replaced with rock protection; however, severe scour was observed behind the rock protection and abutment wall/footing. The northwest wingwall is severely cracked and separating from the abutment wall connection. | | | | | | |

Photo 6-6: View of west structure elevation, wingwalls, exterior curb and parapet wall

| | Monitor inlet conditions frequently. Replace wingwalls or place rock protection to prevent further scour/undercutting of abutment wall/footings. | | | | | | |

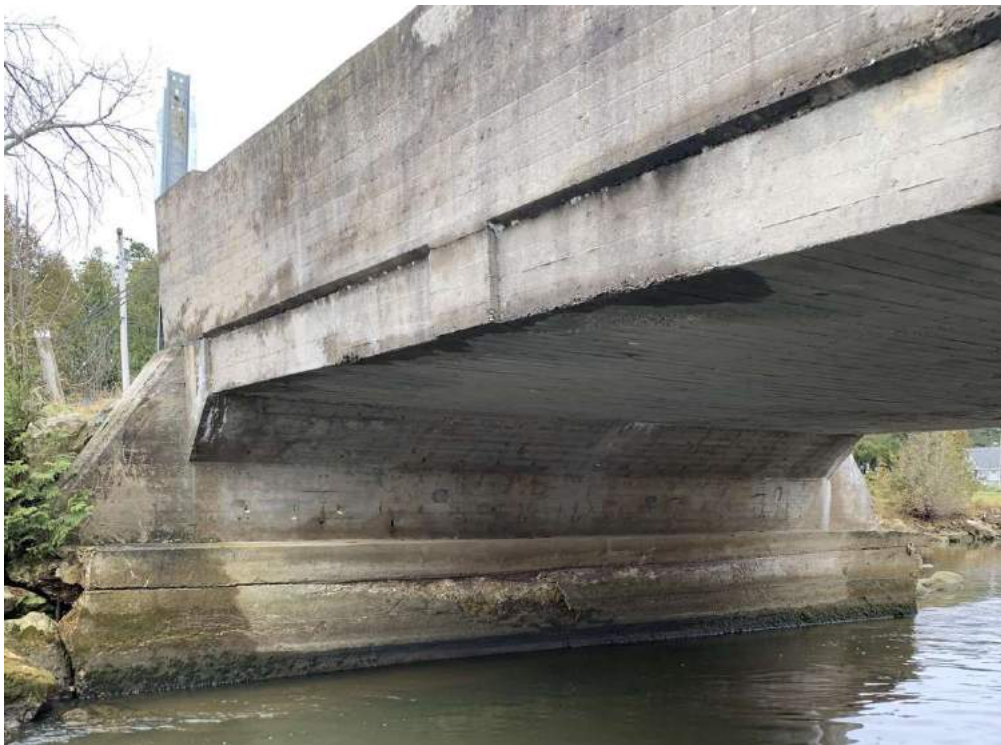
| Comments: | Observed spalling, cracking, and staining with effervescence of the soffit. The spalling is severe at all corners. The southeast haunch is in very poor condition. | | | | | | |

Photo 6-7: View of structure soffit and footing/abutment wall.

| Recommended Work: | None    6-10 Years <input checked="" type="checkbox"/> 1-5 Years    < 1 Year    Urgent<br>Remove all poor concrete, clean reinforcing steel and replace concrete. | | | | | | |

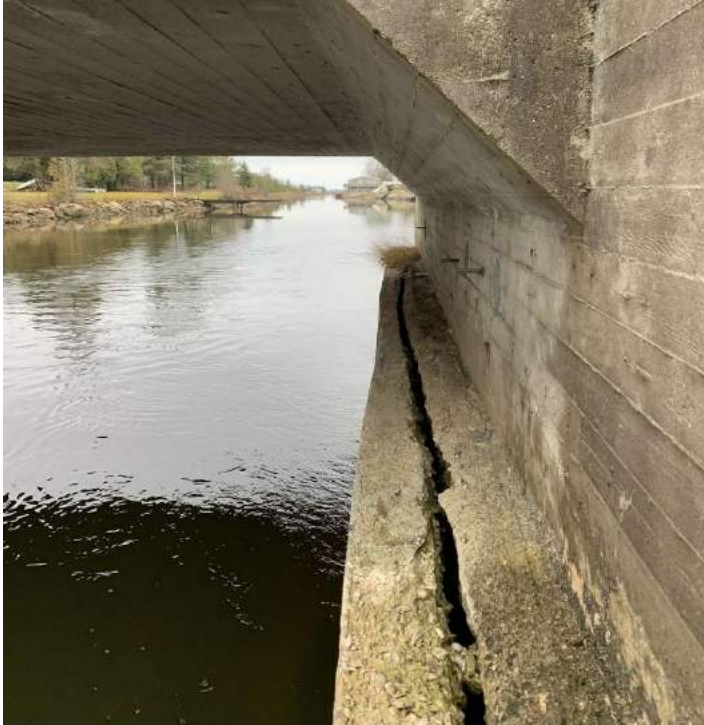
| <b>Comments:</b> | Footings are exhibiting severe spalling and delamination. Both footings are severely split longitudinally throughout, and are separating from the abutment walls. Damaged inlet wingwalls allowing water to flow through cracked sections causing concrete erosion and undermining the structure. Concrete between separation is very soft and unstable. | | | | | | |

Photo 6-8: View of foundation crack/separation and abutment wall

| | Replace wingwalls and repair damaged/undermined footings to prevent further erosion and complete loss of structure stability. | | | | | | |

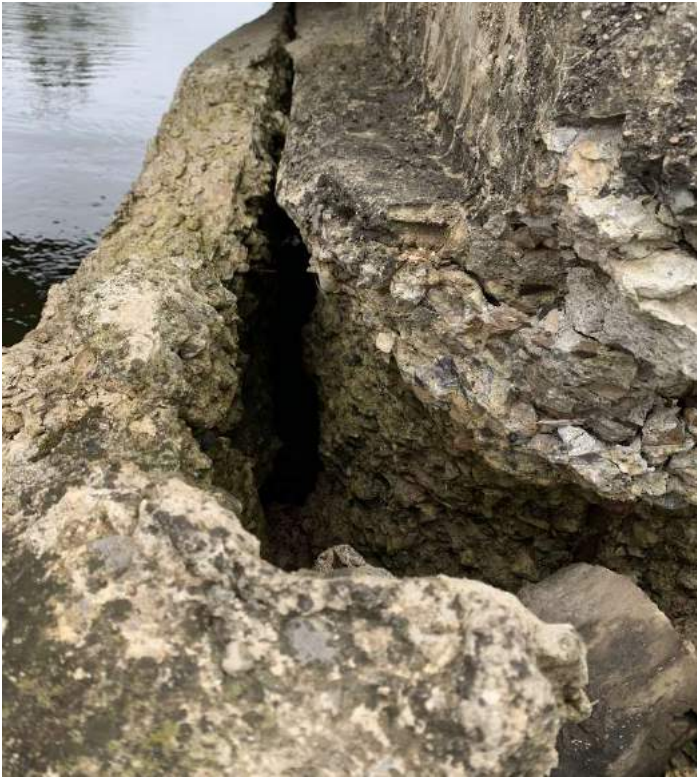
Photo 6-9: Foundation separation and concrete erosion.

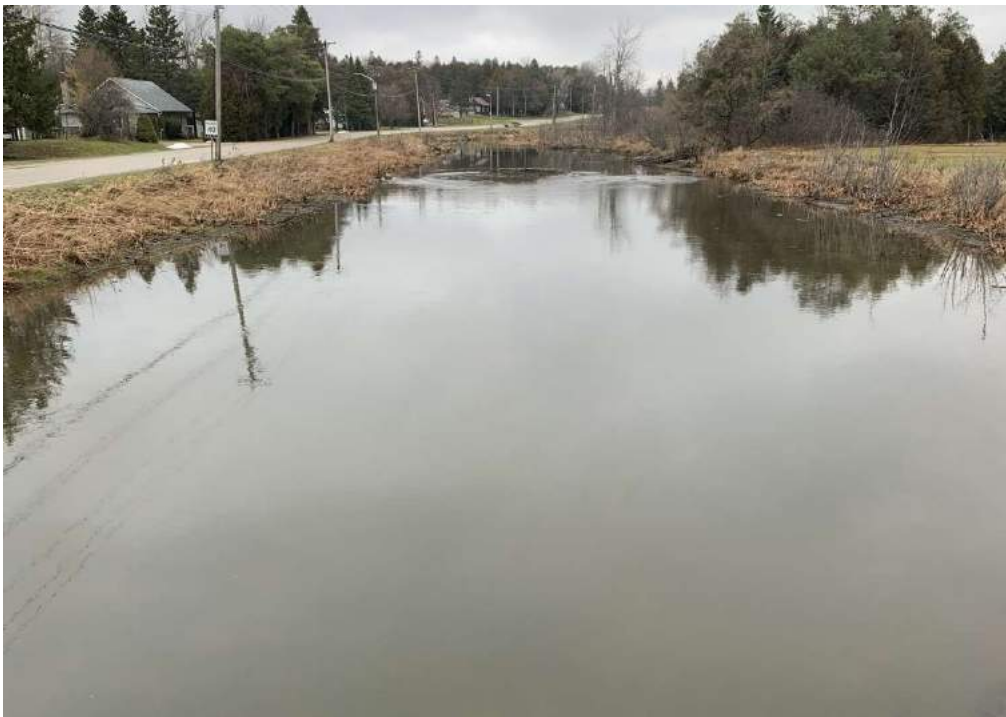
Photo 6-11: View of watercourse upstream

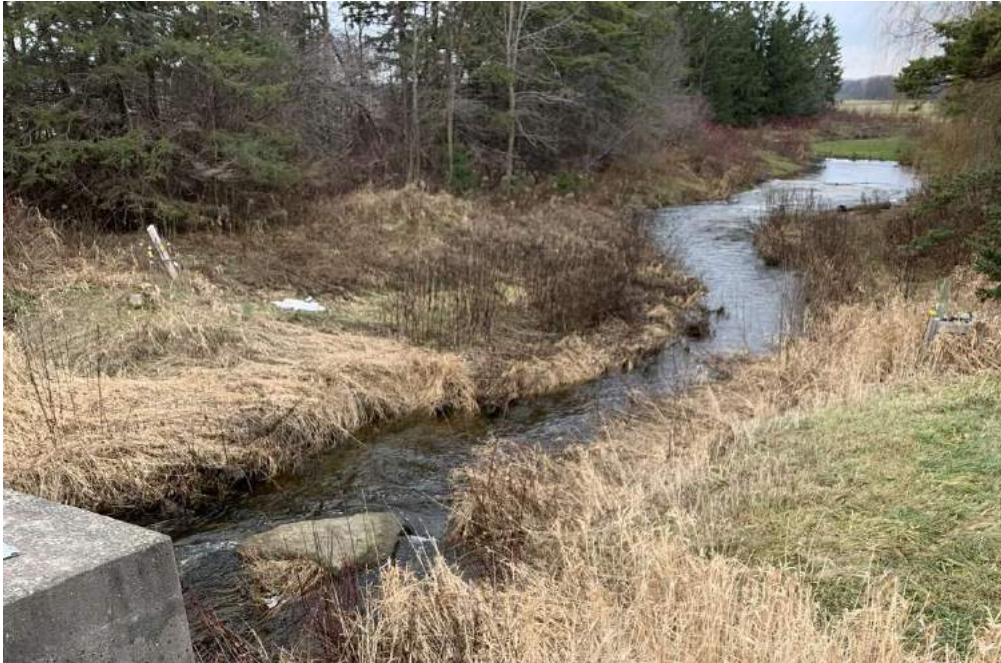
Photo 7-2: View of watercourse upstream and upstream culvert end

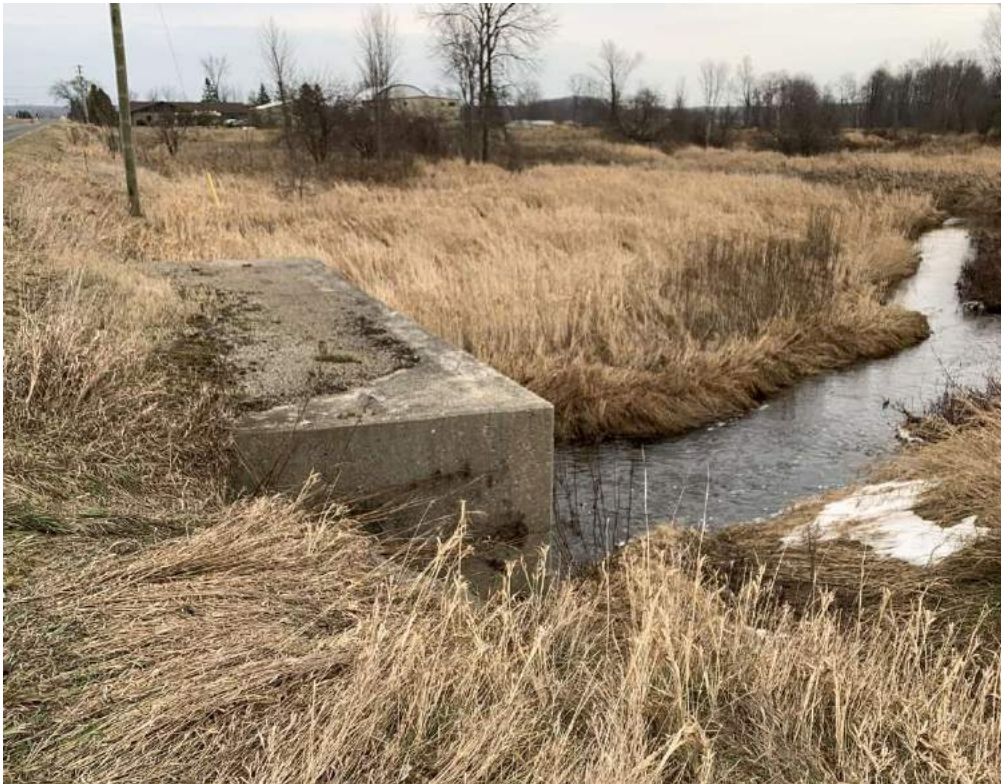
Photo 7-3: View of watercourse downstream and downstream culvert end

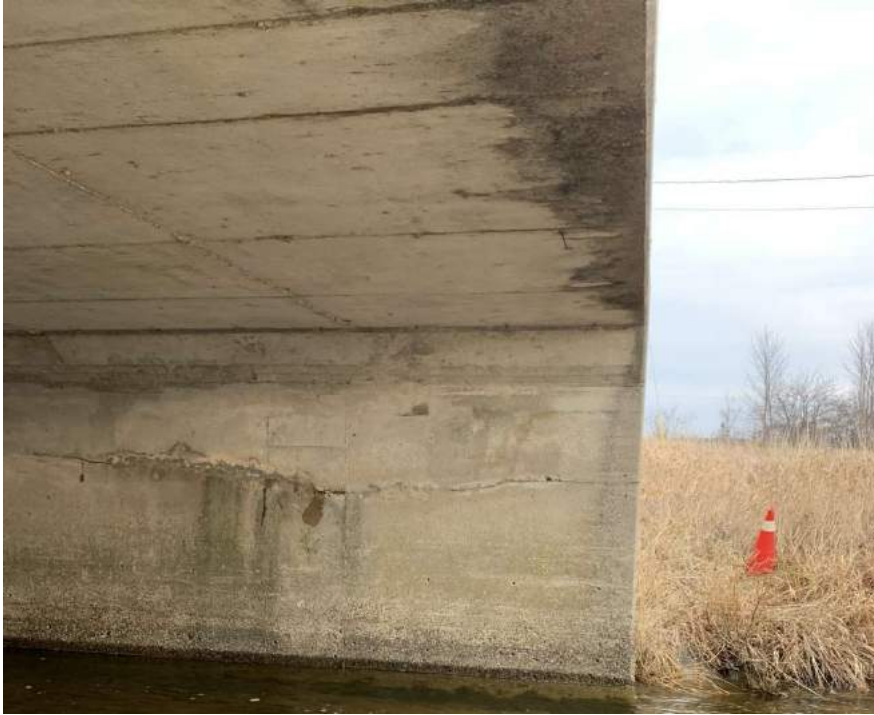
Photo 7-6: View of soffit and abutment walls

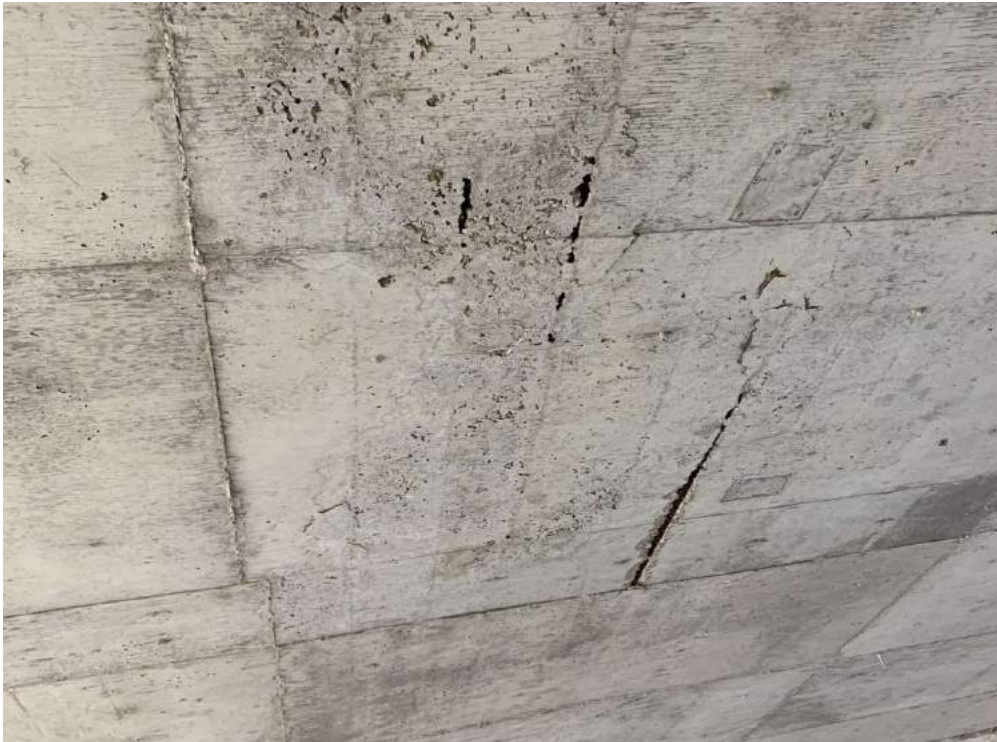
Photo 7-7: View of soffit

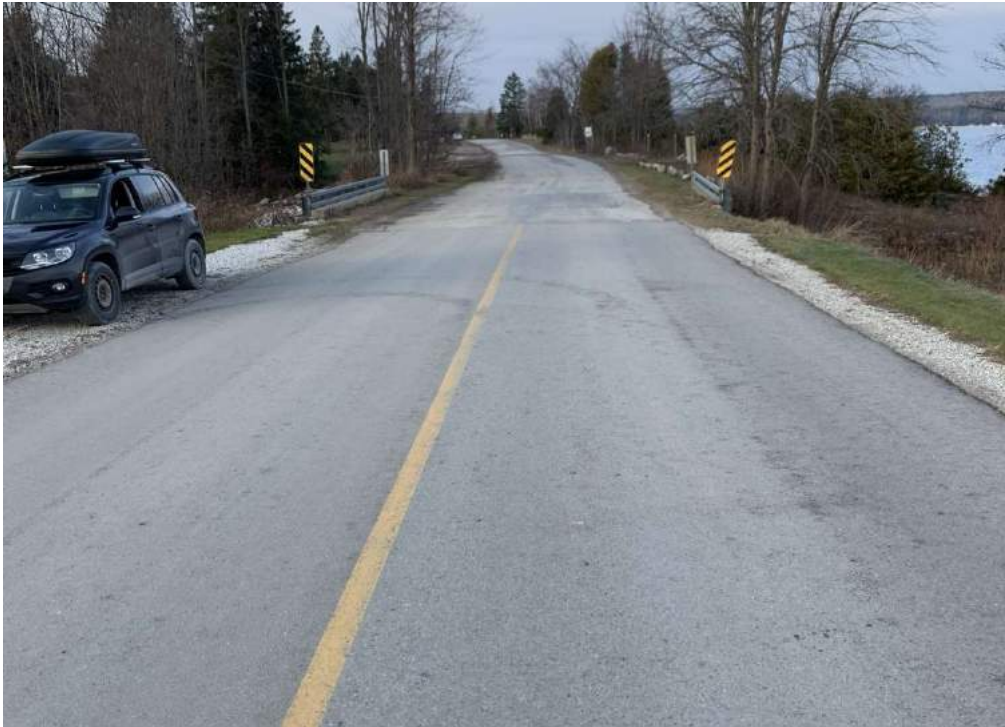
Photo 8-2: View of structure barrier, signage (typ) and encroaching vegetation

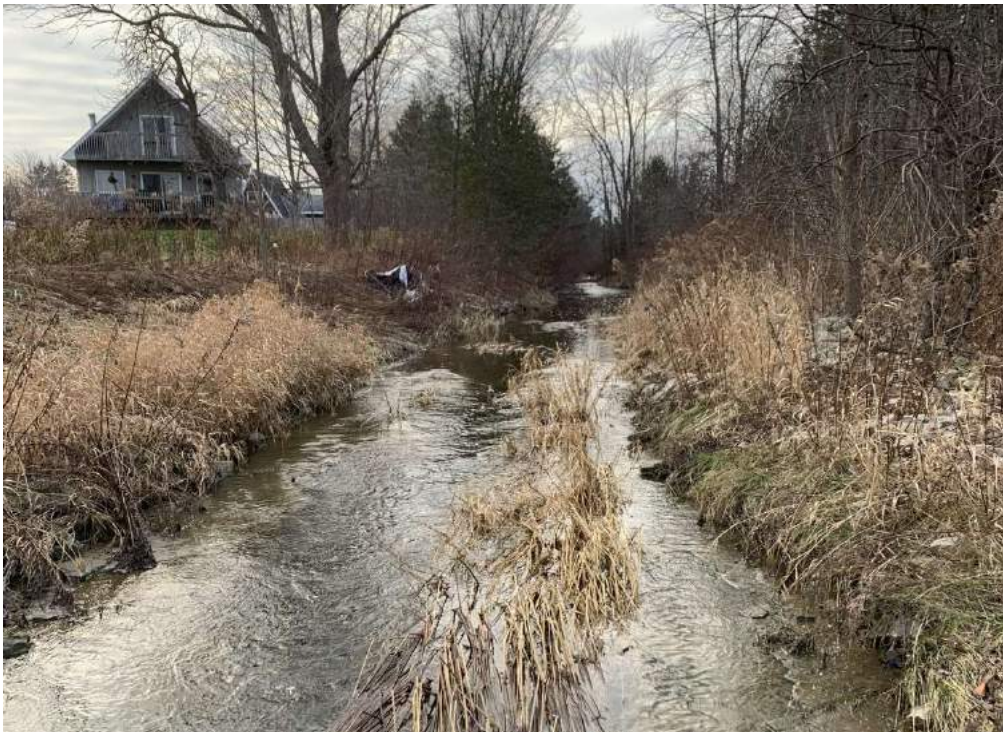
Photo 8-3: View of watercourse upstream

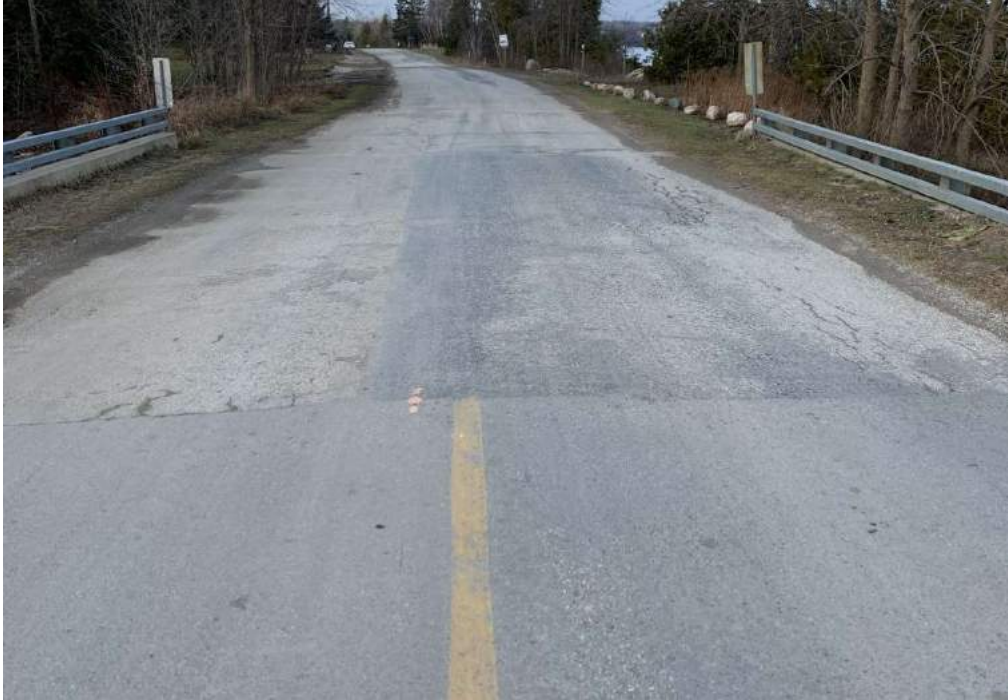
Photo 8-6: View of structure approach and deck wearing surface

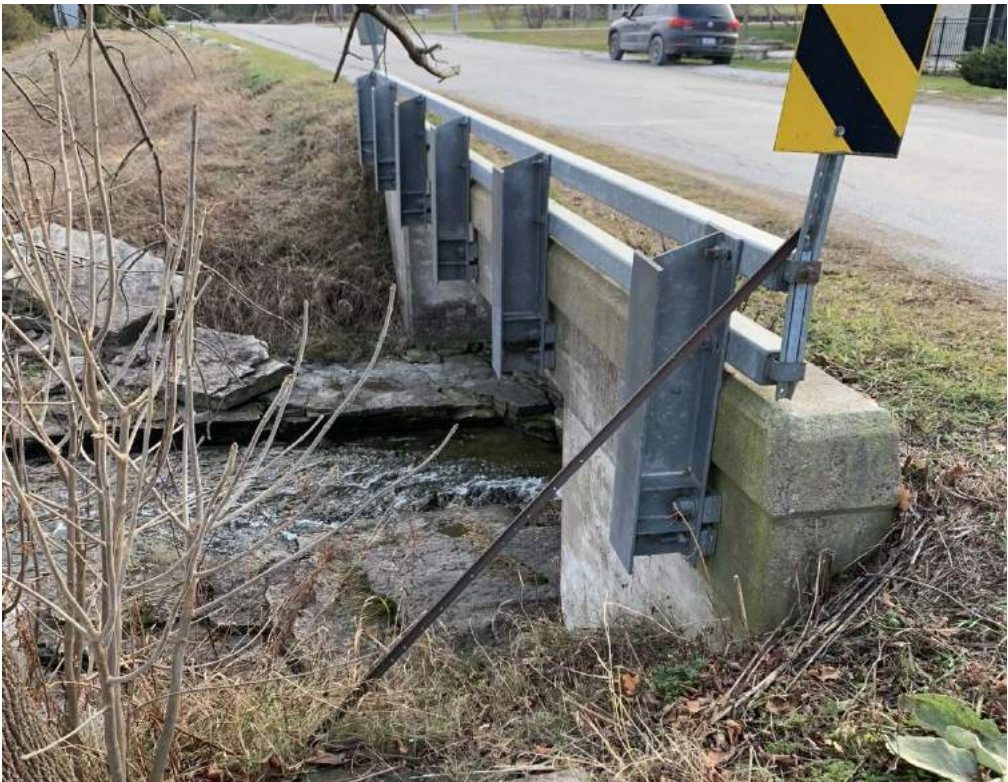
Photo 8-7: View of east structure elevation, wingwalls, exterior soffit and curb

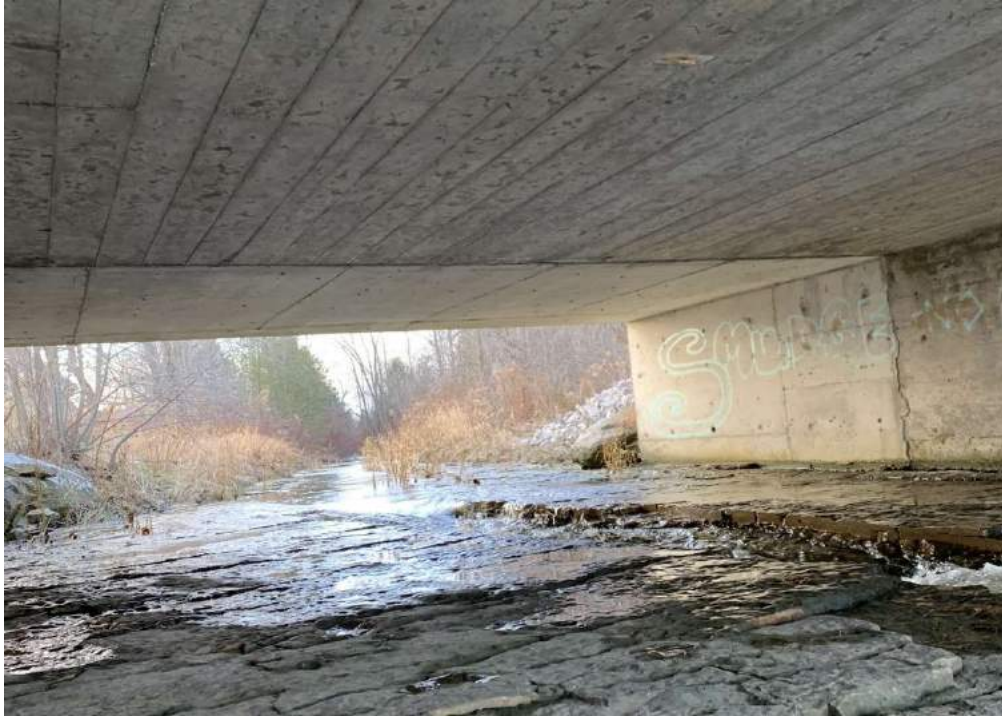
Photo 8-8: View of north abutment wall and bedrock streambed

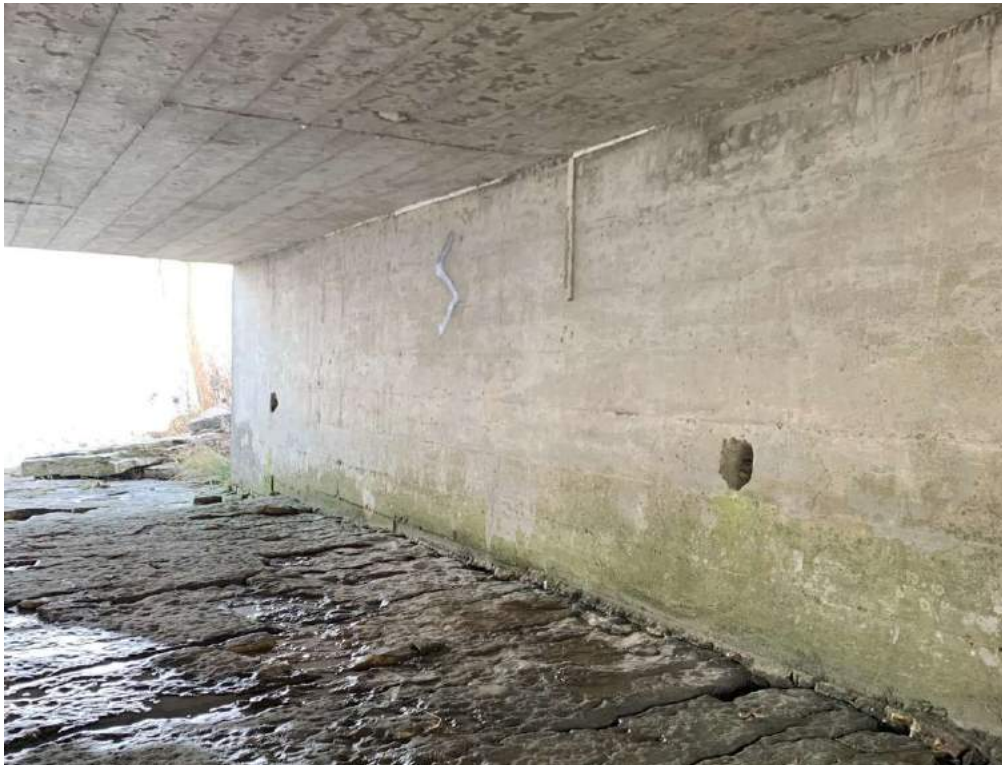
Photo 8-9: View of south abutment wall and soffit

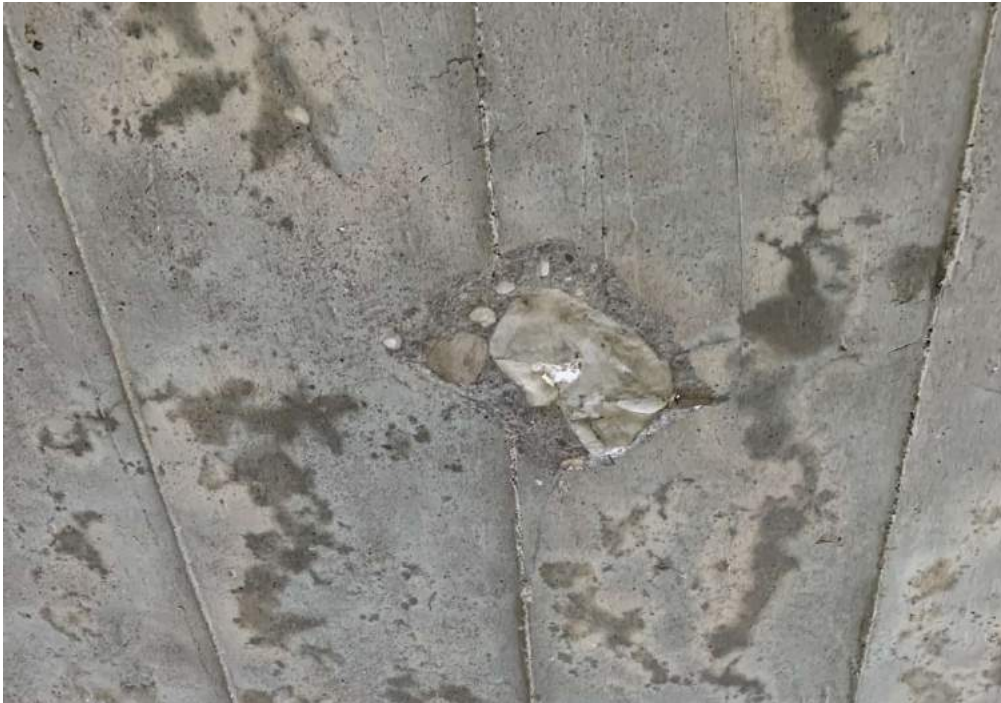
Photo 8-10: View of structure soffit

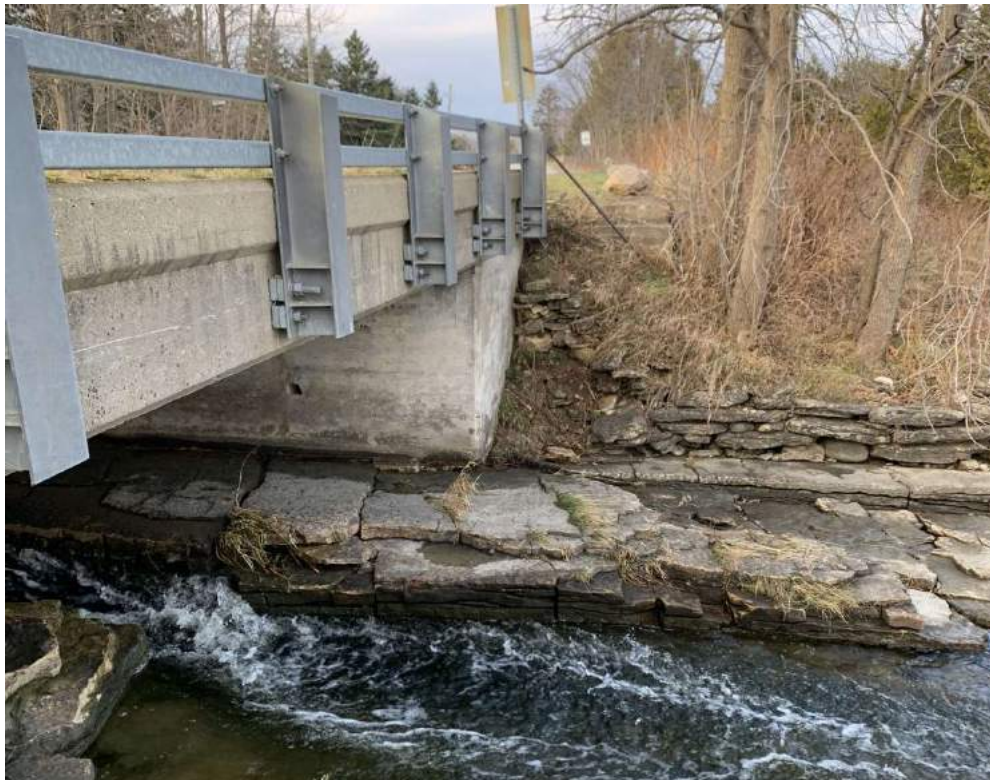
Photo 8-11: View of structure elevation, exterior barrier protection, curb and soffit

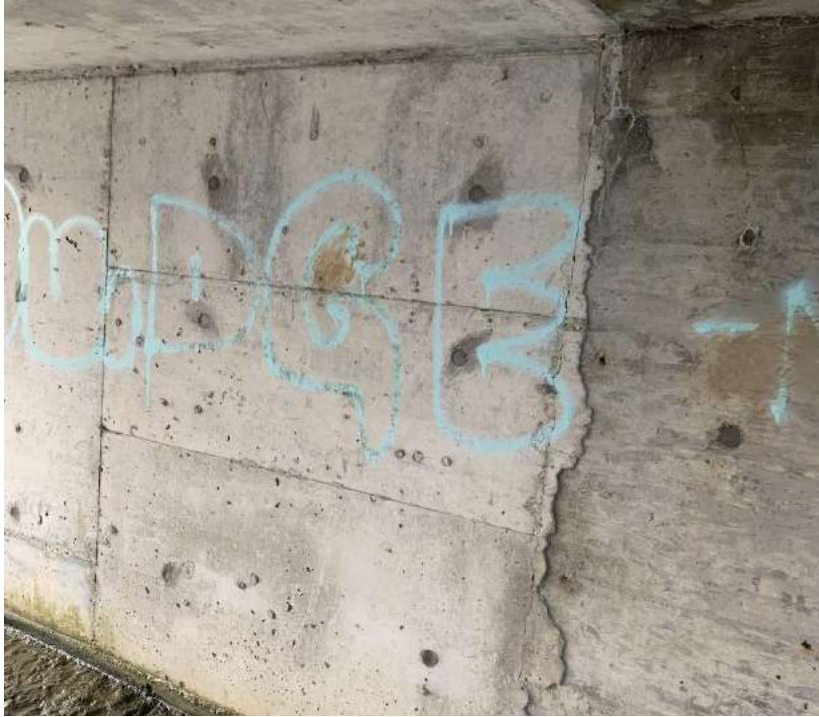
Photo 8-12: View of abutment wall
