MUNICIPALITY OF NORTHERN BRUCE PENINSULA

# 2022 STRUCTURE INSPECTION REPORT

FINAL  
PROJECT NO.: 201-01605-00  
DATE: APRIL 03, 2023

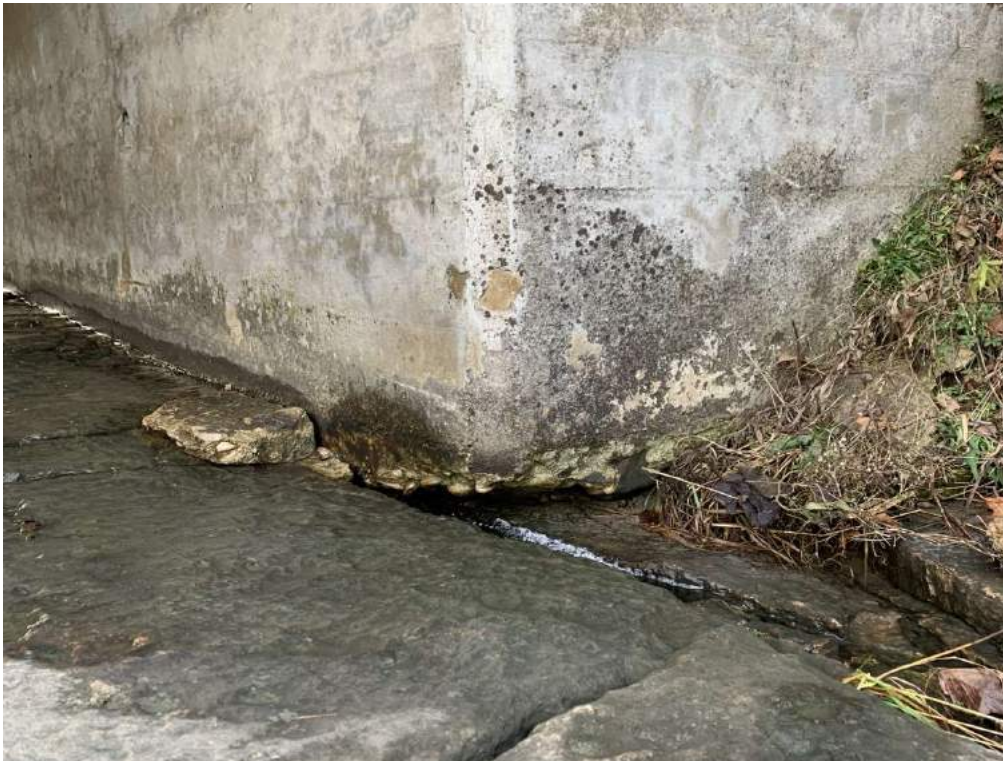
Photo 8-13: View of wingwall

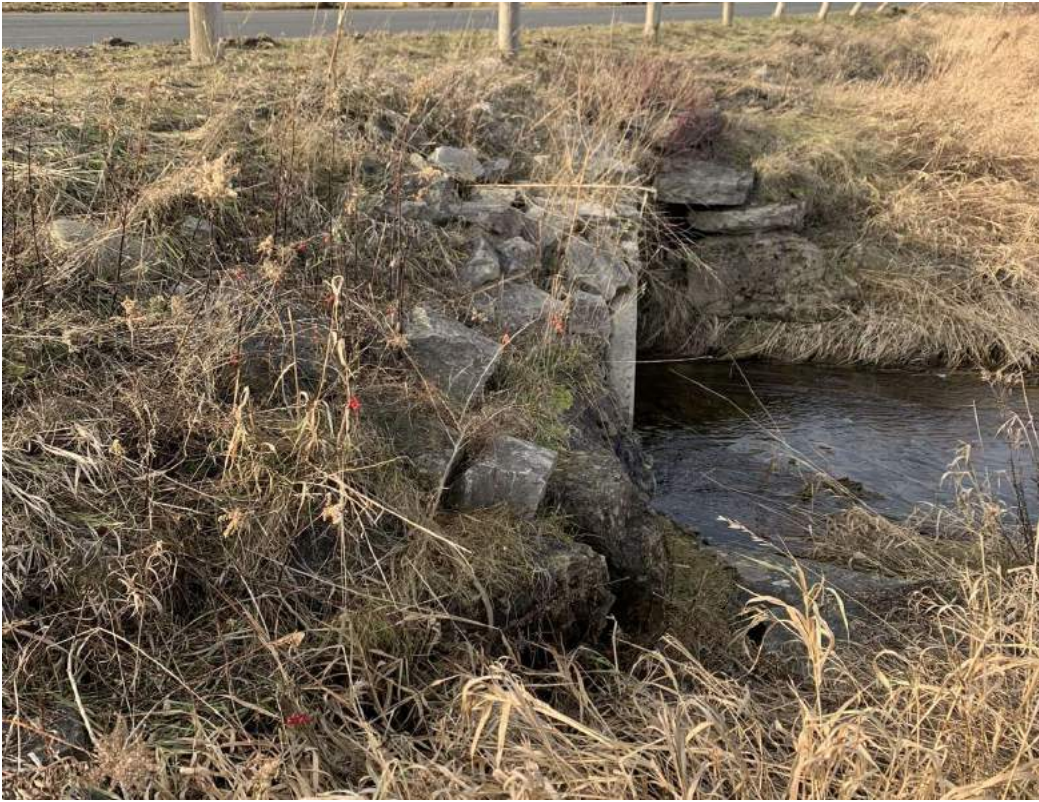
Photo 9-2 - View of structure inlet elevation and embankment

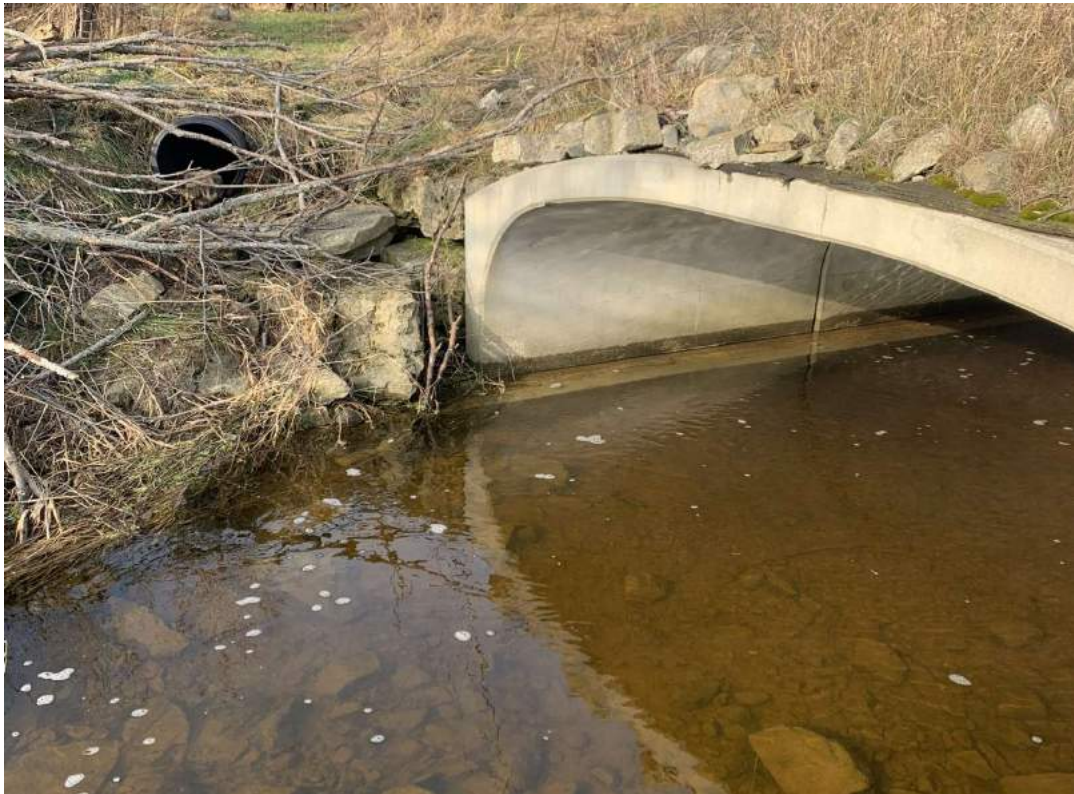
Photo 9-3 - View of structure outlet elevation and embankments

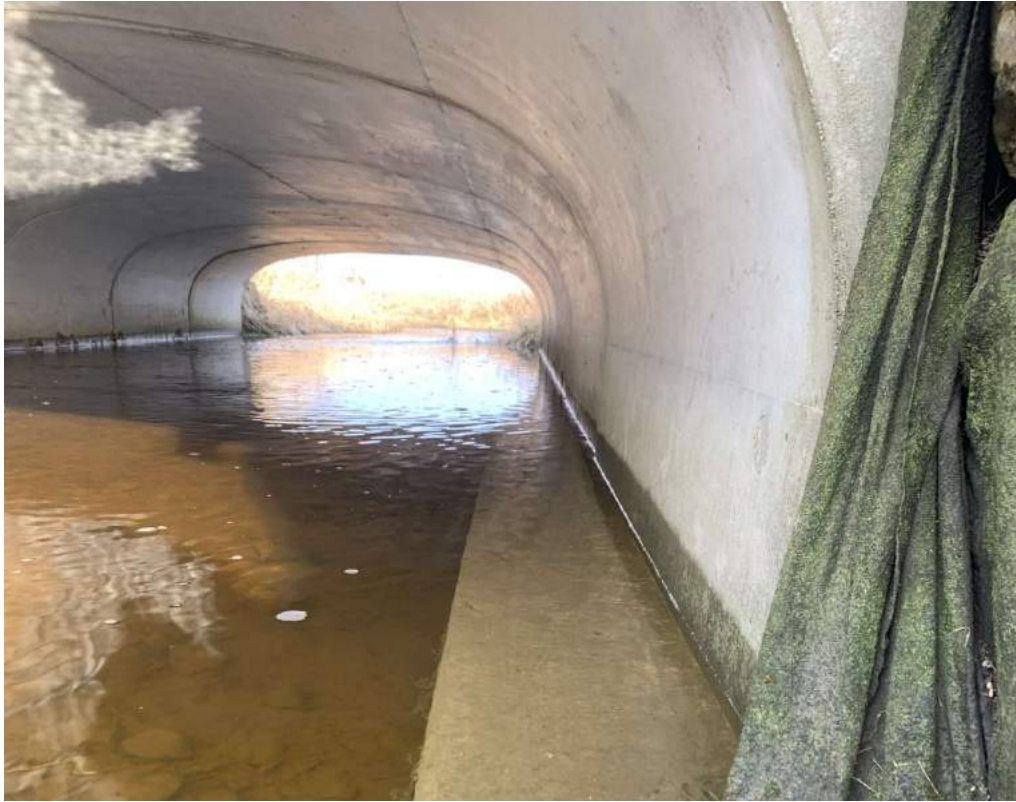
Photo 9-4 - View of pipe arch soffit and walls

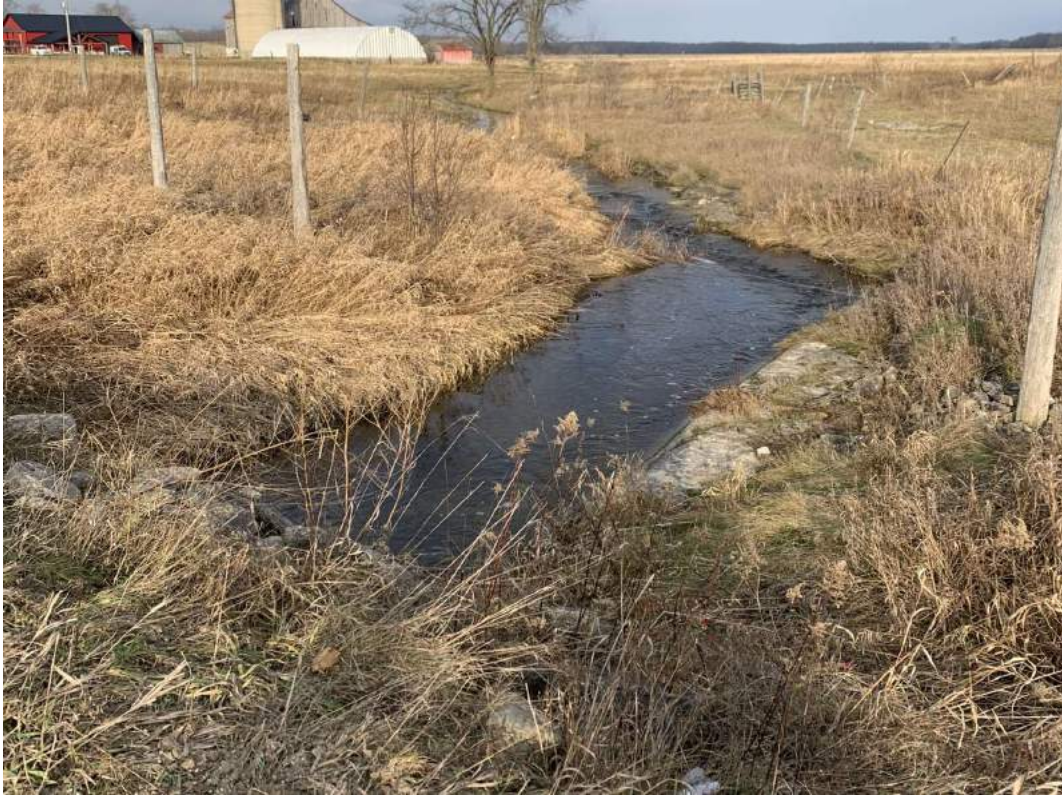
Photo 9-6 - View of watercourse upstream

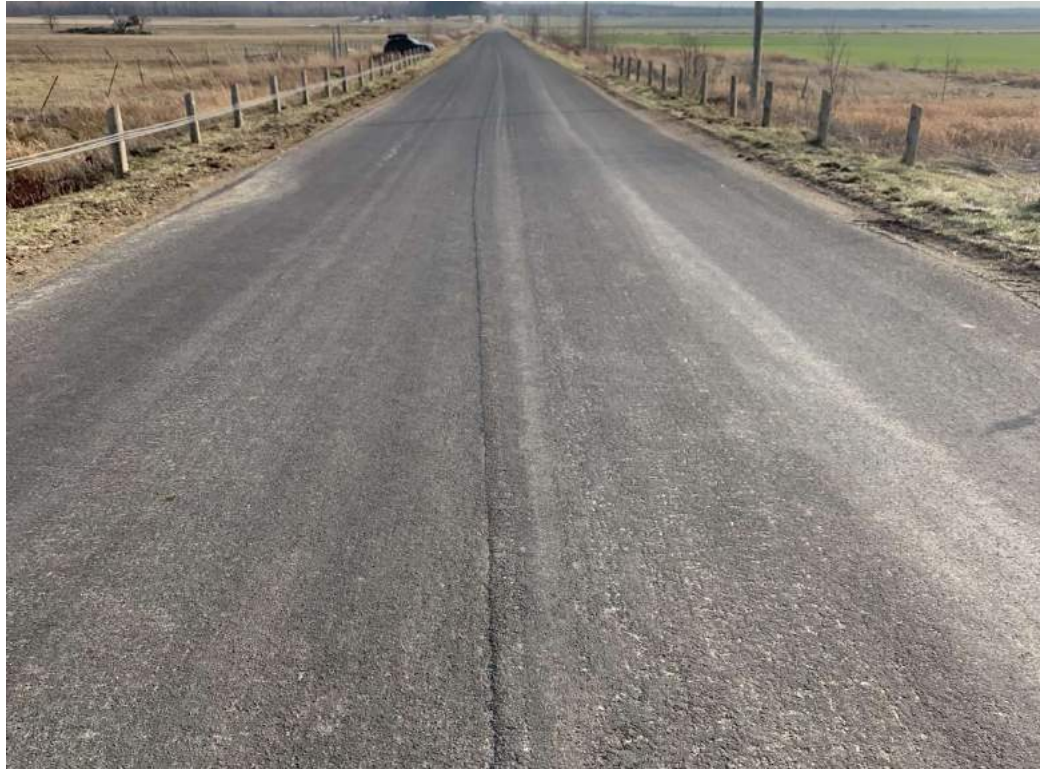
Photo 9-9 - View of structure wearing surface from approaching perspective

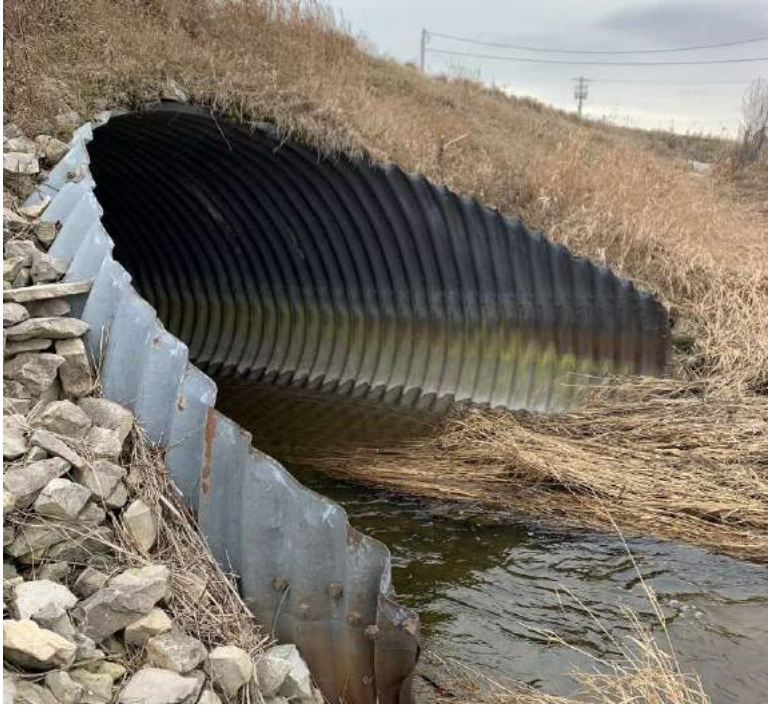
Photo 10-4: View of culvert barrel in elevation

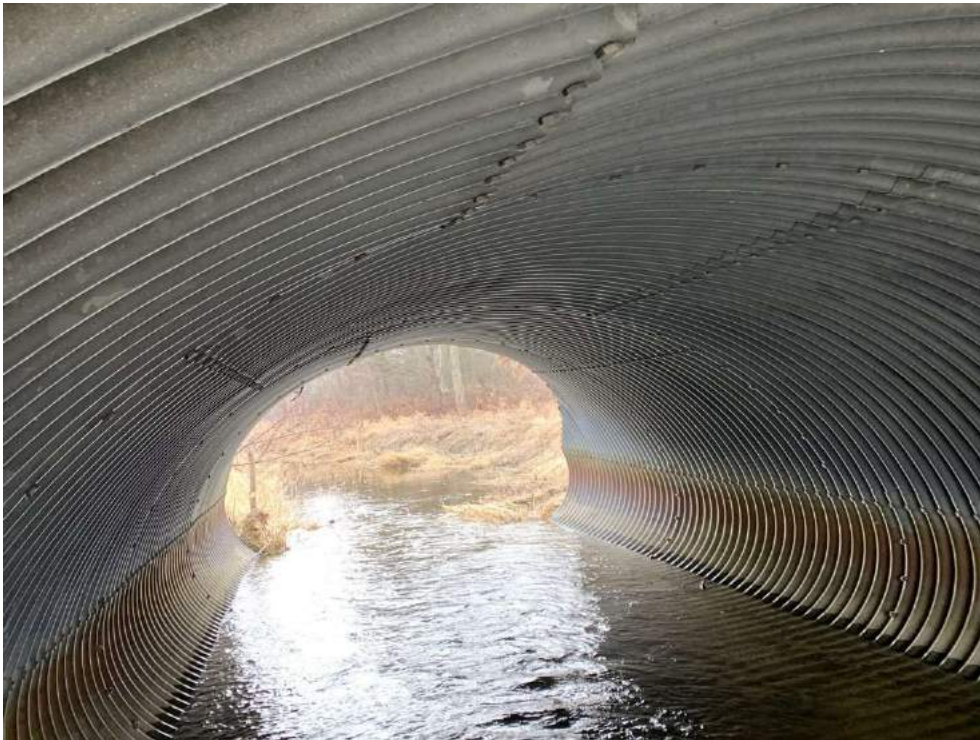
| <b>Comments:</b> | Moderate corrosion at water level with minor section loss observed.<br>Minor localized deformations observed.<br>1m long section in base of culvert has failed due to complete section loss. | | | | | | |

Photo 10-5: View of interior culvert barrel

| <b>Recommended Work:</b> | None    6-10 Years <input type="checkbox"/> 1-5 Years <input type="checkbox"/> < 1 Year    Urgent<br>Monitor the section loss and overall structure stability, consider repair vs replacement when section loss exceeds acceptable limits. | | | | | | |

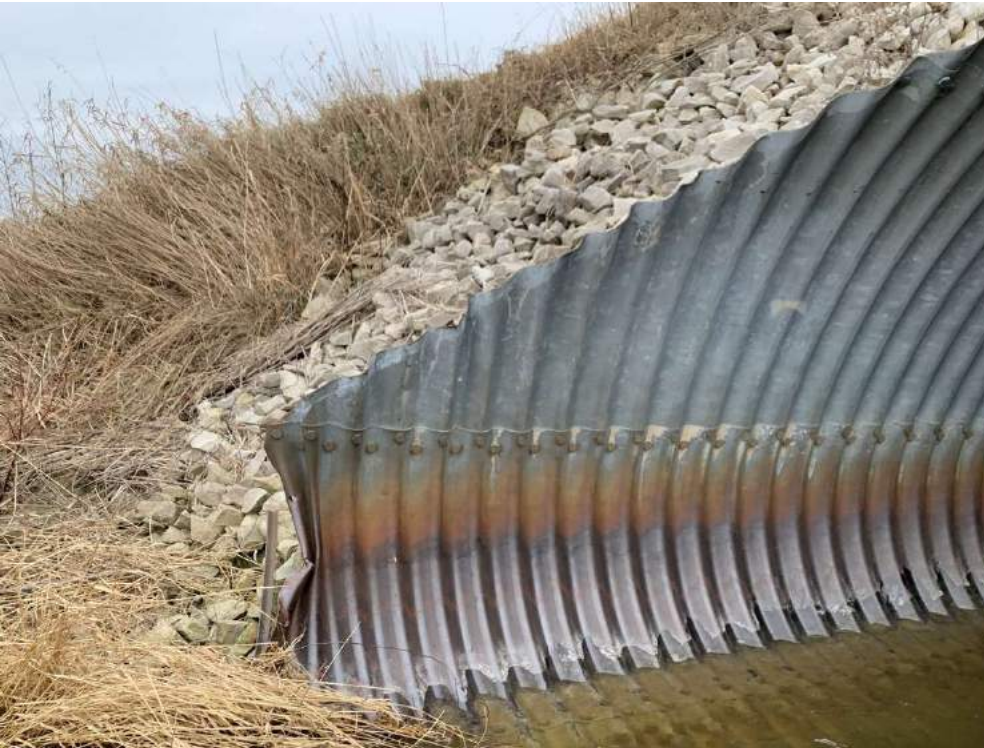
Photo 10-7: View of embankment and culvert inlet interior

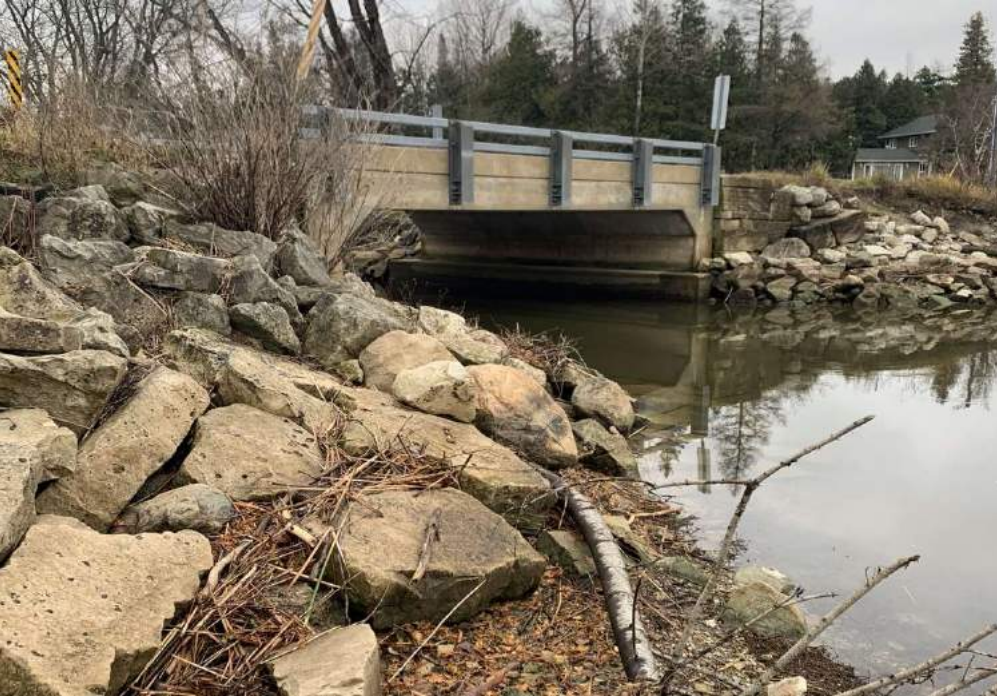
Photo 11-2: View of east structure elevation, exterior soffit, barrier and embankments

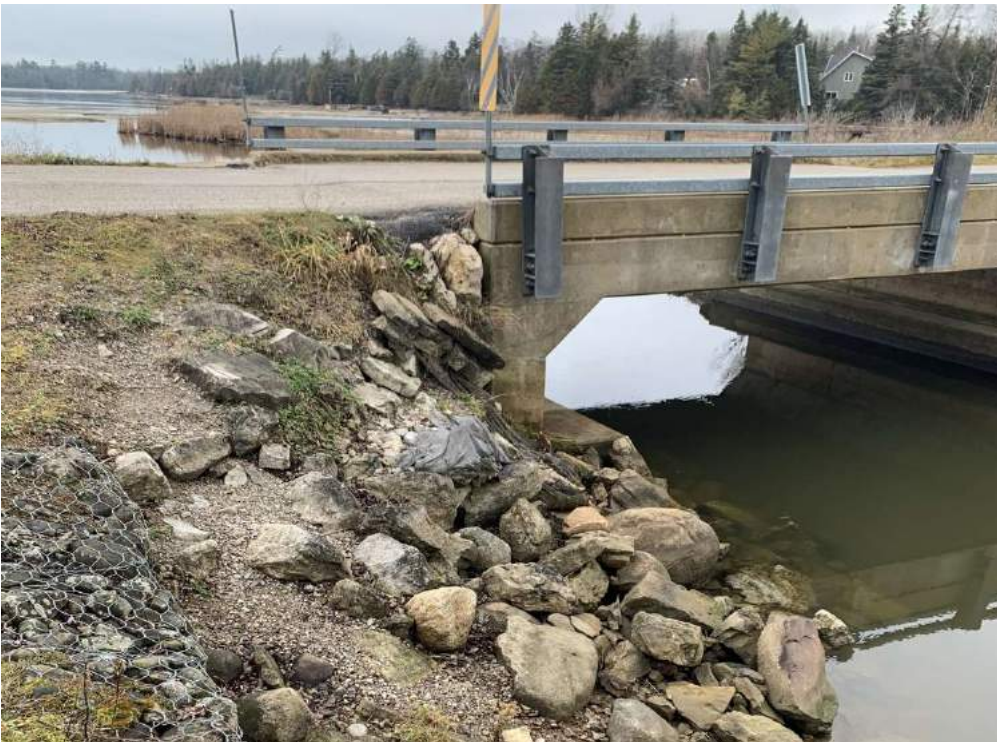
Photo 11-3: View of exterior barrier protection, soffit and wingwalls

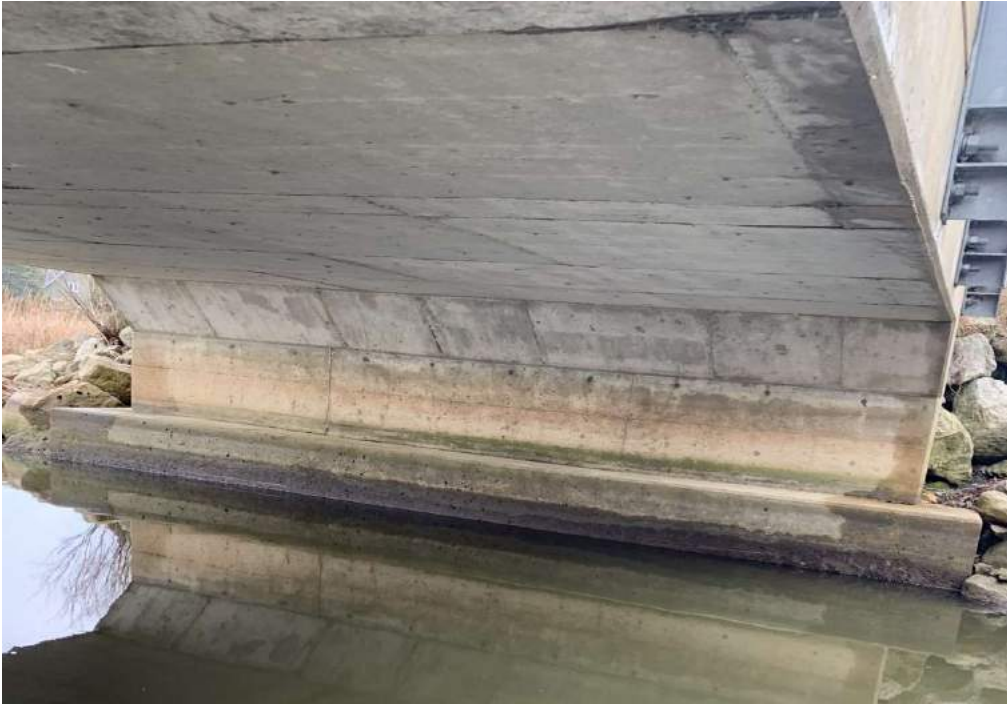
| <b>Comments:</b> | The soffit is in good condition with no visible defects. | | | | | | |

11-4: View of structure soffit

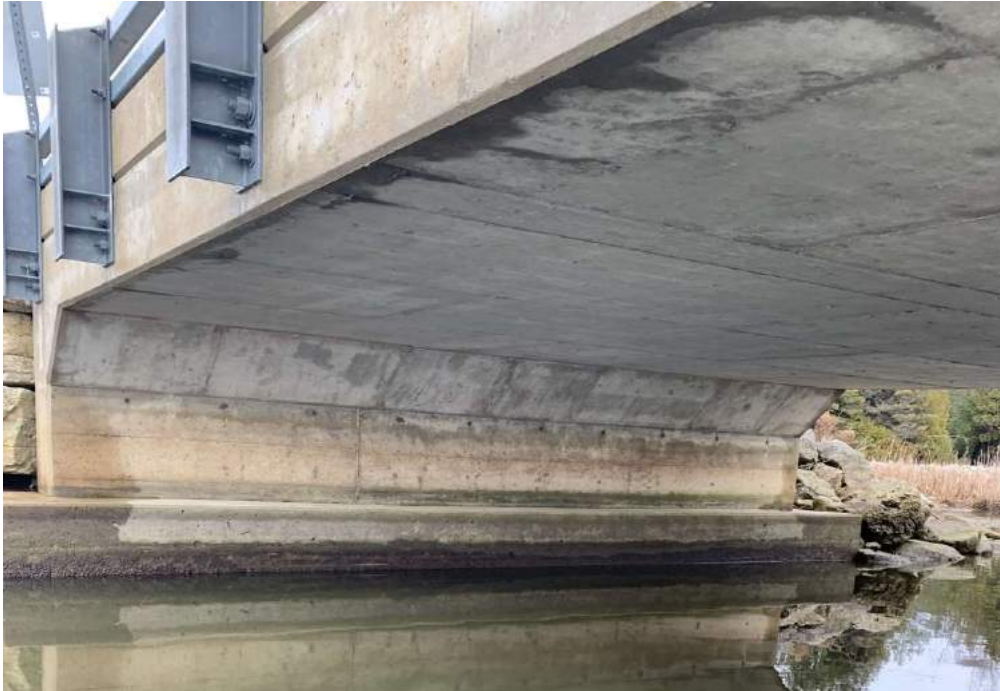
11-6: View of north abutment wall and soffit

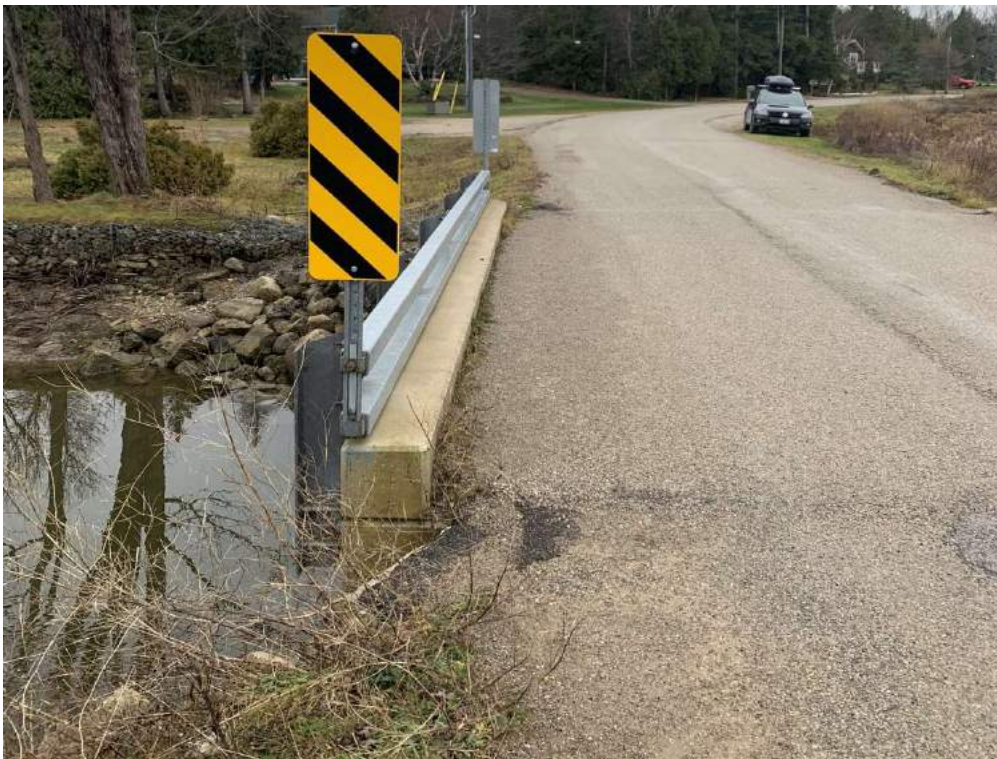
11-7: View of structure wearing surface, barrier protection and end hazard signage

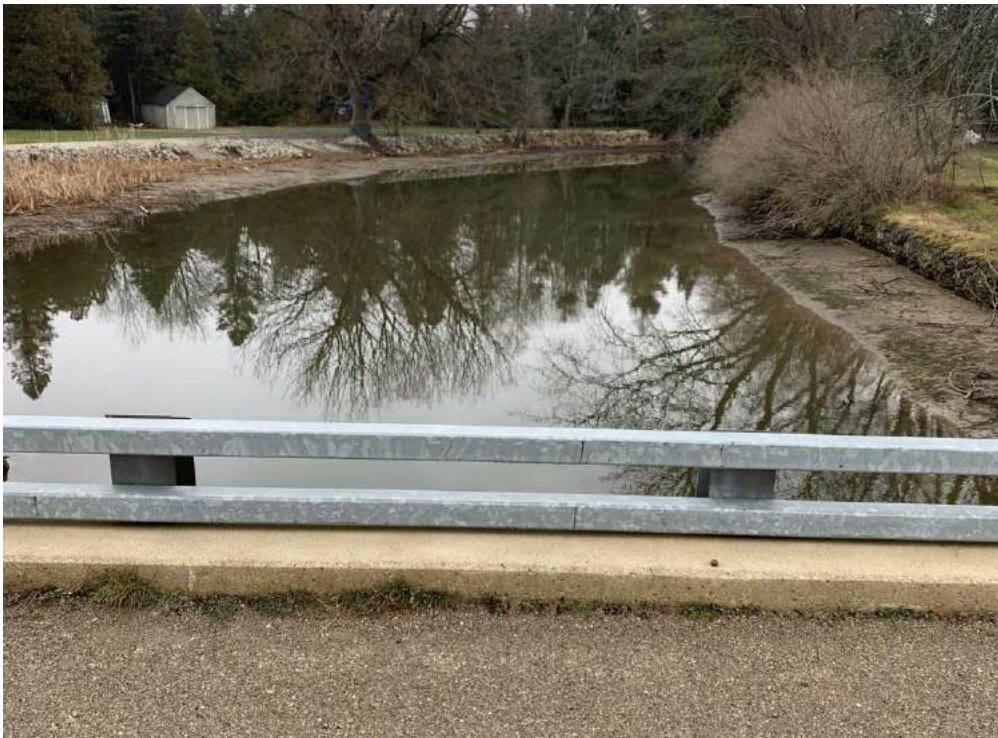
11-7: View of watercourse upstream

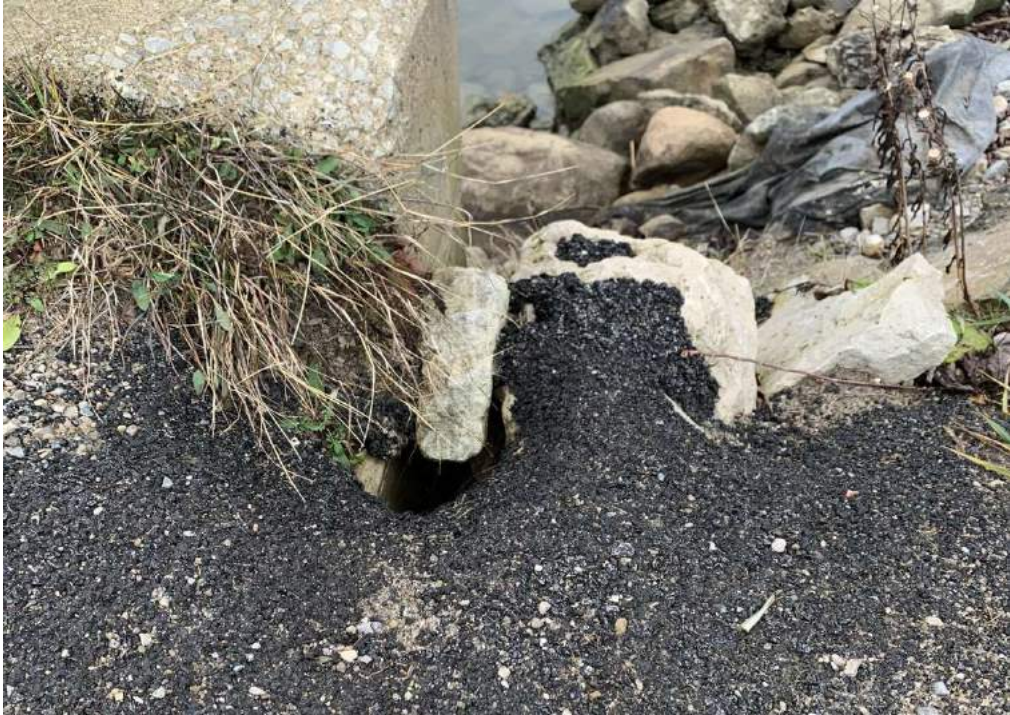
11-10: Minor erosion at the northwest structure quadrant

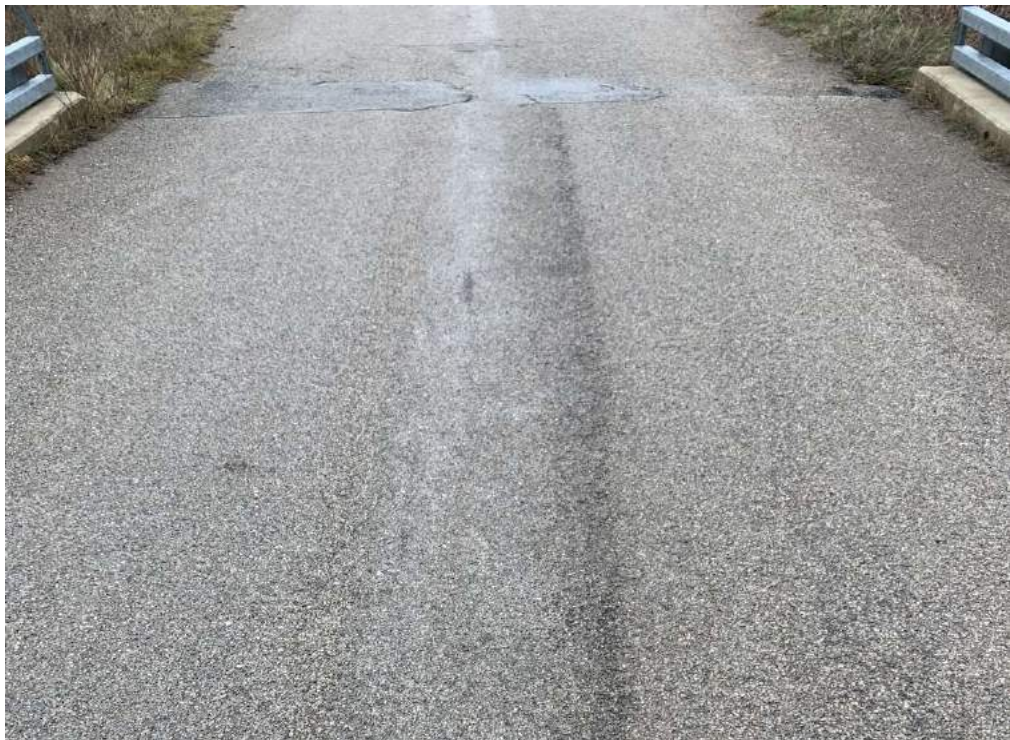
| <b>Comments:</b> | The surface treatment is relatively new and in good condition. | | | | | | |

11-11: Structure wearing surface

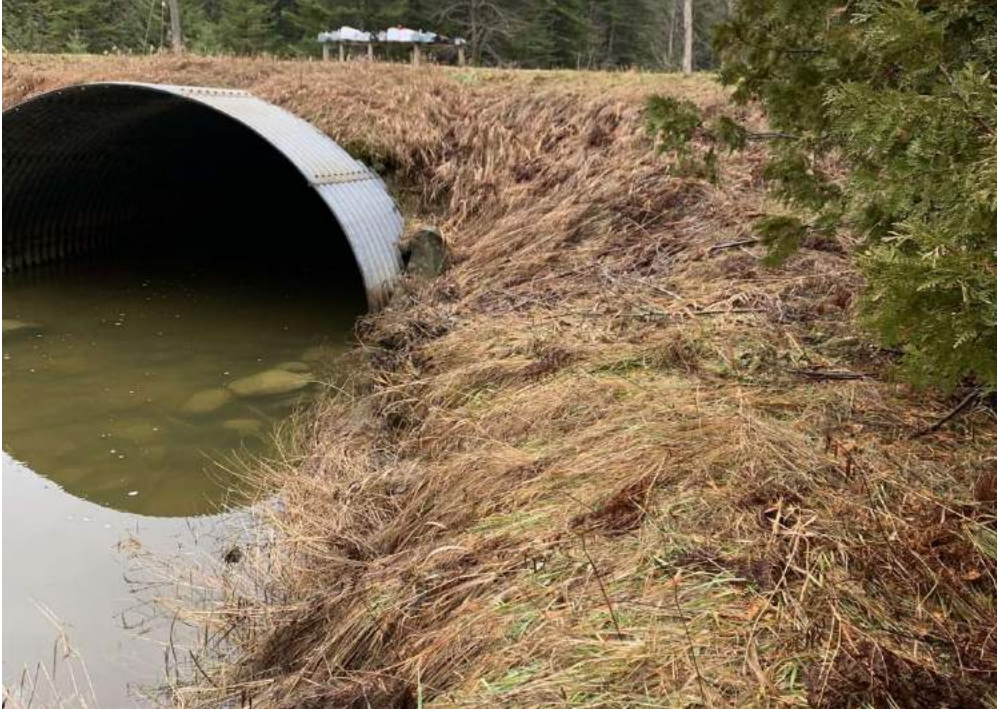
Photo 12-2: View of culvert inlet in elevation (north perspective)

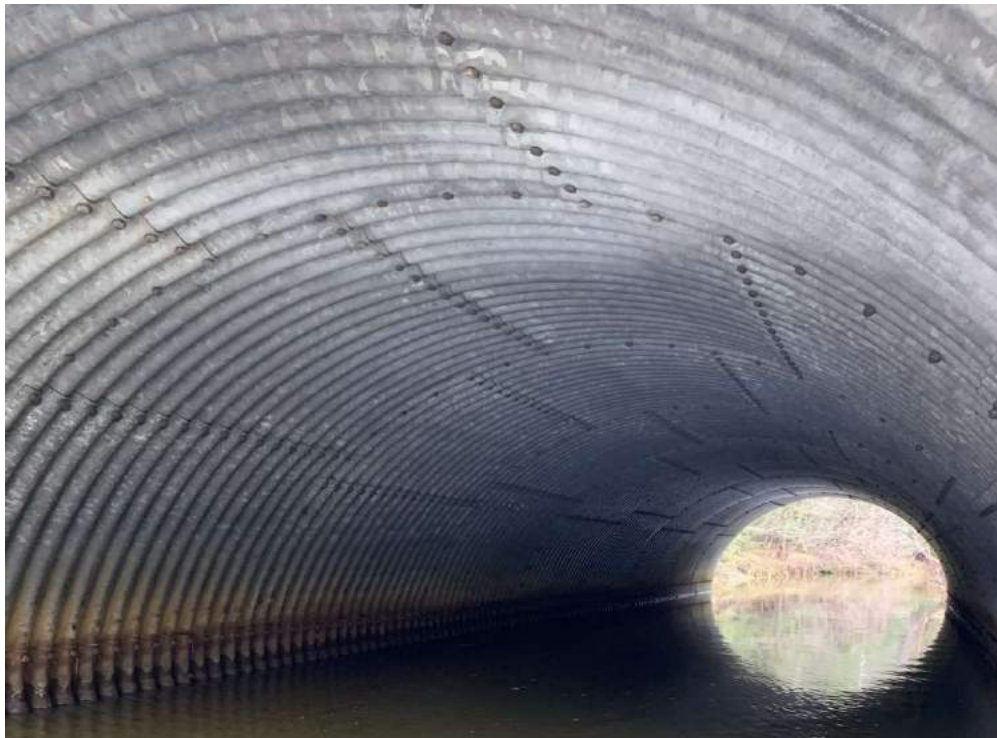
Photo 12-3: View of culvert barrel interior

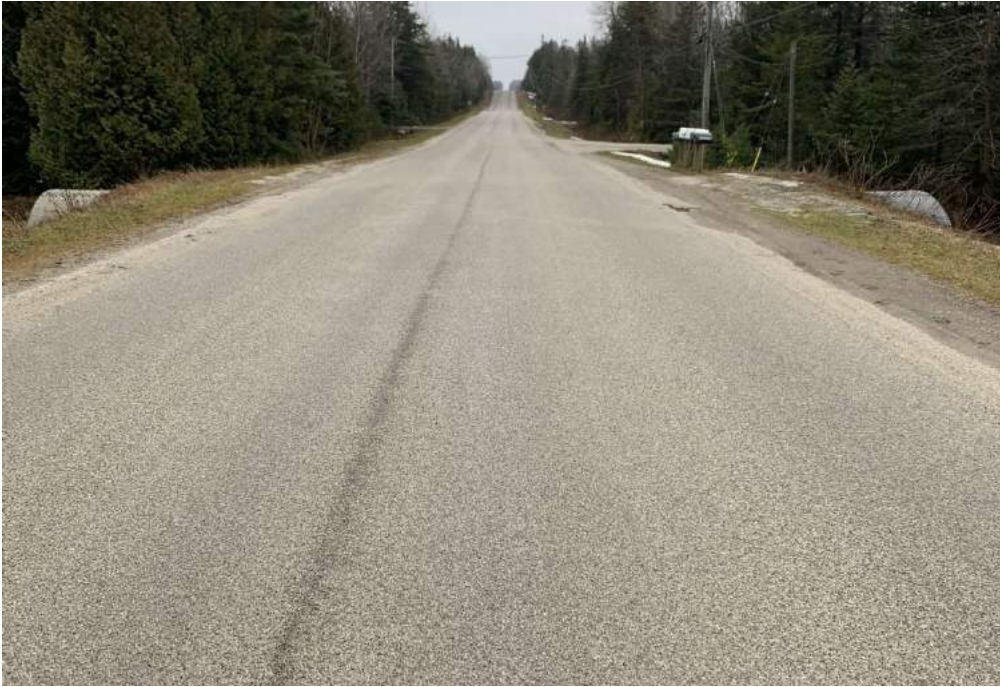
Photo 12-4: View of surface treatment wearing surface

| | Replace the surface treatment with road resurfacing. | | | | | | |

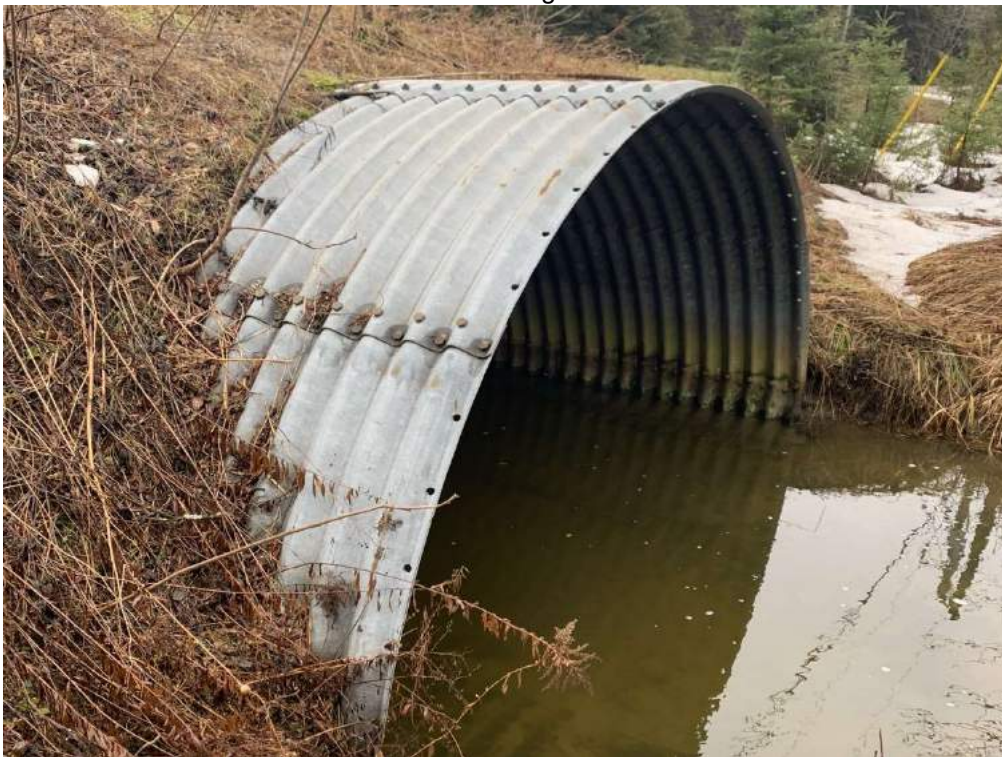
Photo 12-5: View of culvert outlet

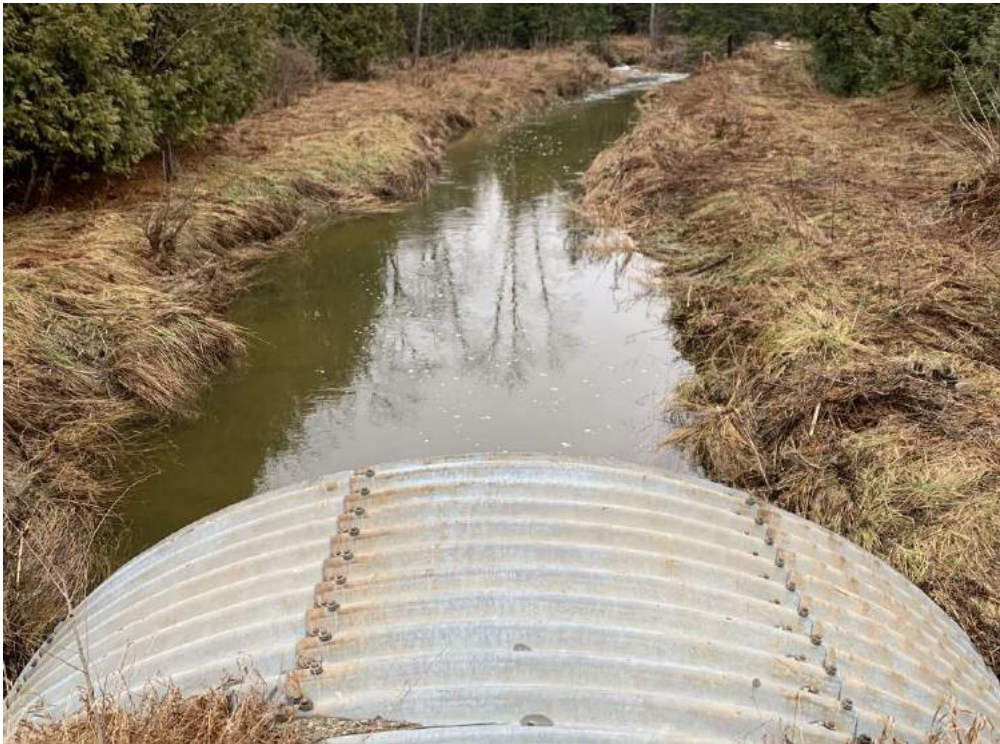
Photo 12-7: View of watercourse upstream

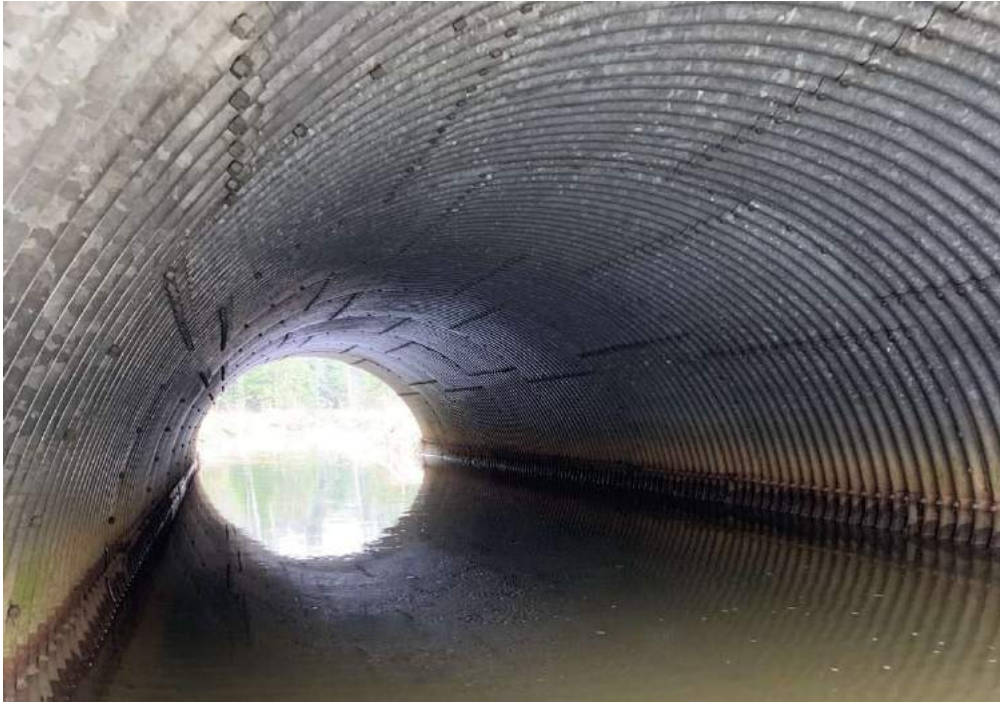
Photo 12-8: View of culvert barrel interior

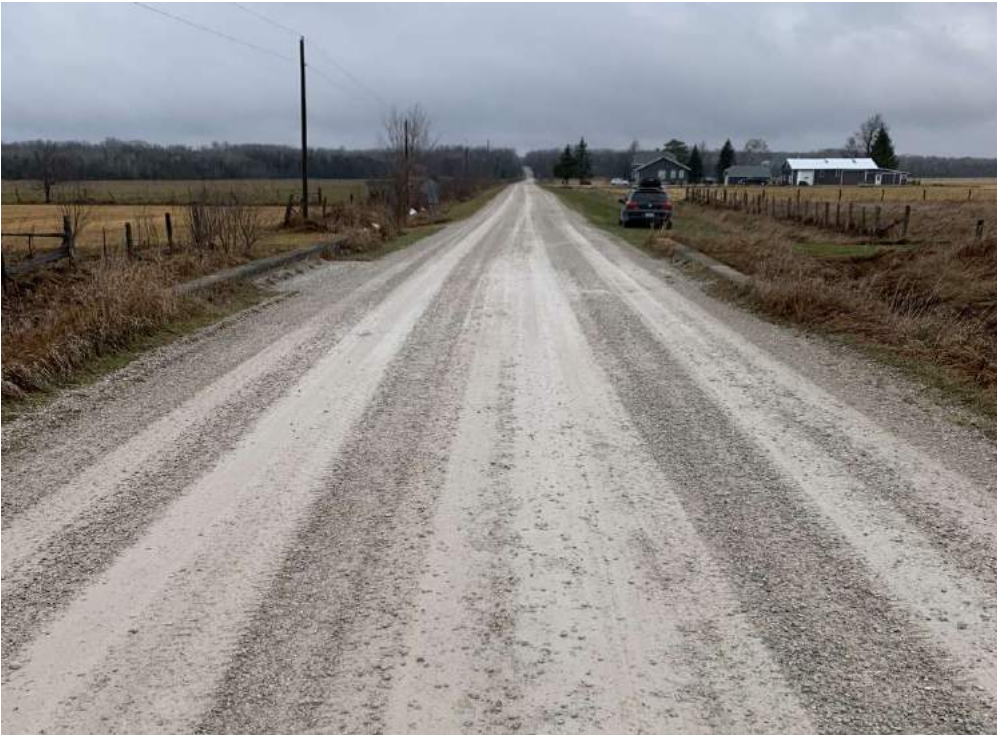
Photo 13-2: View of structure from the south approach

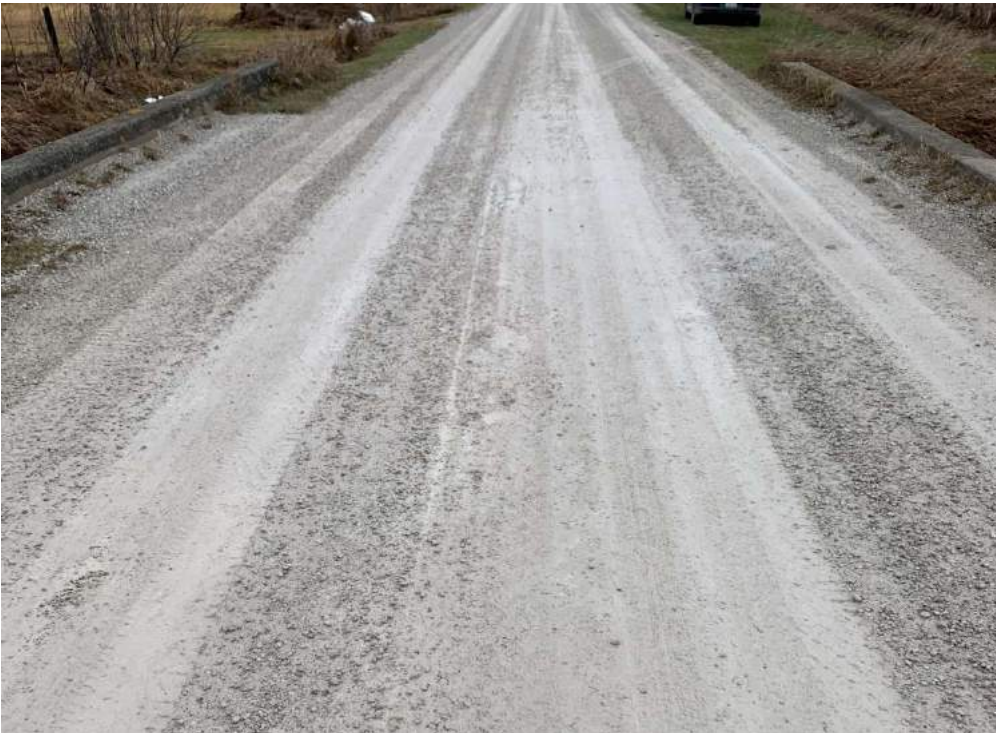
Photo 13-4: Approach and structure wearing surface

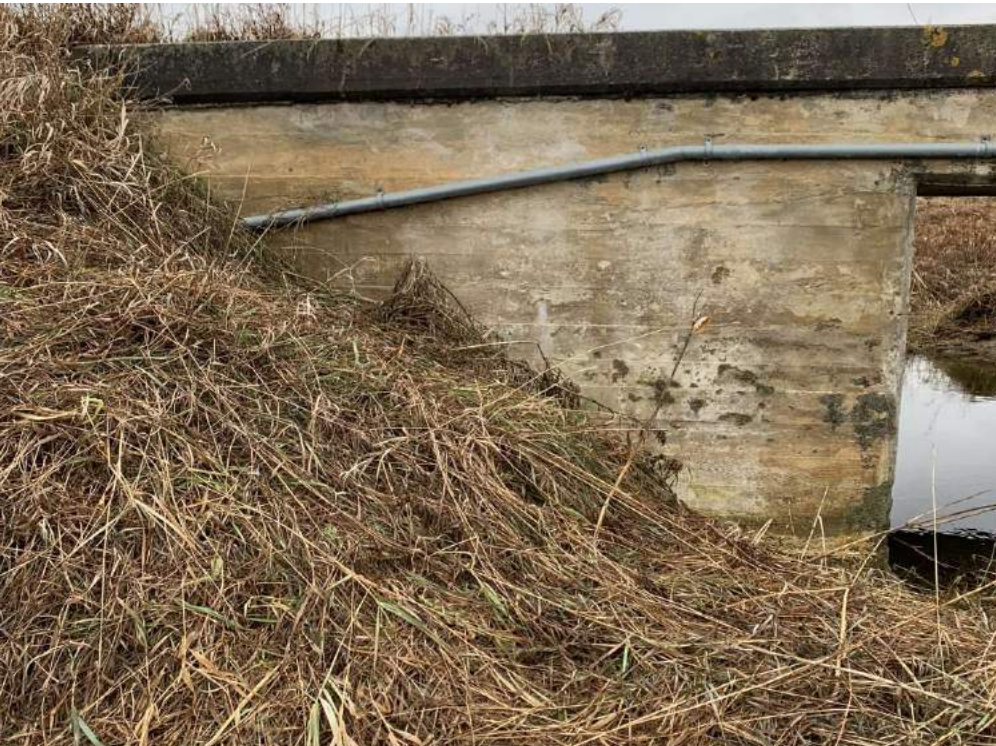
Photo 13-5: Southwest structure wingwall (typical)

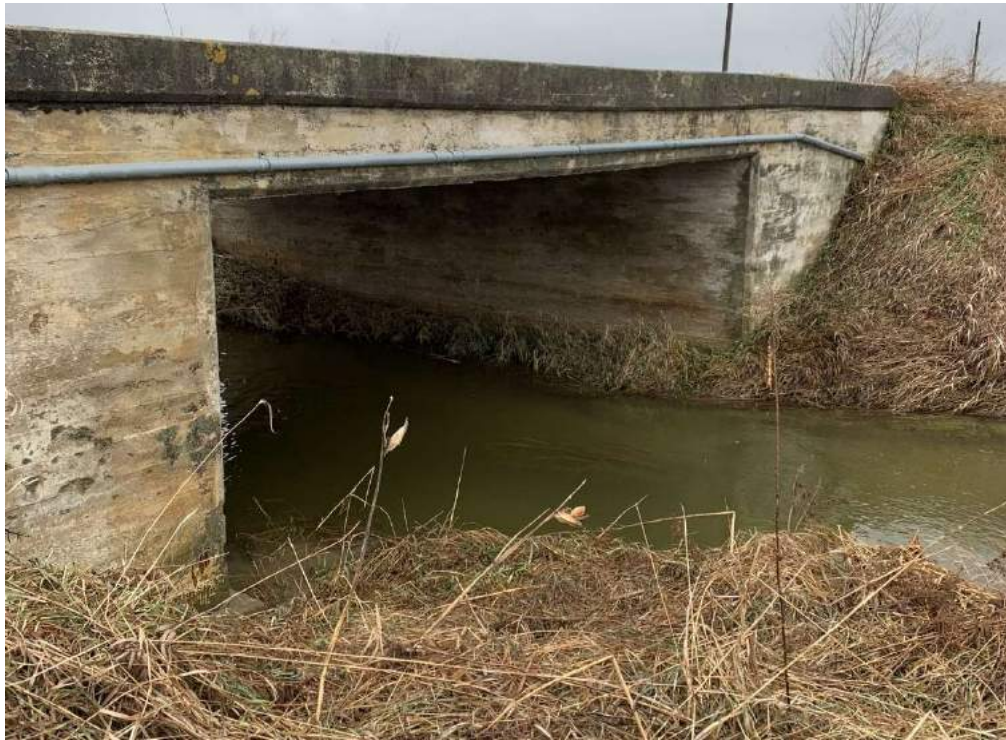
Photo 13-6: View of east structure elevation, exterior soffit and north abutment wall

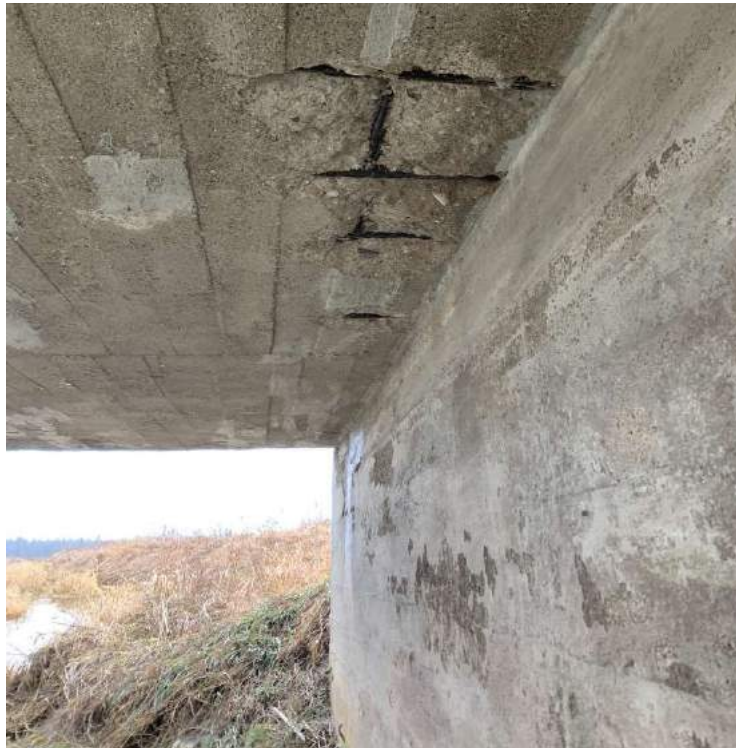
Photo 13-7: View of structure soffit and north abutment wall

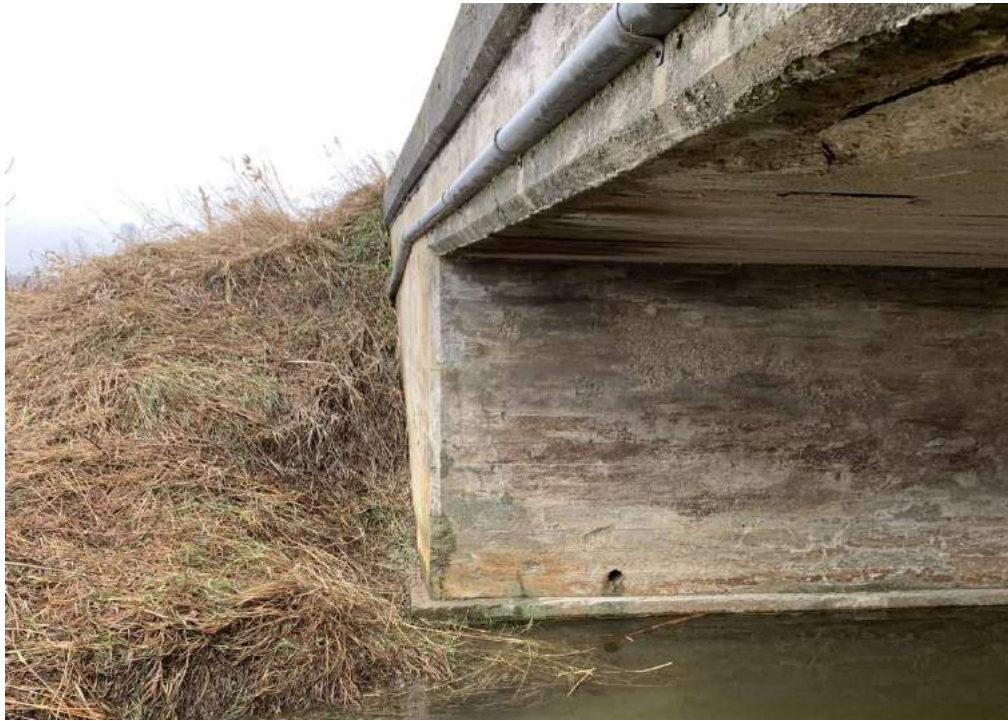
Photo 13-8: View of south abutment wall and exposed footing

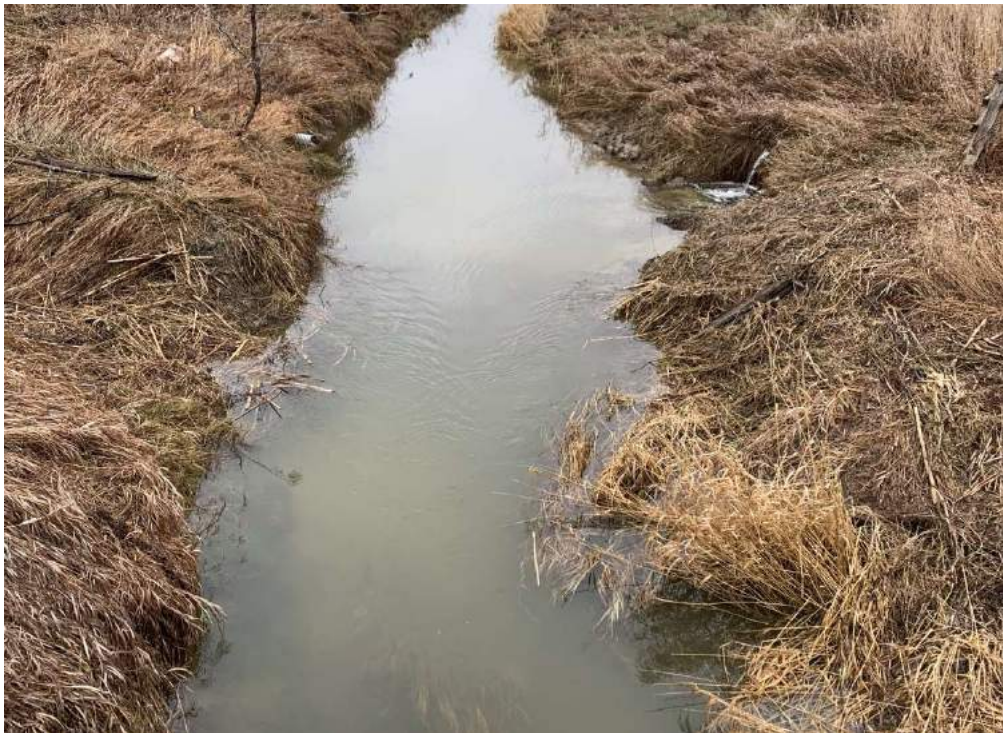
Photo 13-9: View of watercourse upstream
