MUNICIPALITY OF NORTHERN BRUCE PENINSULA

# 2022 STRUCTURE INSPECTION REPORT

FINAL  
PROJECT NO.: 201-01605-00  
DATE: APRIL 03, 2023

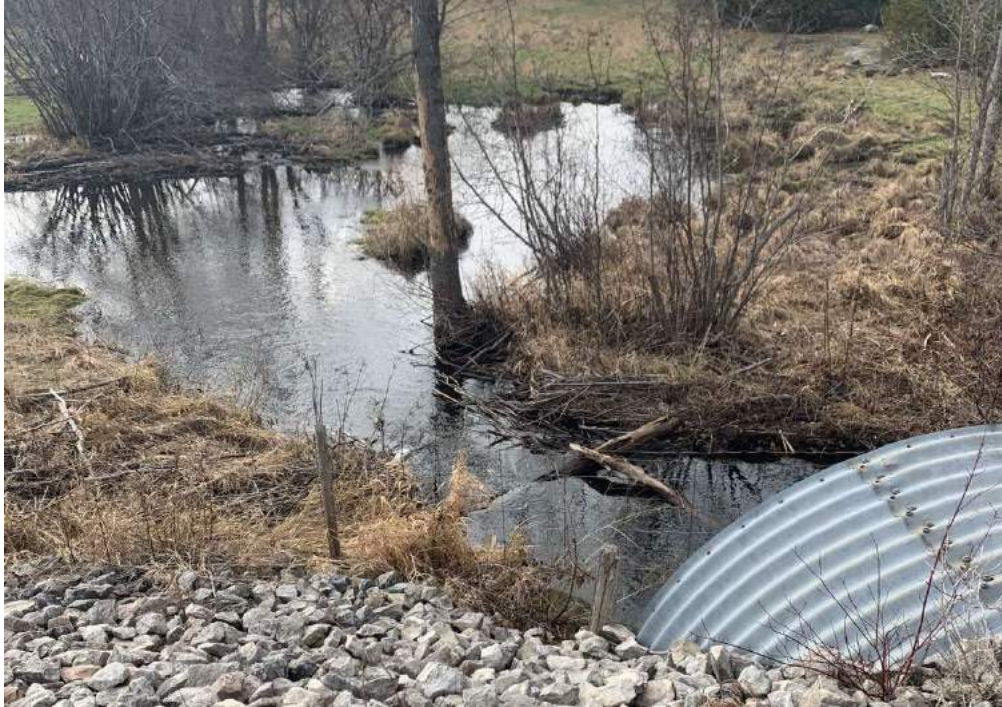
Photo 14-4: View of watercourse upstream

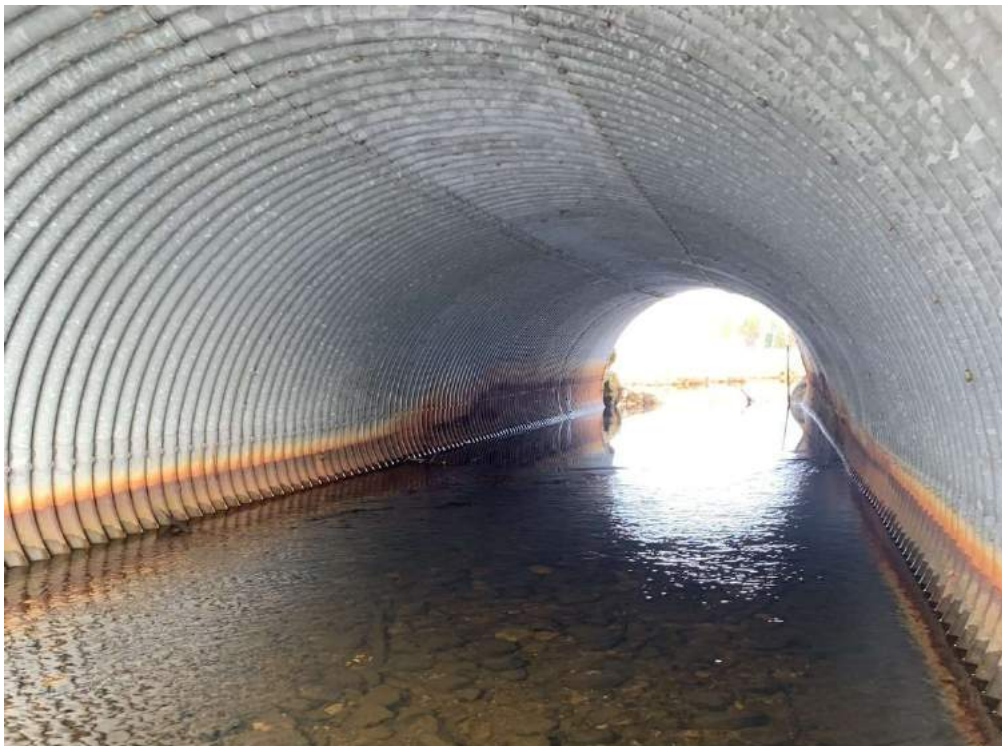
Photo 14-5: View of culvert barrel interior, obvert

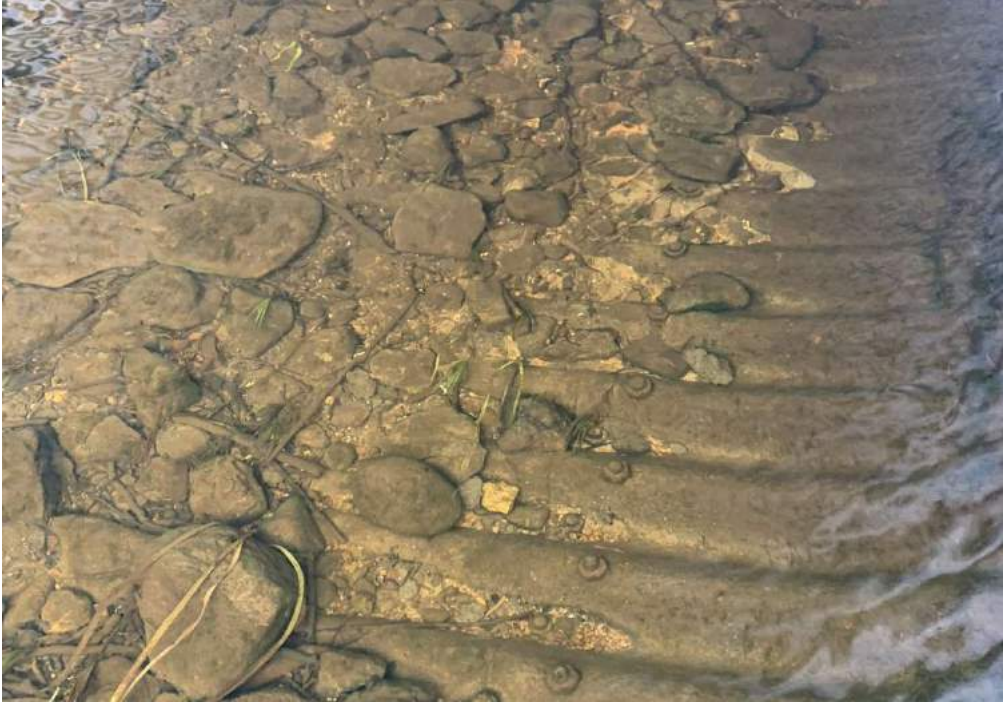
Photo 14-6: View of culvert barrel interior

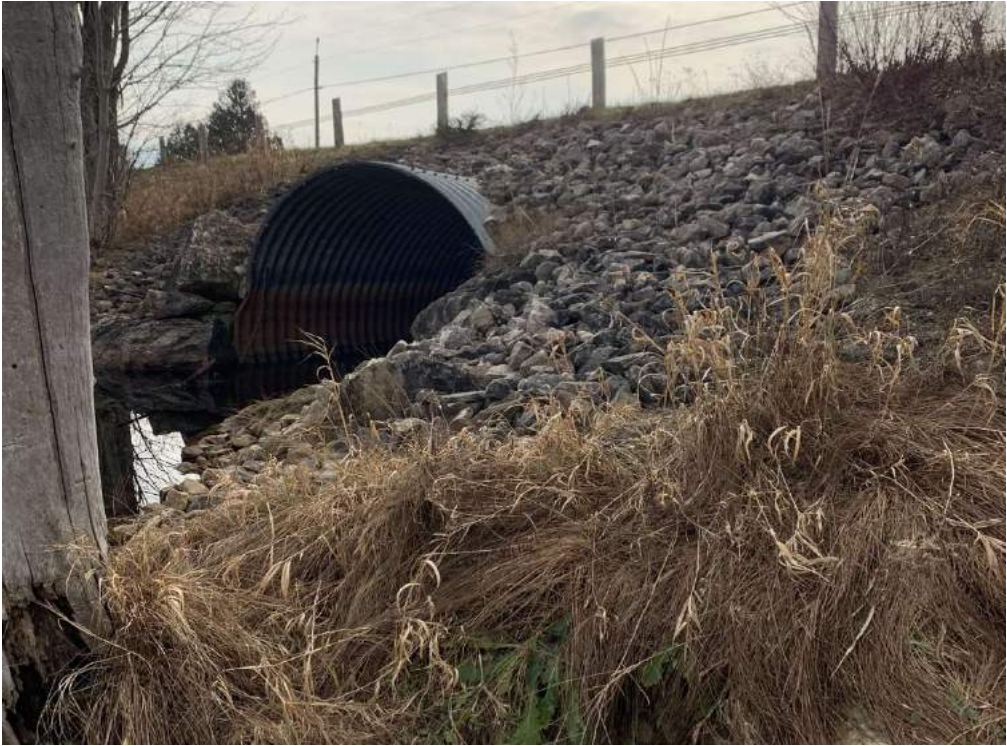
Photo 14-7: View of slope protection

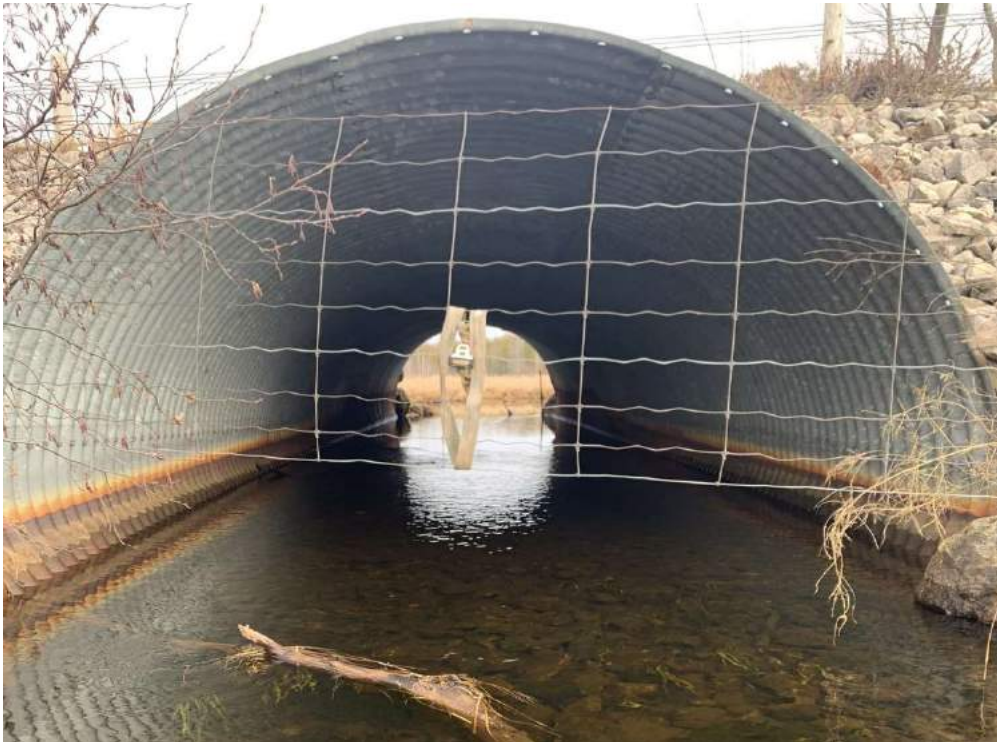
Photo 14-9: View of culvert interior

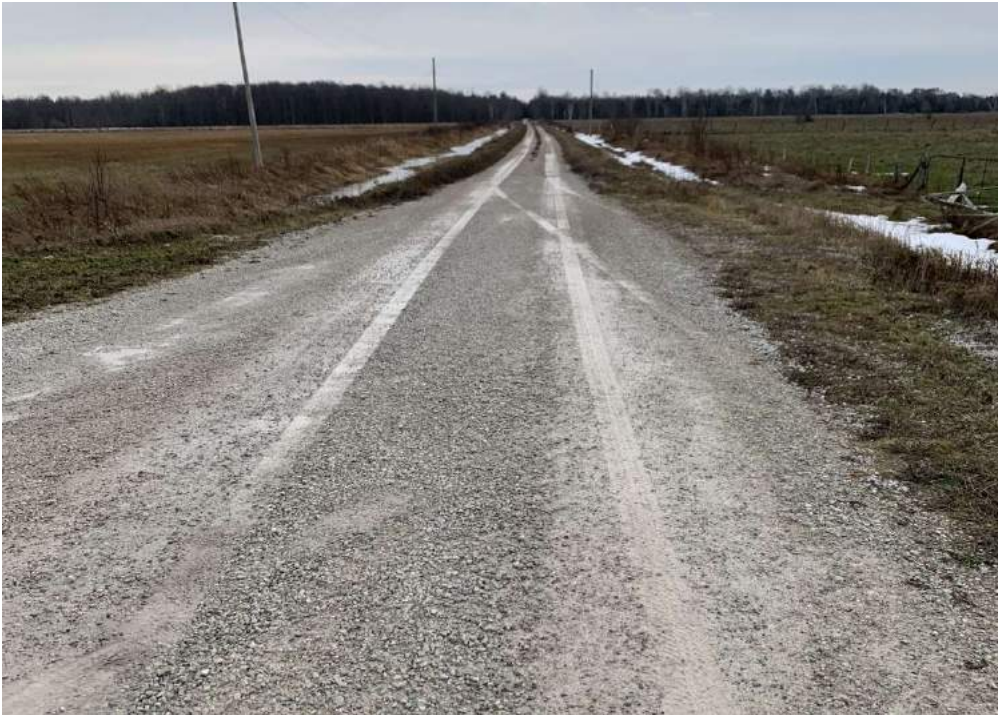
| <b>Comments:</b> | The granular wearing surface is uneven and requires grading to achieve drainage. | | | | | | |

Photo 15-2: View of approach and structure wearing surface

| | Grade annually and clear vegetation from shoulders. | | | | | | |

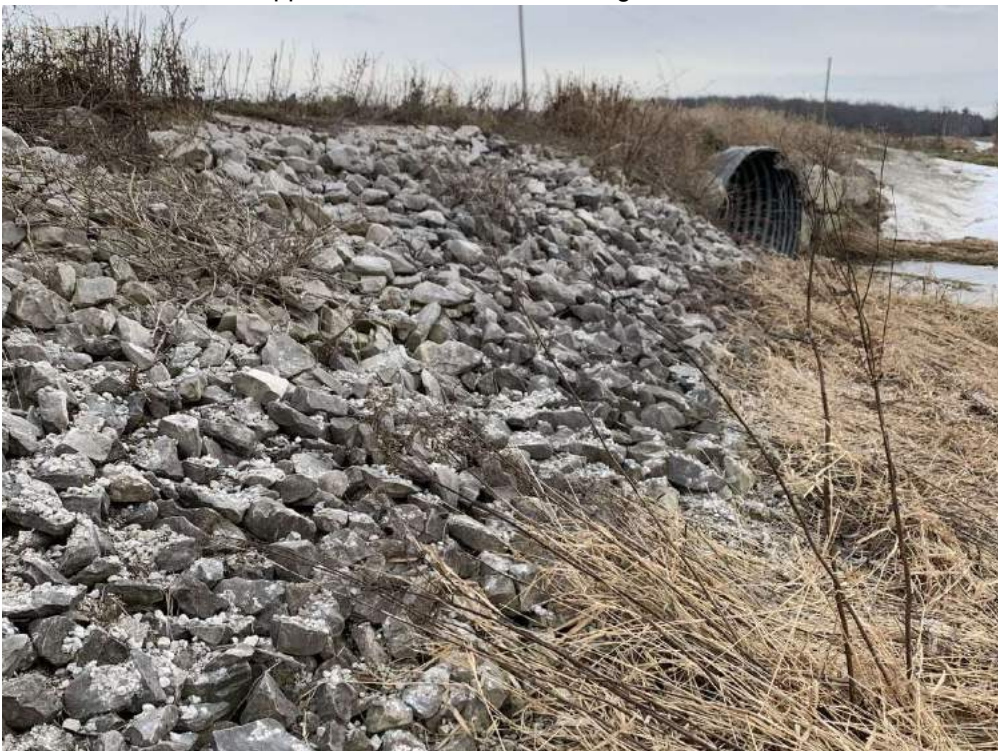
| <b>Comments:</b> | The low level CSP pipe culvert is partially submerged underwater. There is some observed erosion of the embankments at the culvert inlet. | | | | | | |

Photo 15-3: Rock protection at inlet end

| | Repair erosion and add rip-rap slope protection. | | | | | | |

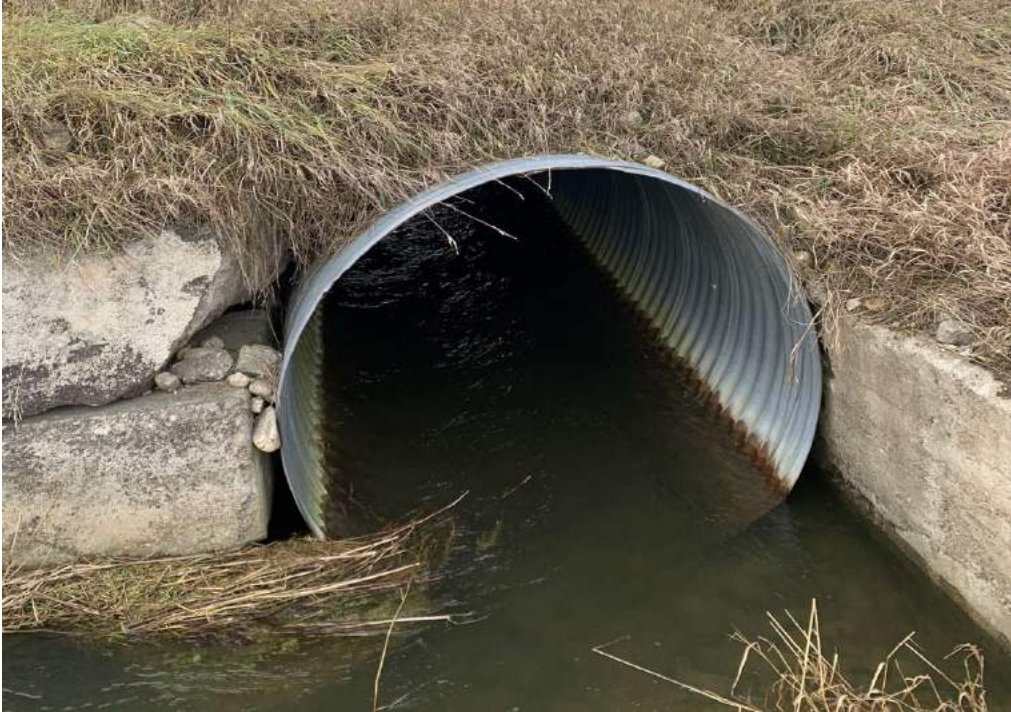
Photo 15-4: View of west culvert end

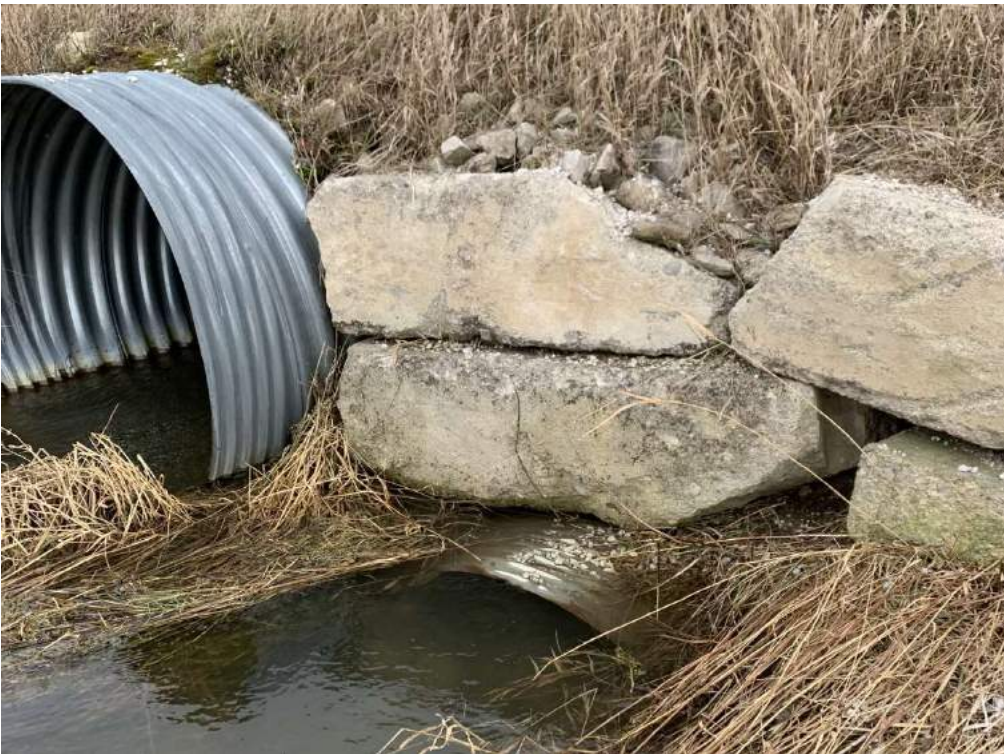
Photo 15-5: View of east culvert end

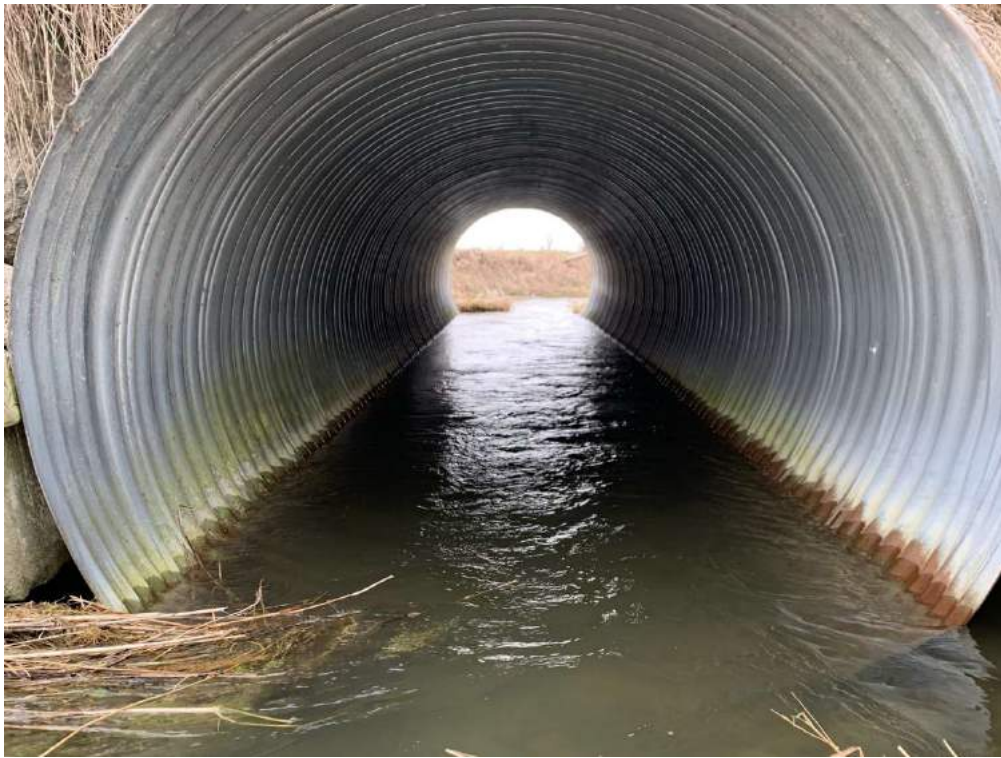
Photo 15-7: View of culvert barrel interior

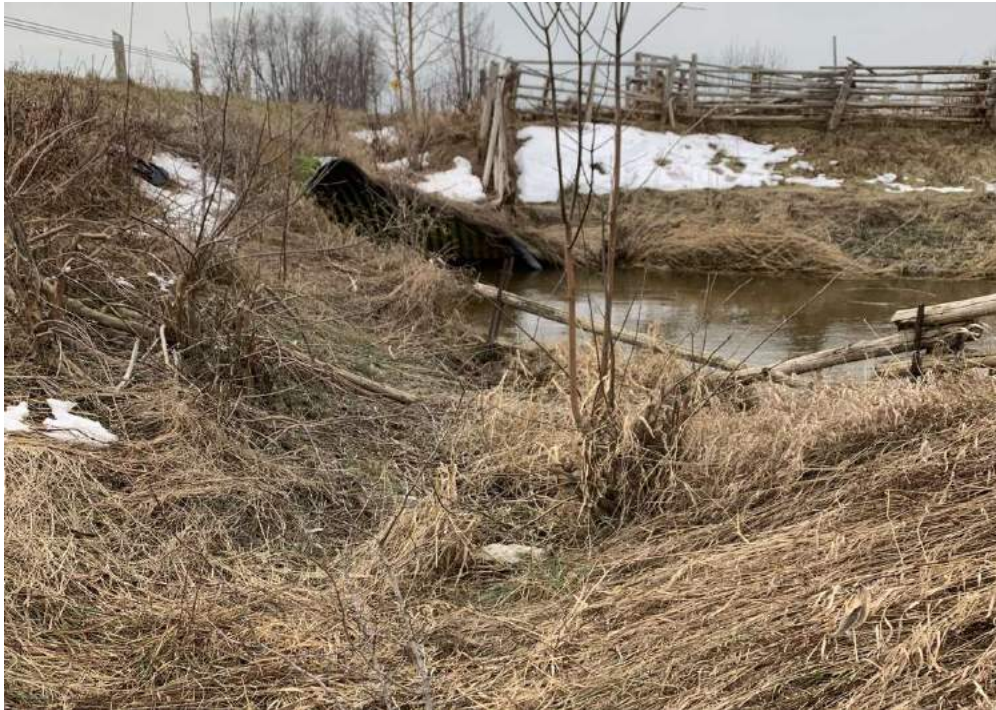
Photo 16-2: View of culvert barrel in elevation (outlet end)

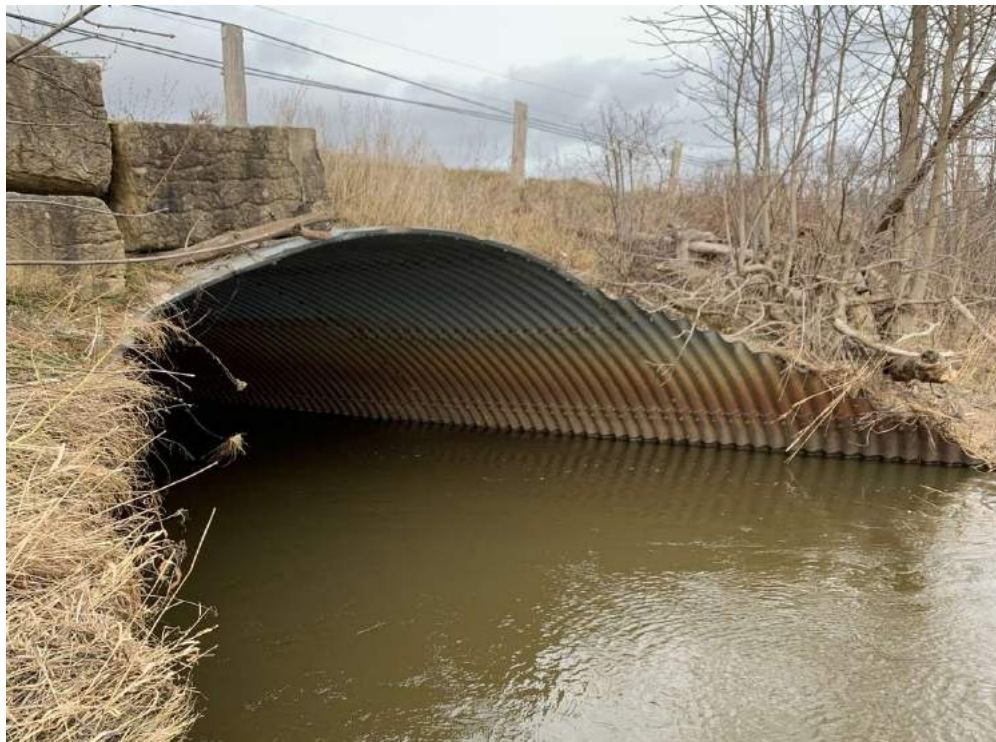
| <b>Comments:</b> | Some erosion was observed under the large block stones protecting the south slope. | | | | | | |

Photo 16-3: View of culvert barrel in elevation (inlet end)

| <b>Recommended Work:</b> | None <input type="checkbox"/> 6-10 Years <input checked="" type="checkbox"/> 1-5 Years <input type="checkbox"/> < 1 Year <input type="checkbox"/> Urgent<br>Place additional stone blocks and rip-rap. Remove the debris at the inlet. | | | | | | |

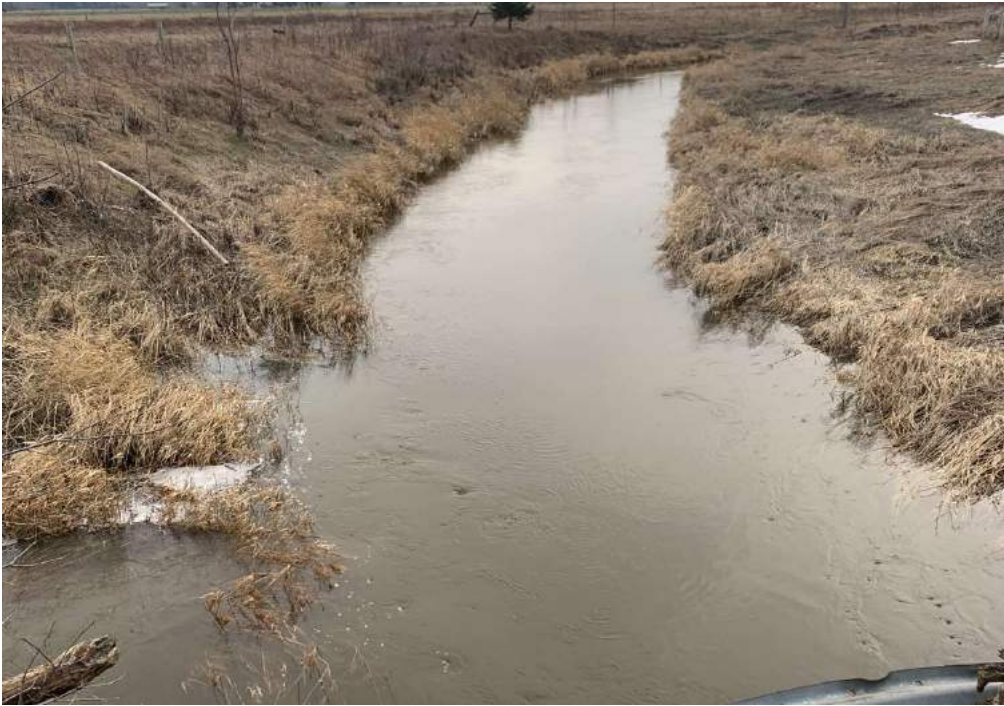
Photo 16-4: View of watercourse upstream

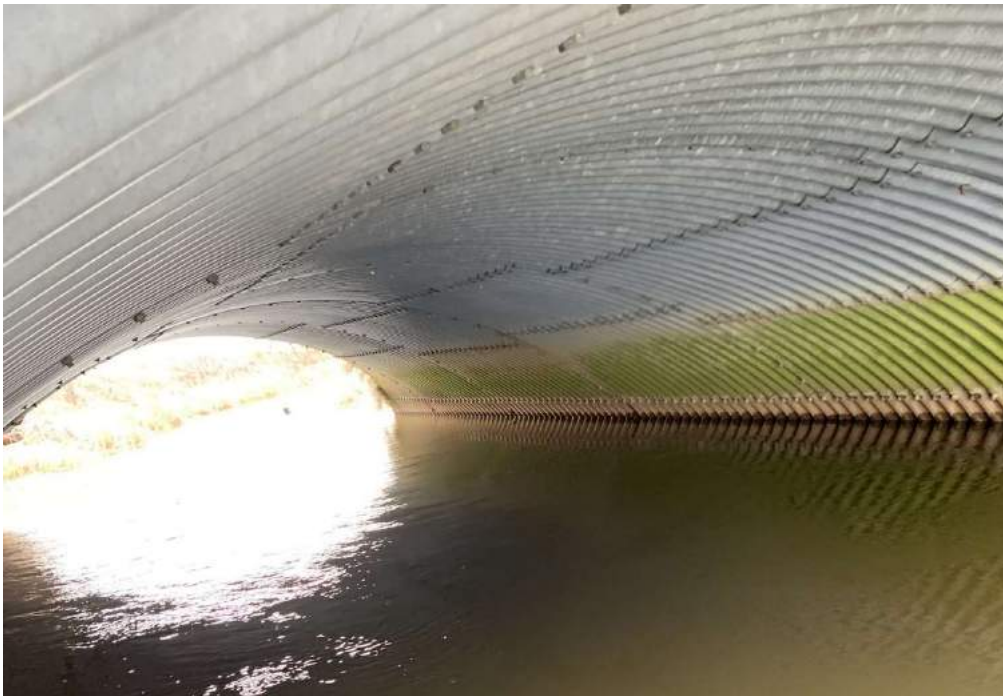
| <b>Comments:</b> | Corrosion and swelling were observed at water level. No section loss. Monitor the corrosion. | | | | | | |

Photo 16-6: Culvert barrel interior

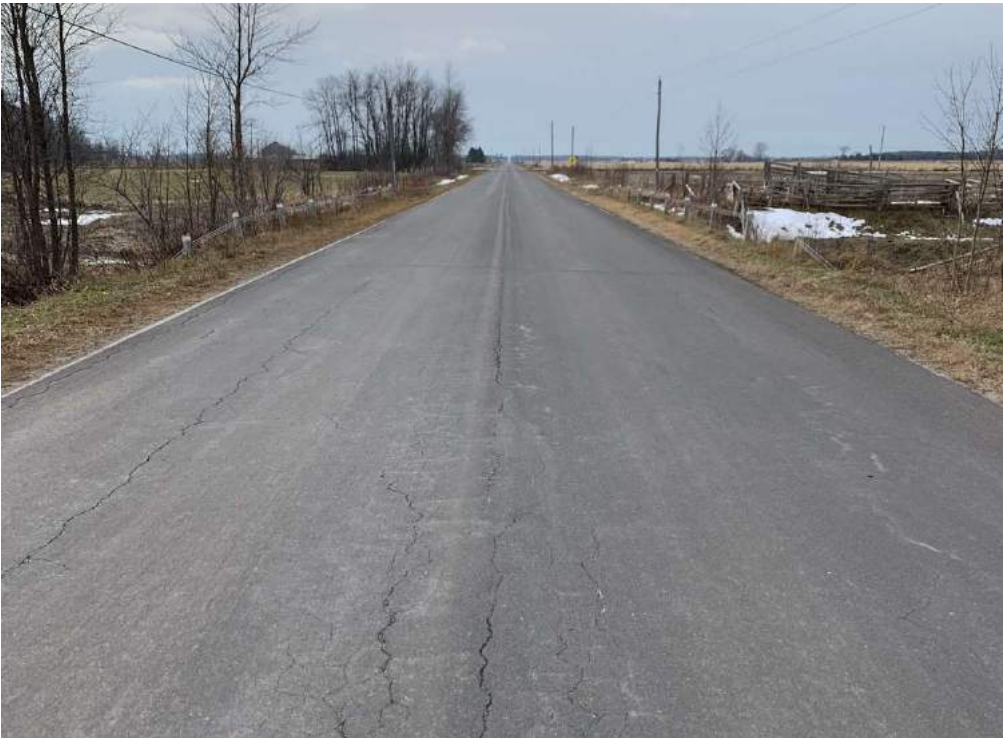
Photo 16-7: View of structure from approach

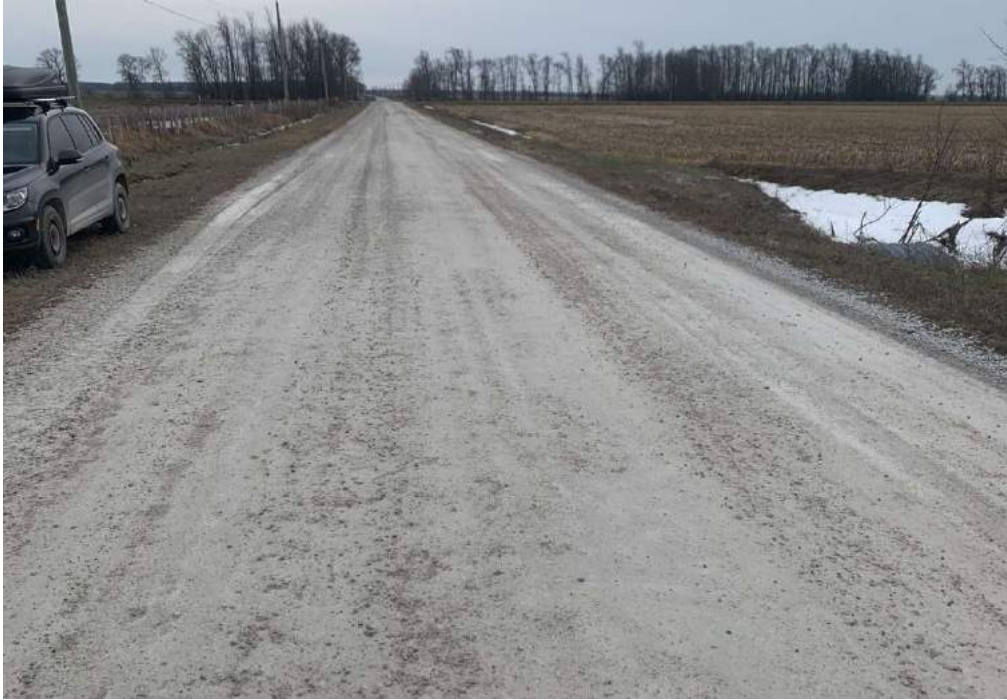
Photo 17-2: View of structure and approach wearing surface

| | Continue annual maintenance (annual grading). | | | | | | |

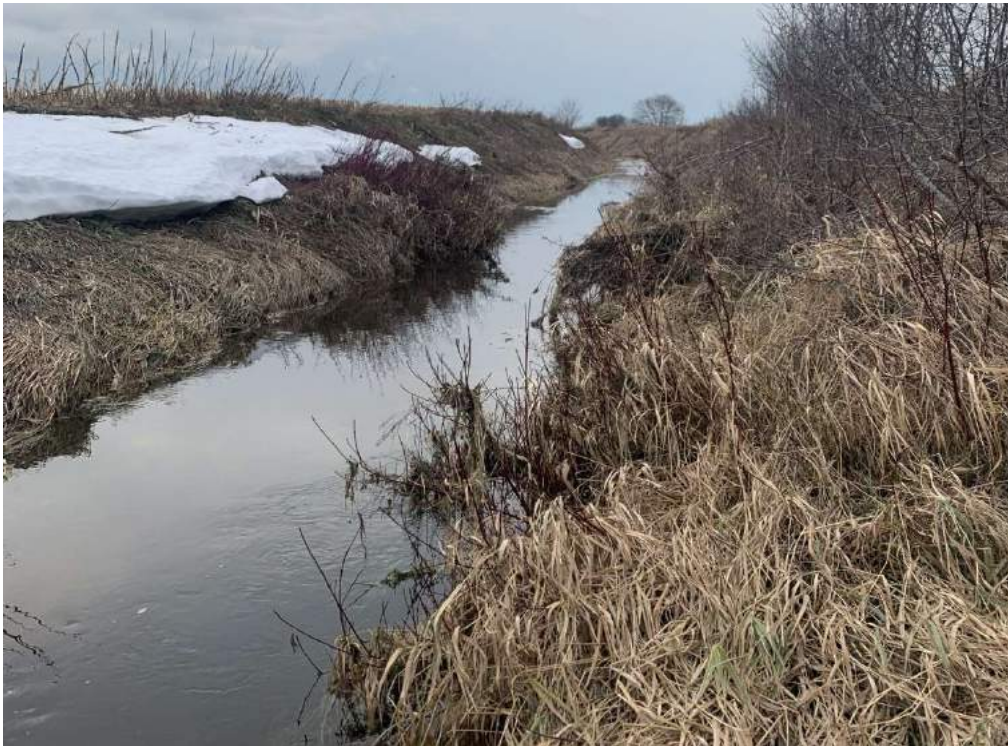
Photo 17-3: View of watercourse upstream

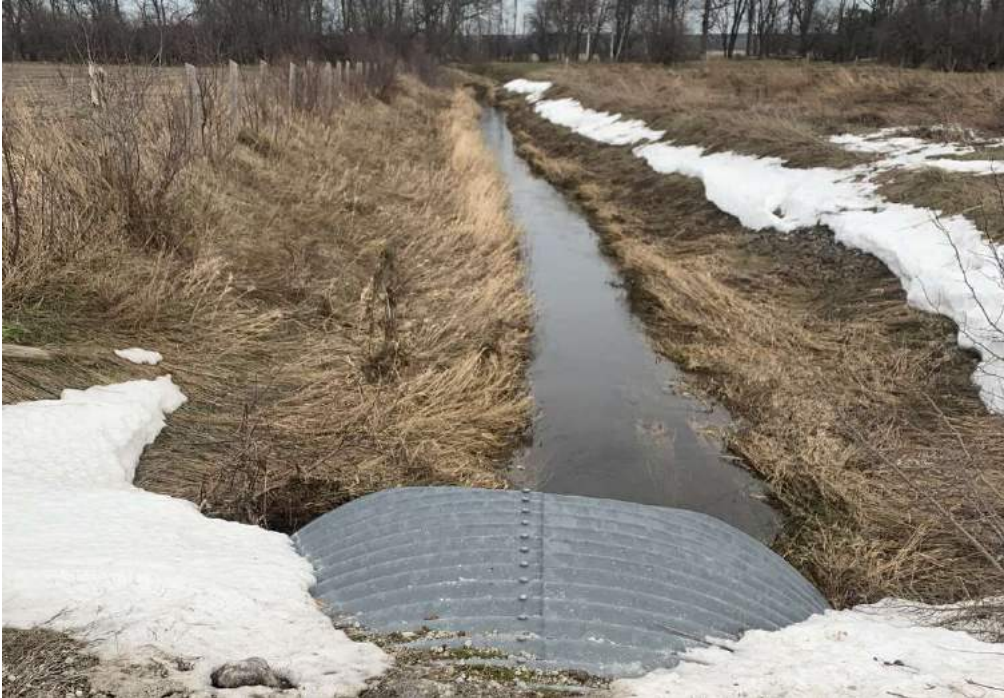
Photo 17-4: View of watercourse downstream and outlet culvert end

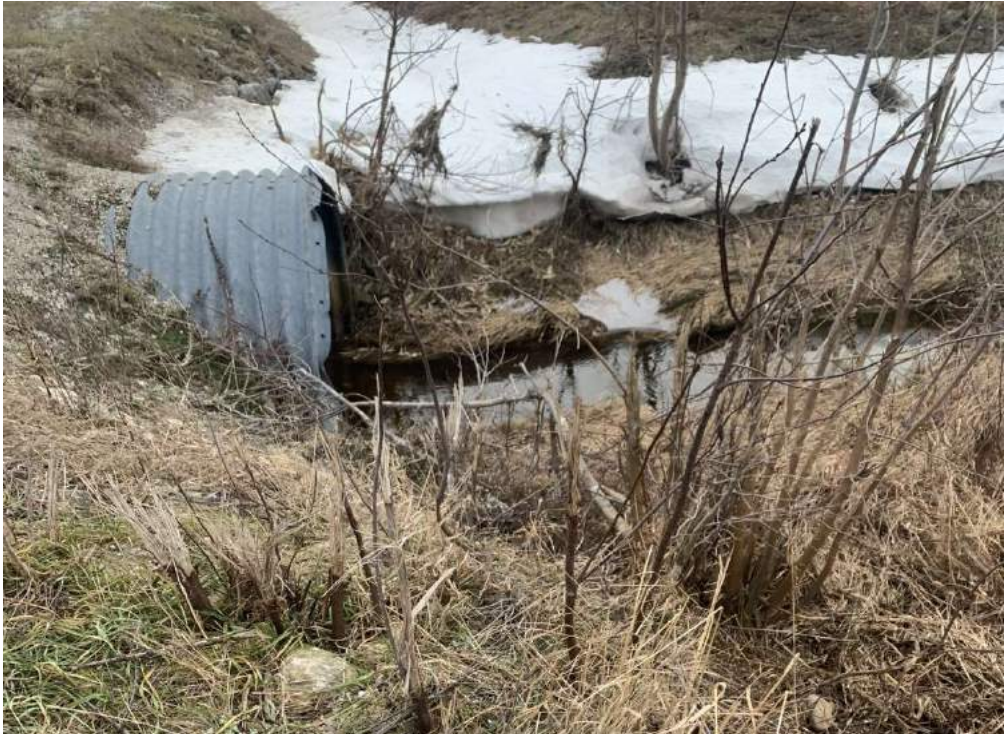
Photo 17-5: View of culvert in elevation and inlet components

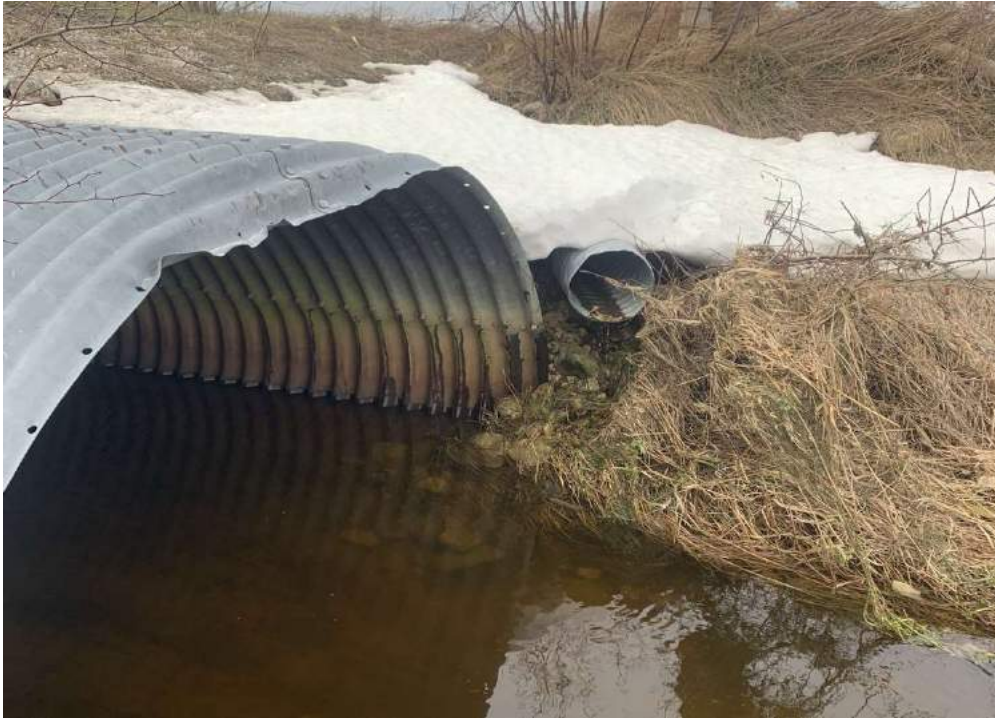
Photo 17-6: View of embankment

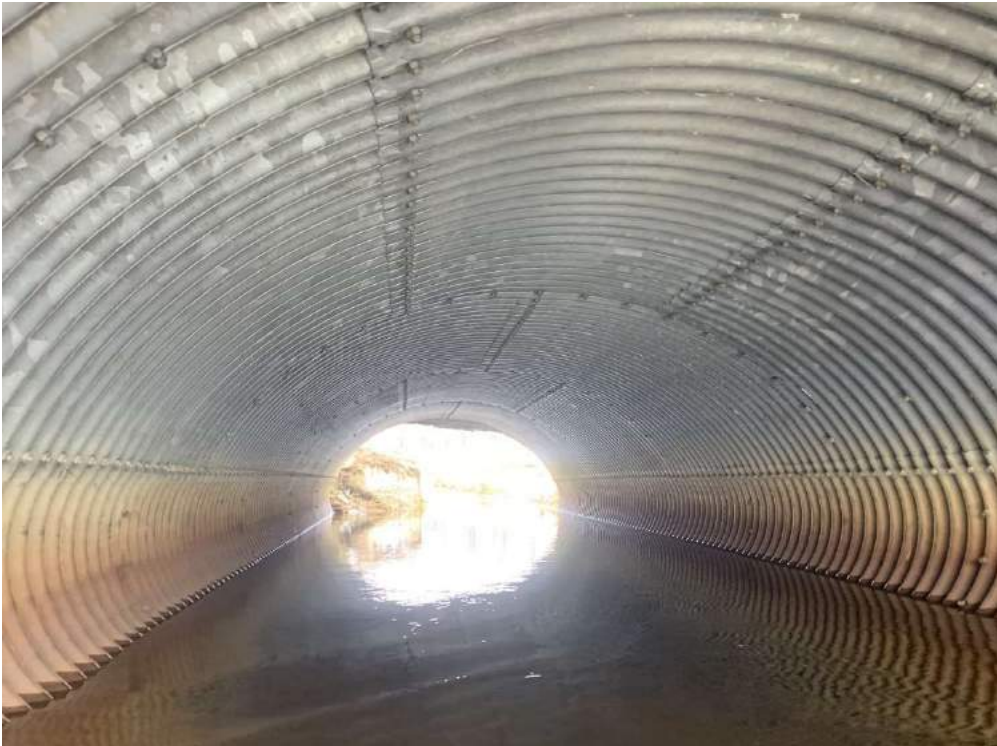
Photo 17-7: View of culvert barrel interior

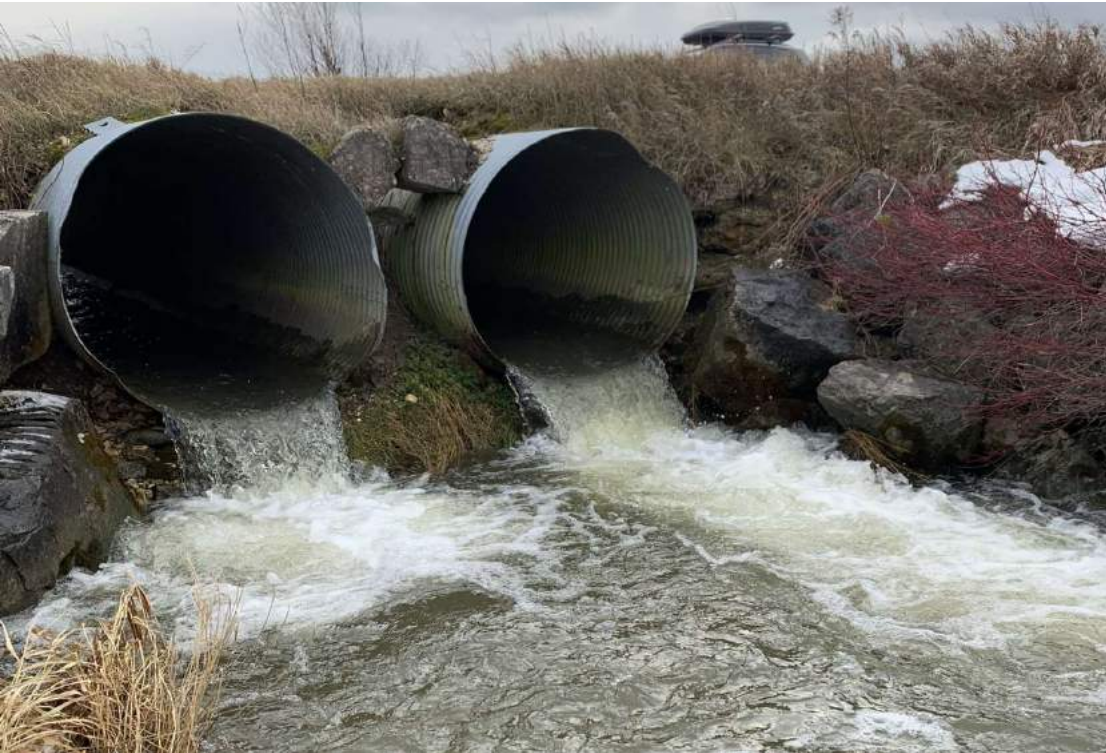
Photo 18-3: View of culvert in elevation and outlet end components

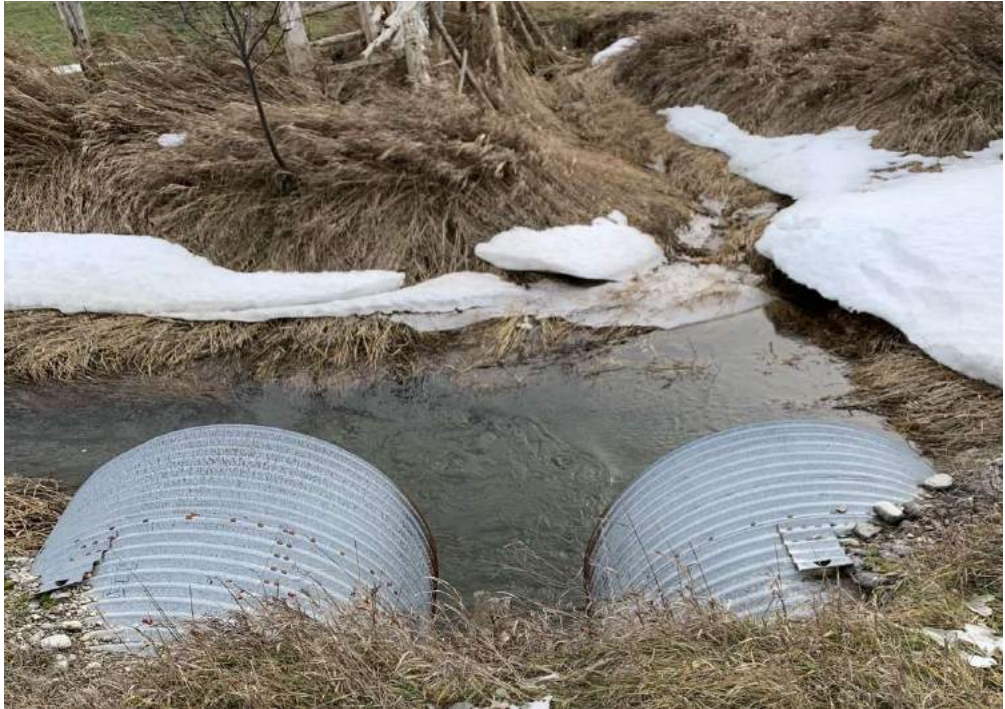
Photo 18-4: View of watercourse upstream and inlet ends

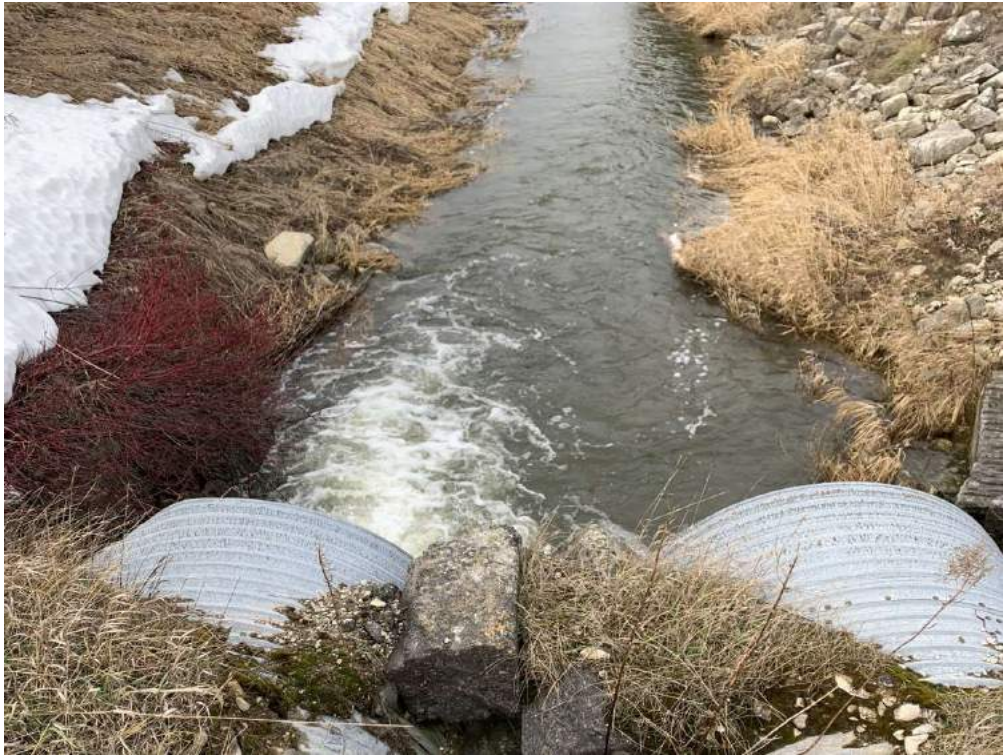
Photo 18-5: View of watercourse downstream and outlet culvert ends

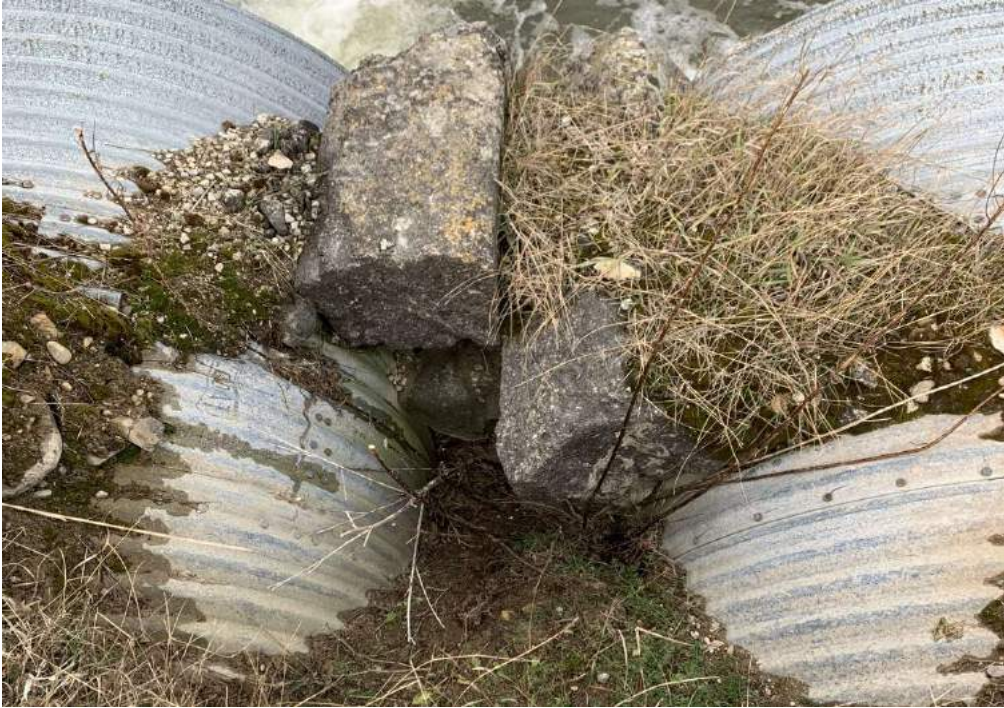
Photo 18-6: View of erosion of embankment and between pipes

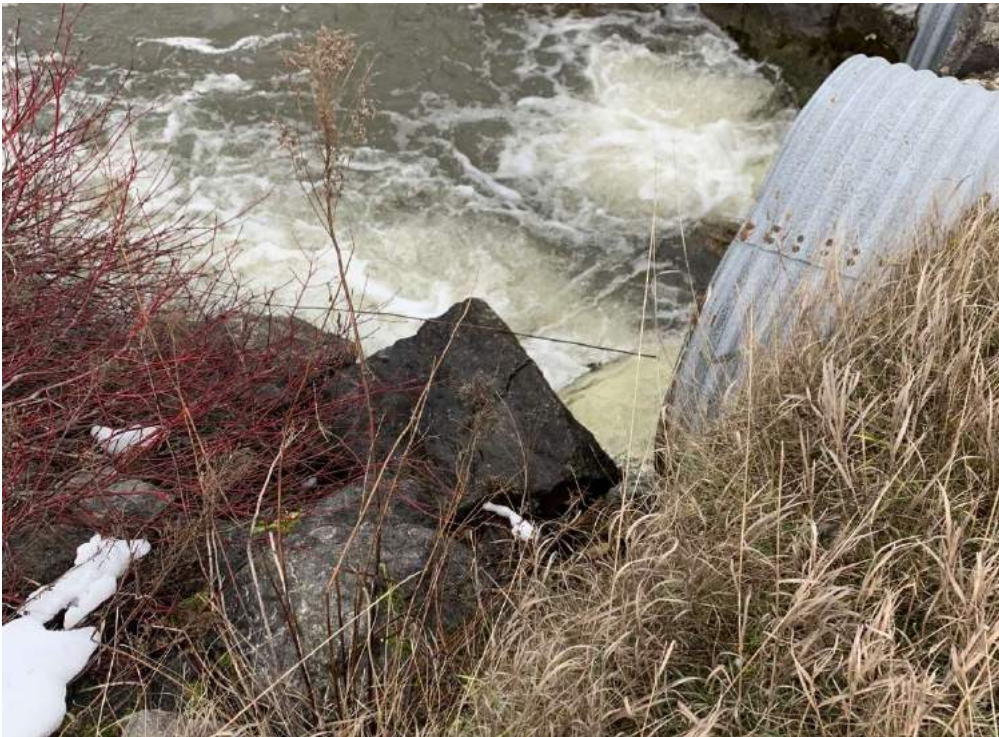
Photo 18-7: Erosion at the haunch of the outlet pipe

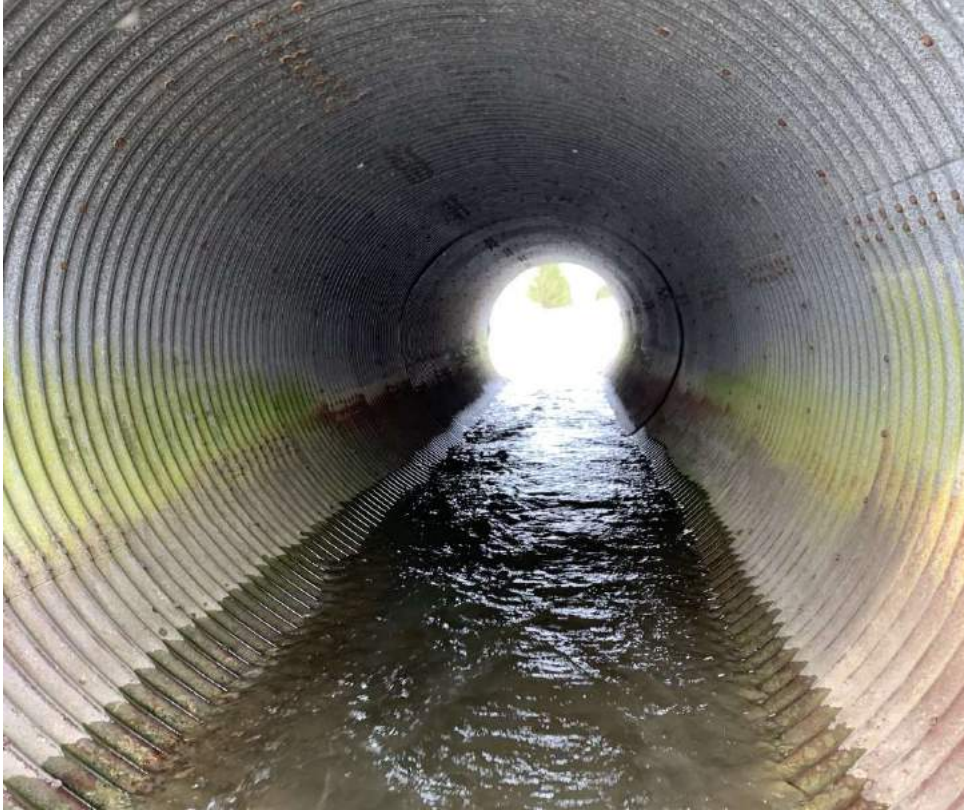
Photo 18-8: View of east culvert barrel interior

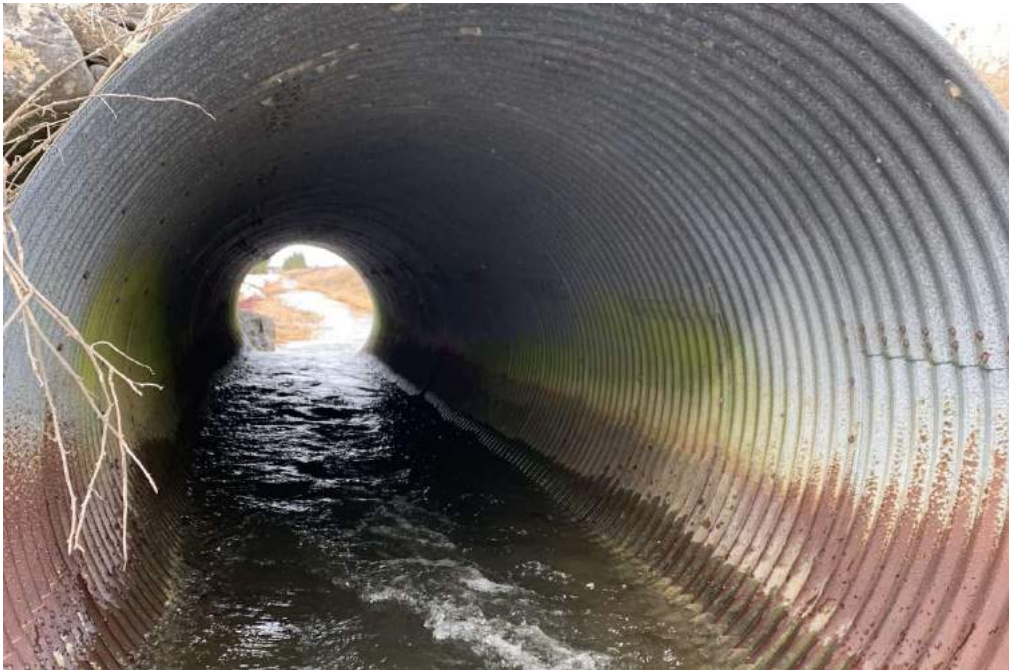
Photo 18-9: View of west culvert barrel interior

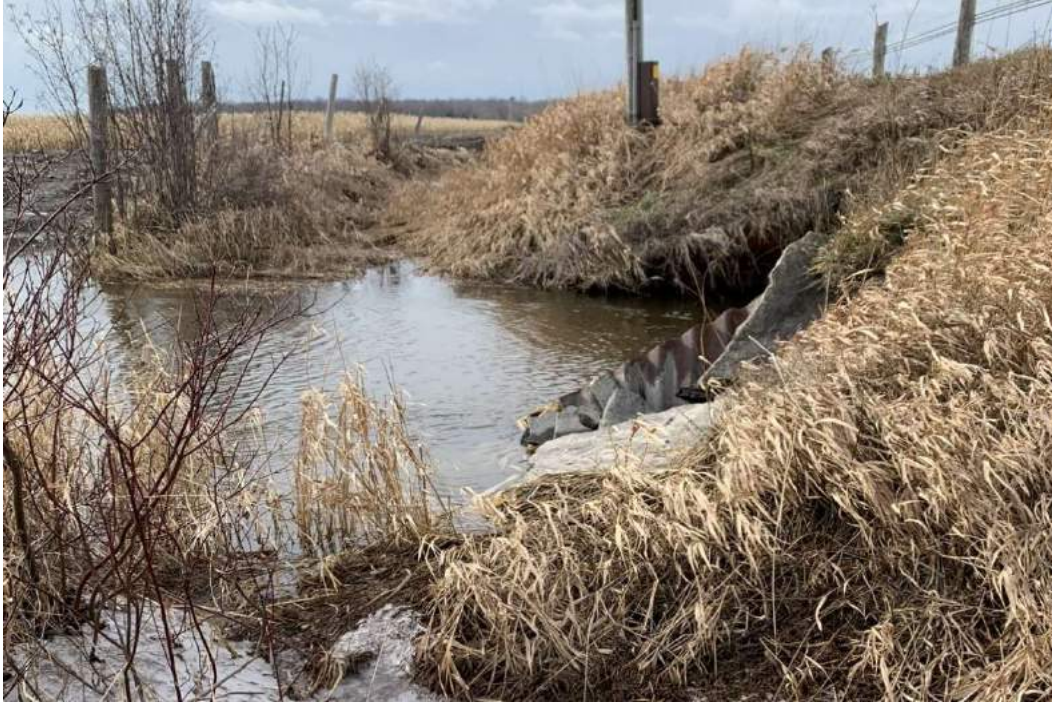
Photo 19-2: View of culvert in elevation and inlet components

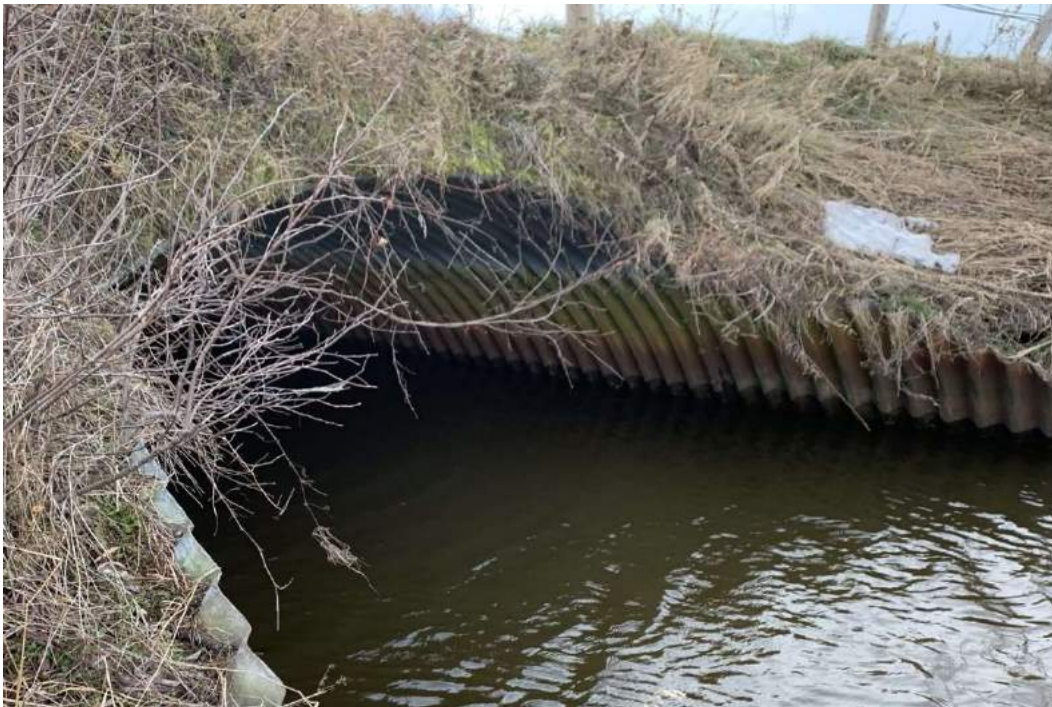
Photo 19-3: View of culvert in elevation and outlet components
