MUNICIPALITY OF NORTHERN BRUCE PENINSULA

# 2022 STRUCTURE INSPECTION REPORT

FINAL  
PROJECT NO.: 201-01605-00  
DATE: APRIL 03, 2023

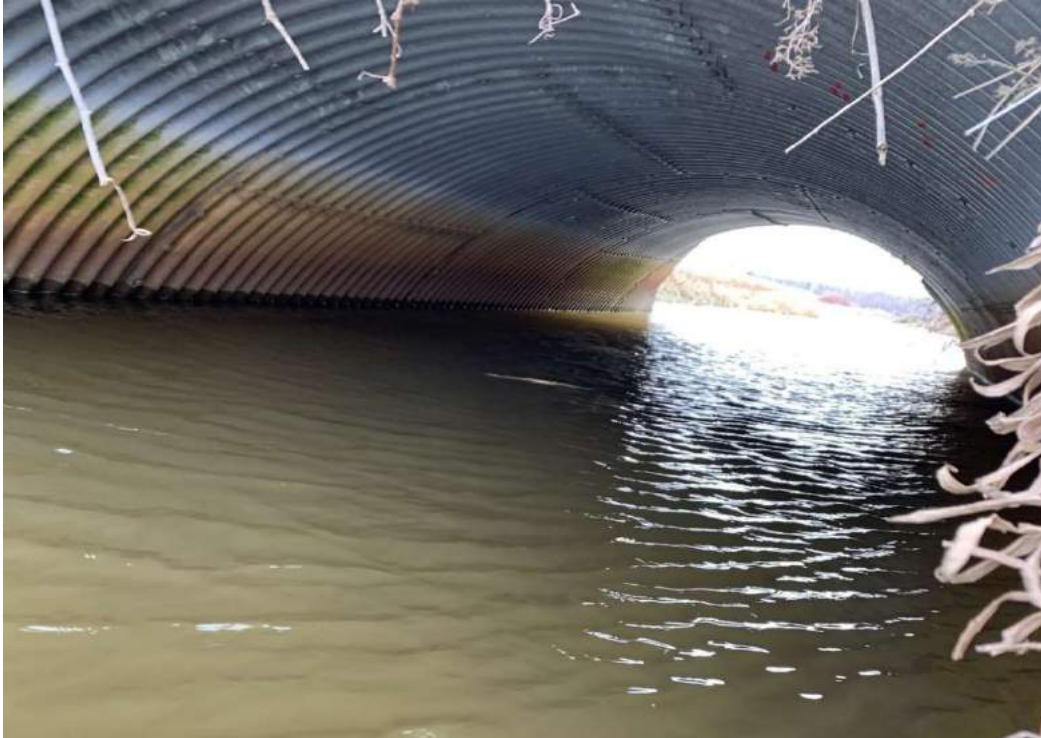
Photo 19-4: View of culvert barrel interior

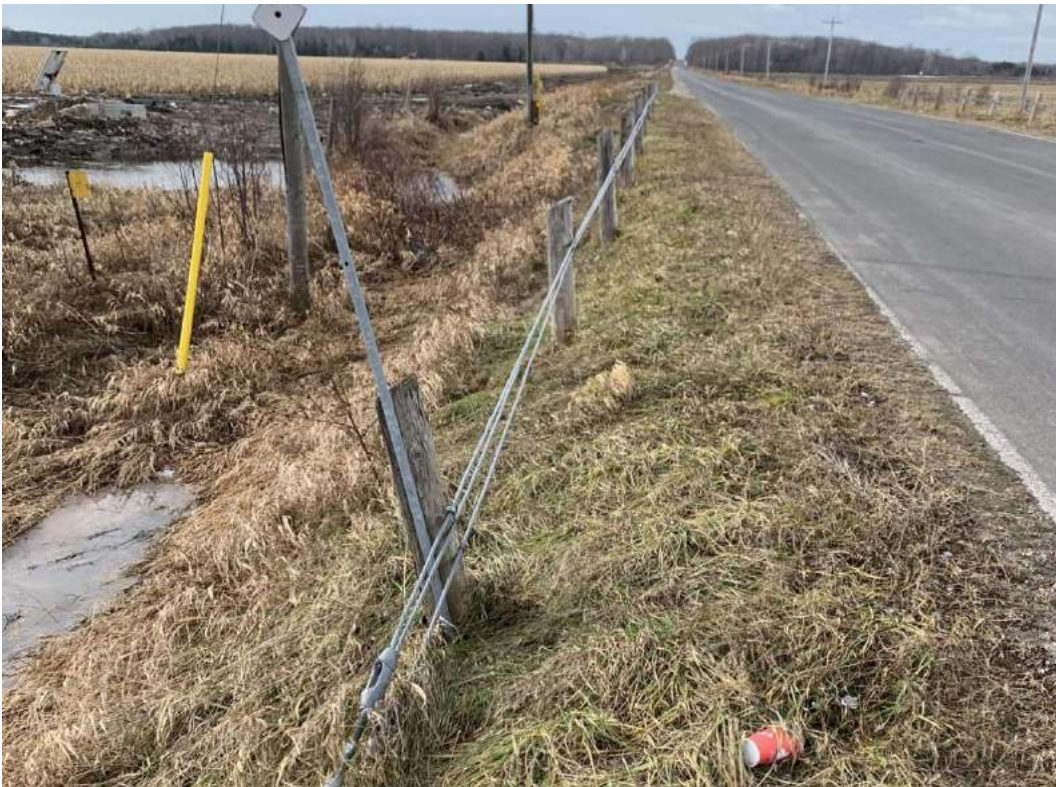
Photo 19-7: View of structure barrier protection (typical)

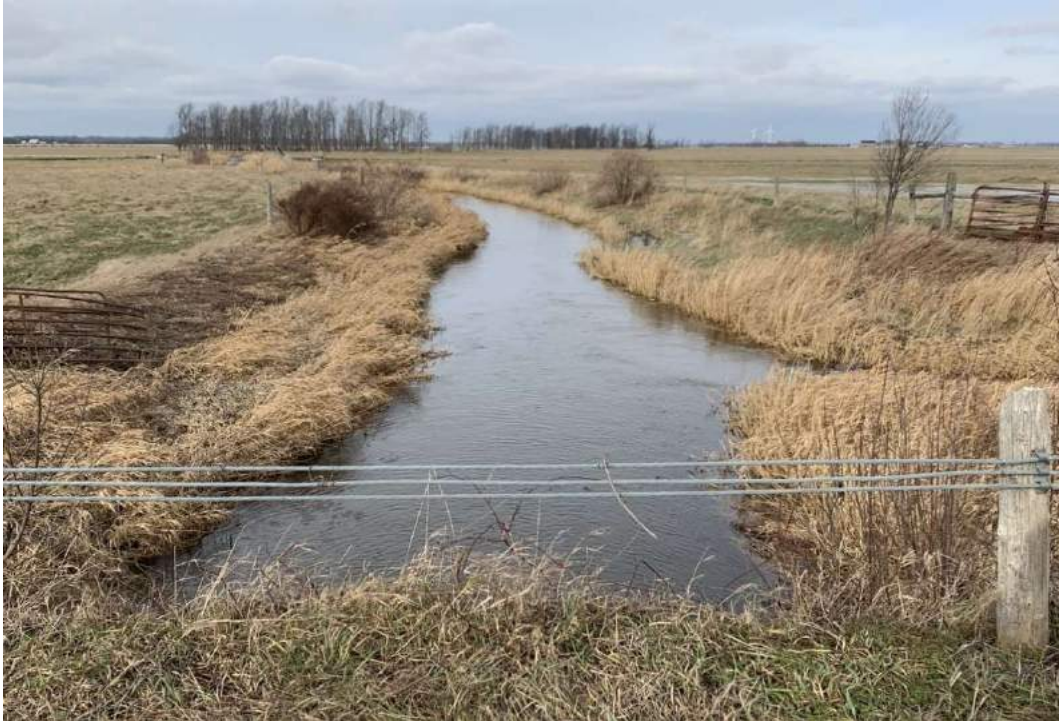
Photo 19-8: View of watercourse upstream

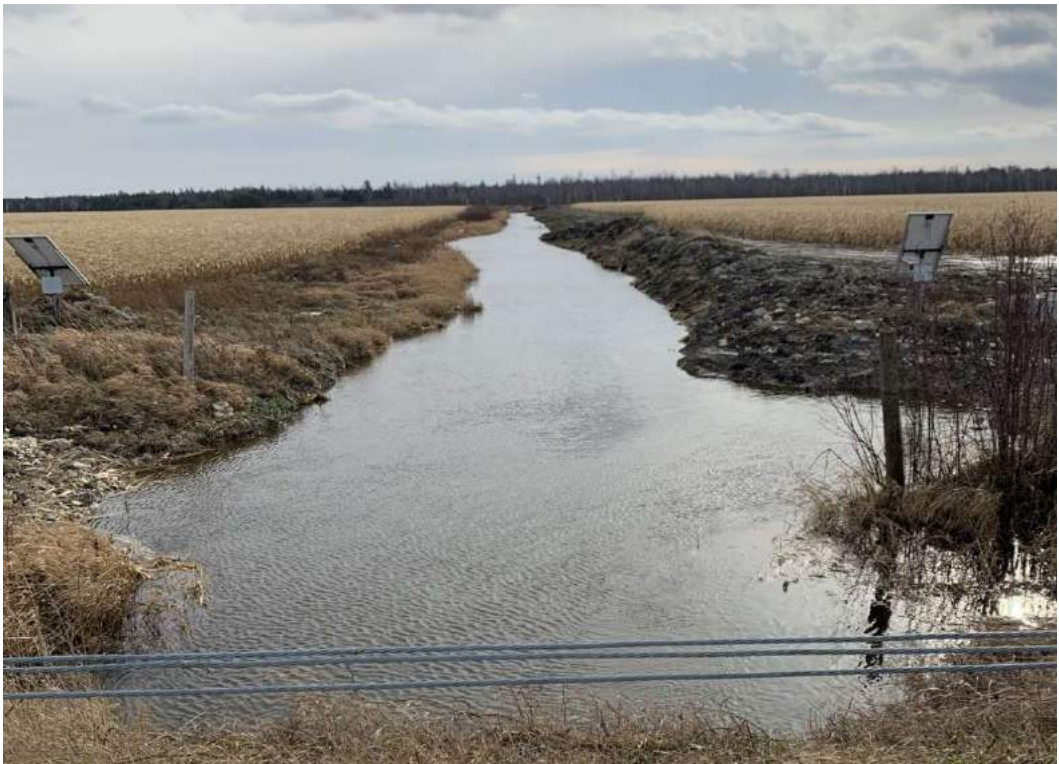
Photo 19-9: View of structure downstream

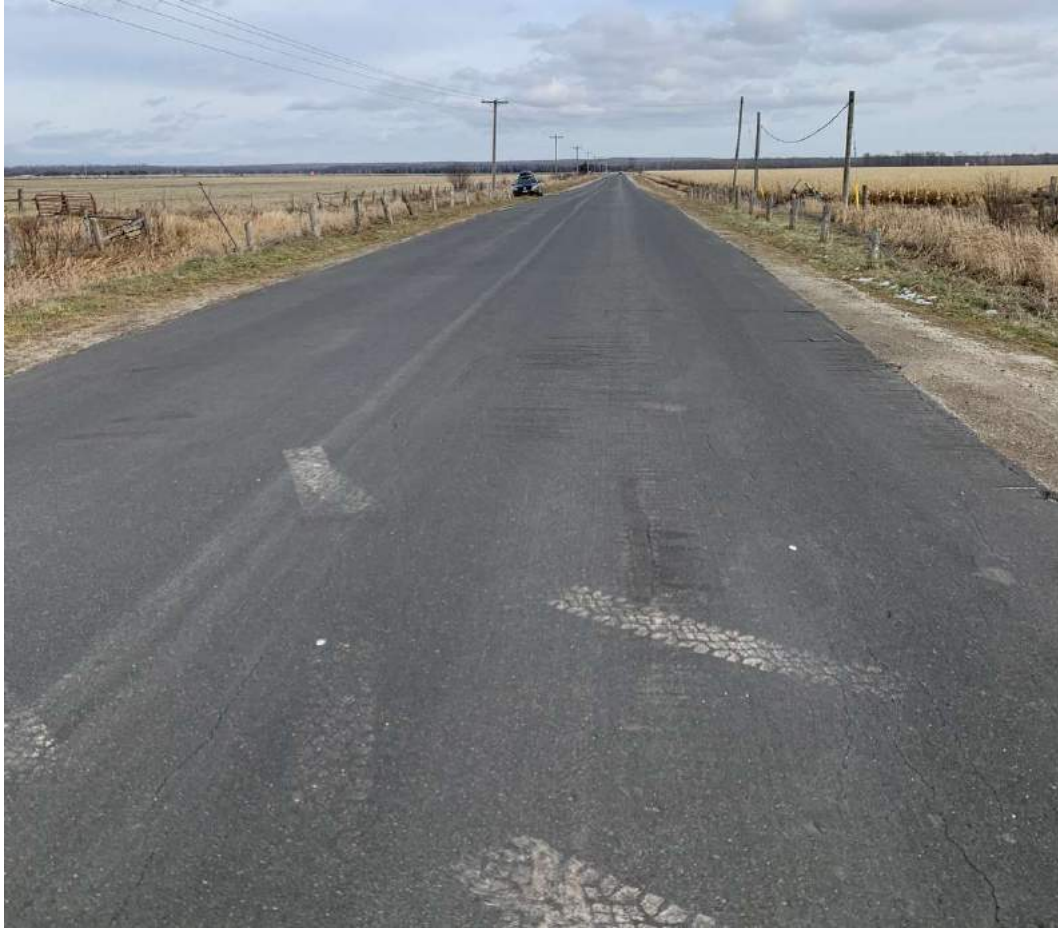
| <b>Comments:</b> | Recently placed surface treatment is in good condition. | | | | | | |

Photo 19-10: View of structure and approach wearing surface
