MUNICIPALITY OF NORTHERN BRUCE PENINSULA

# 2022 STRUCTURE INSPECTION REPORT

FINAL  
PROJECT NO.: 201-01605-00  
DATE: APRIL 03, 2023

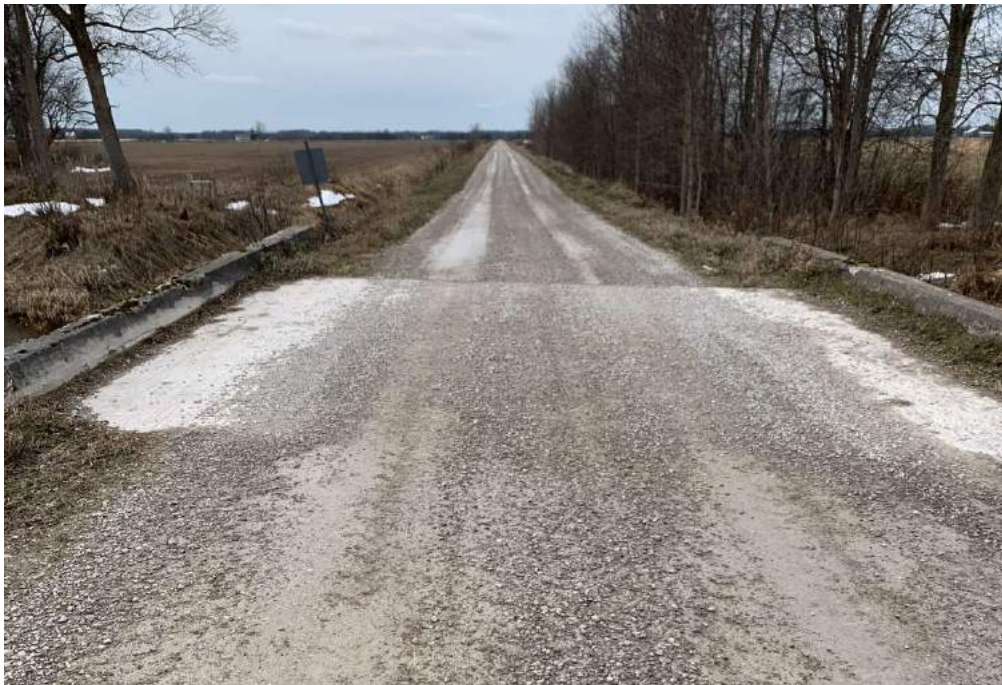
Photo 2-3: Structure deck

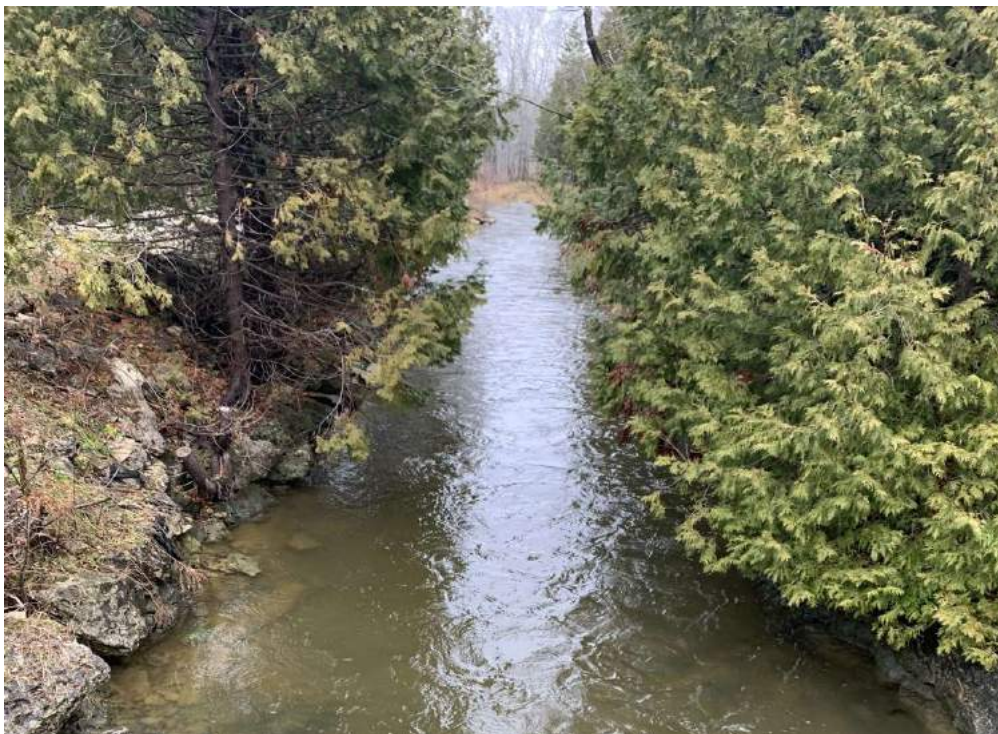
Photo 5-9: View of upstream watercourse

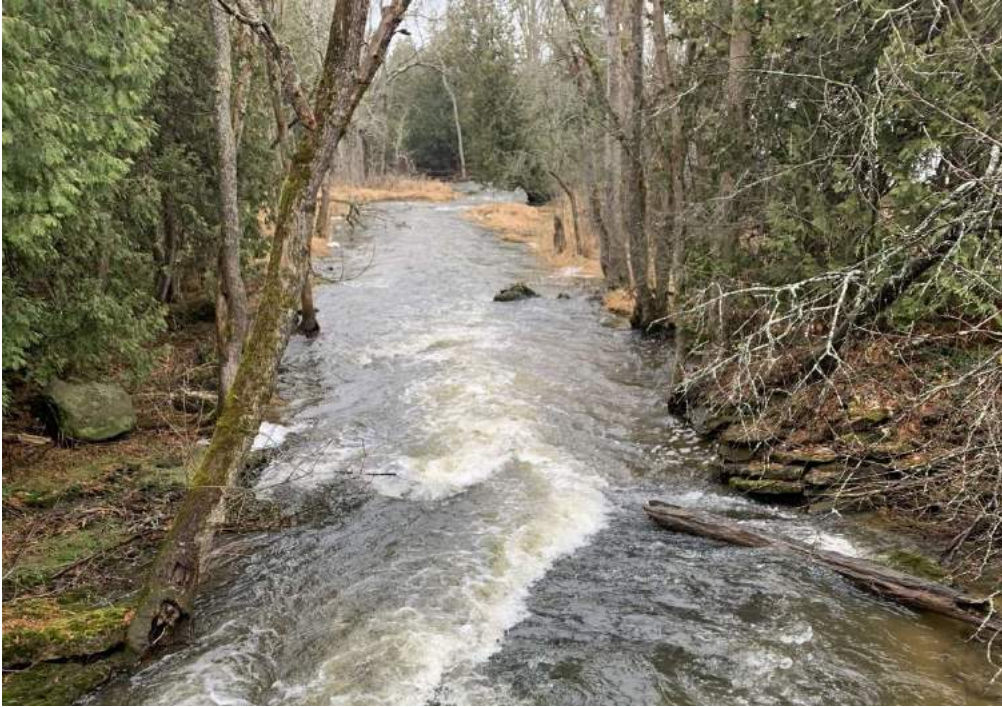
Photo 5-10: View of downstream watercourse

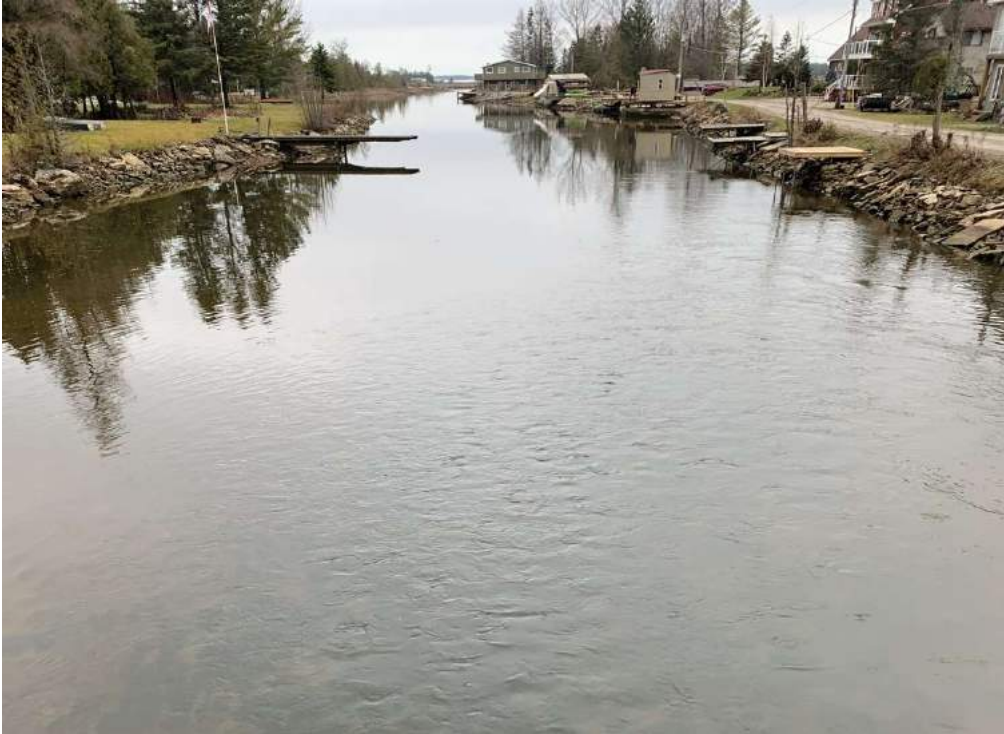
Photo 6-10: View of watercourse downstream

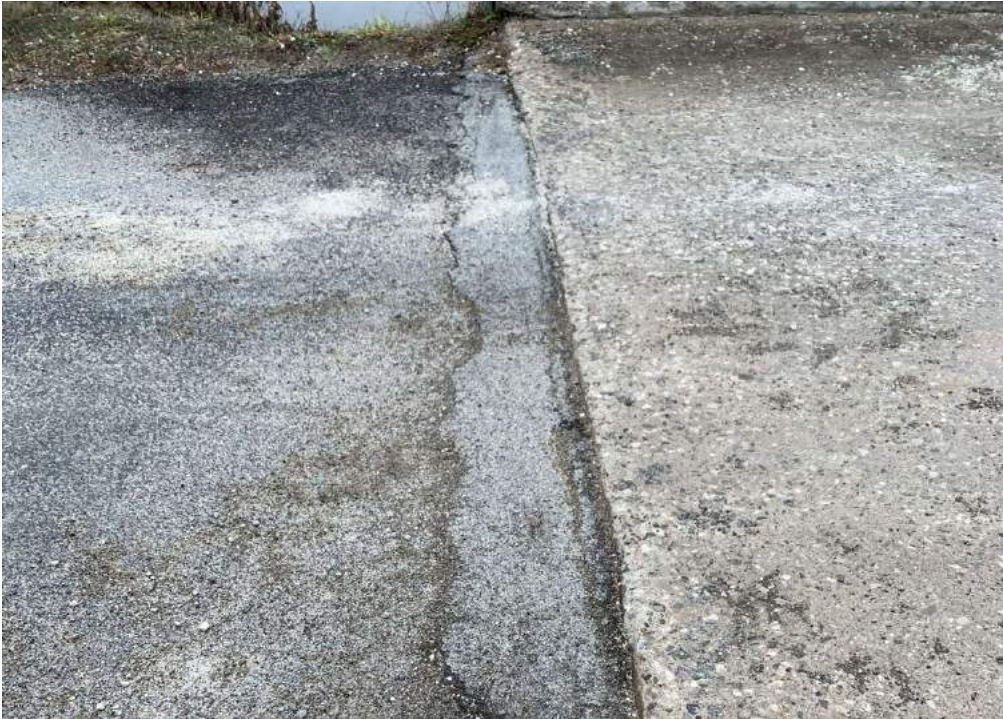
Photo 6-14: View of wearing surface

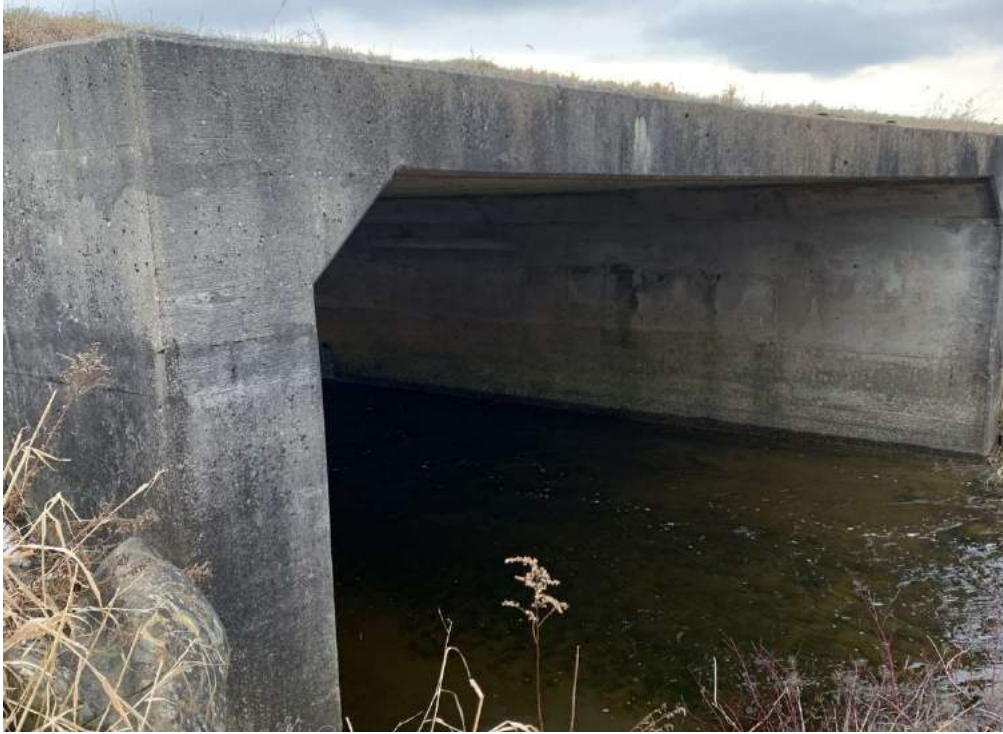
Photo 7-4: Structure Elevation

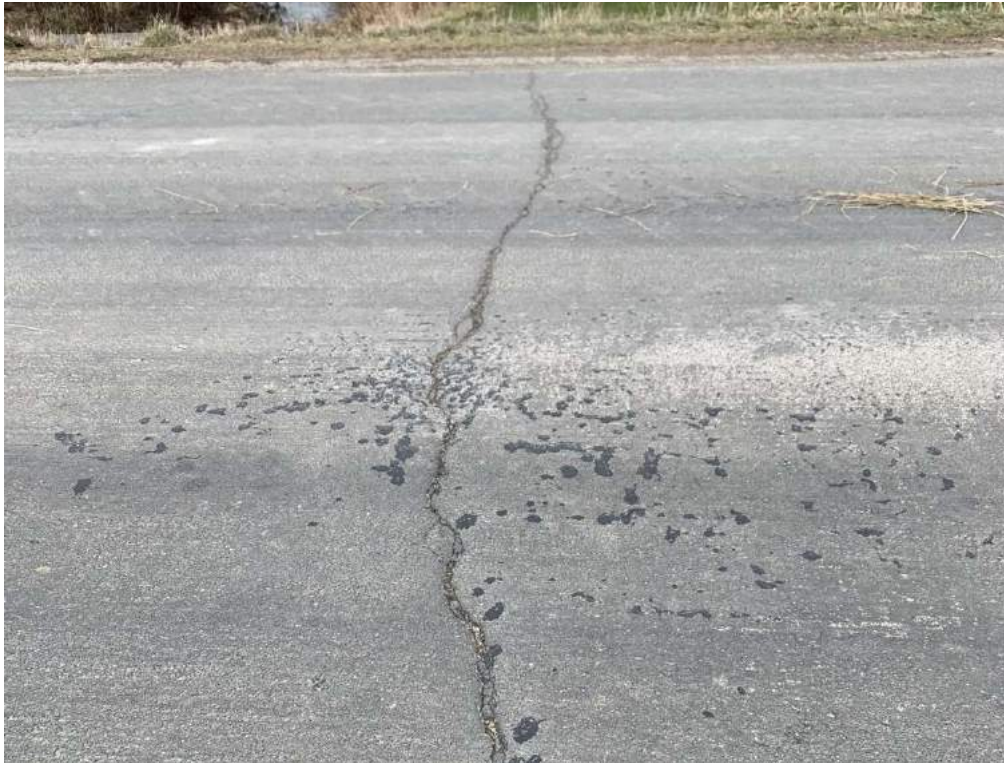
Photo 7-5: Wearing Surface

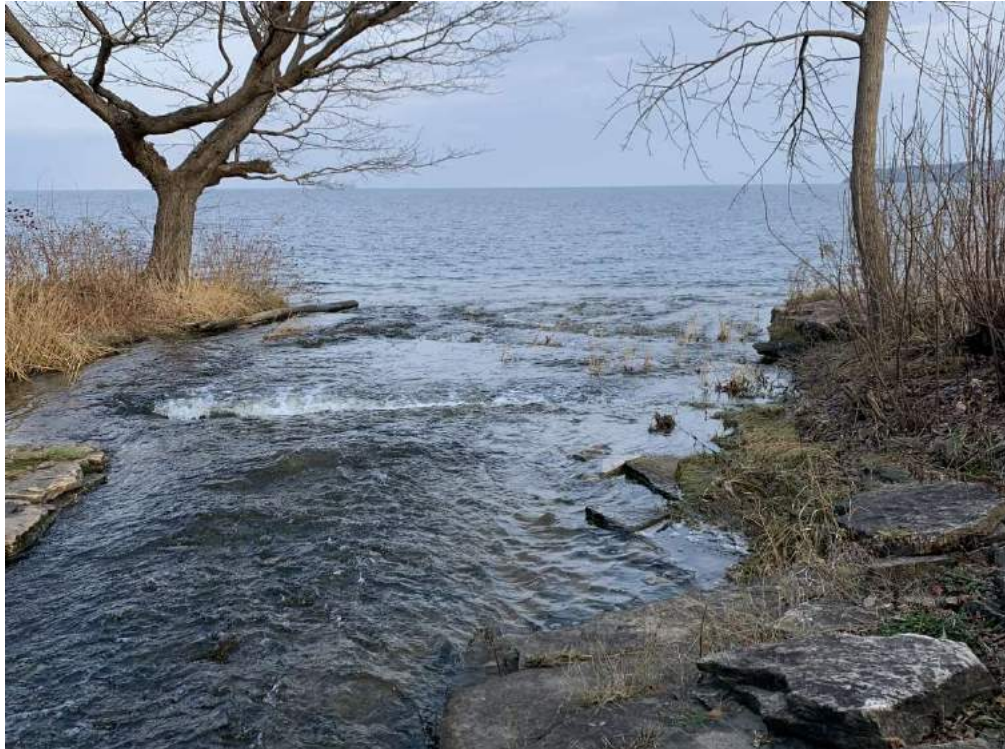
Photo 8-5: View of watercourse downstream

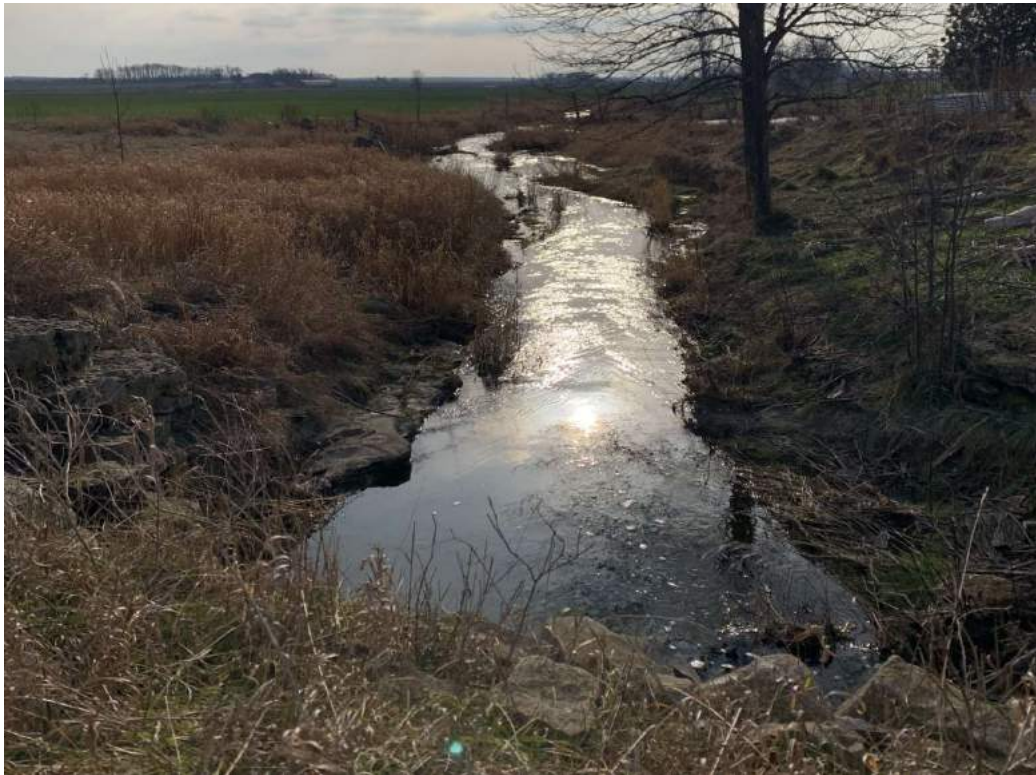
Photo 9-7 - View of watercourse downstream

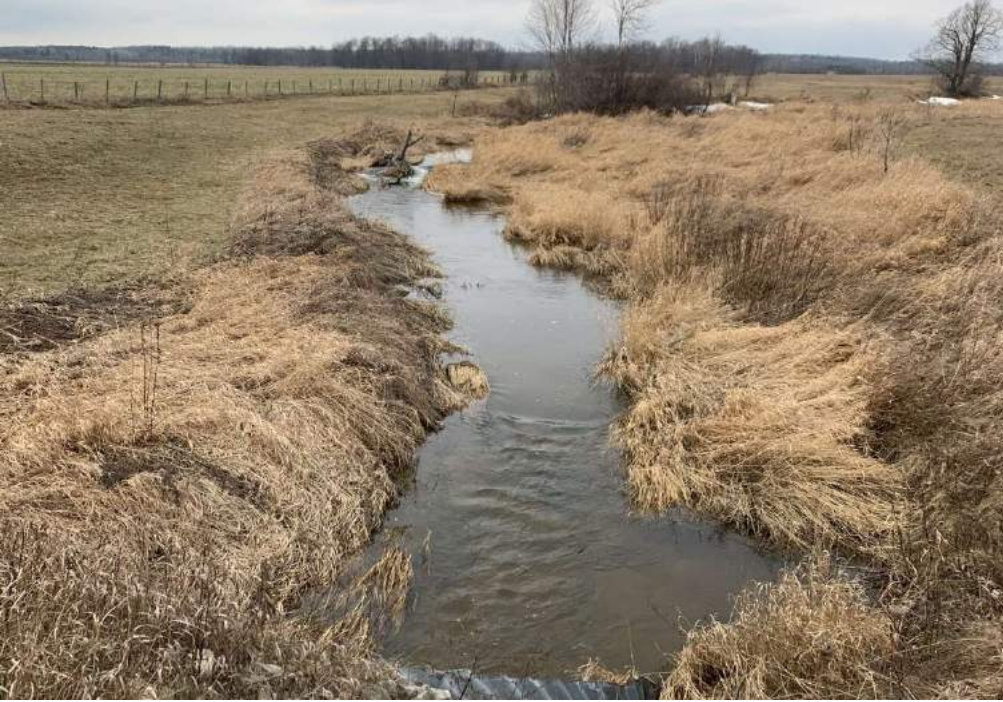
Photo 10-2: View of watercourse upstream and inlet component

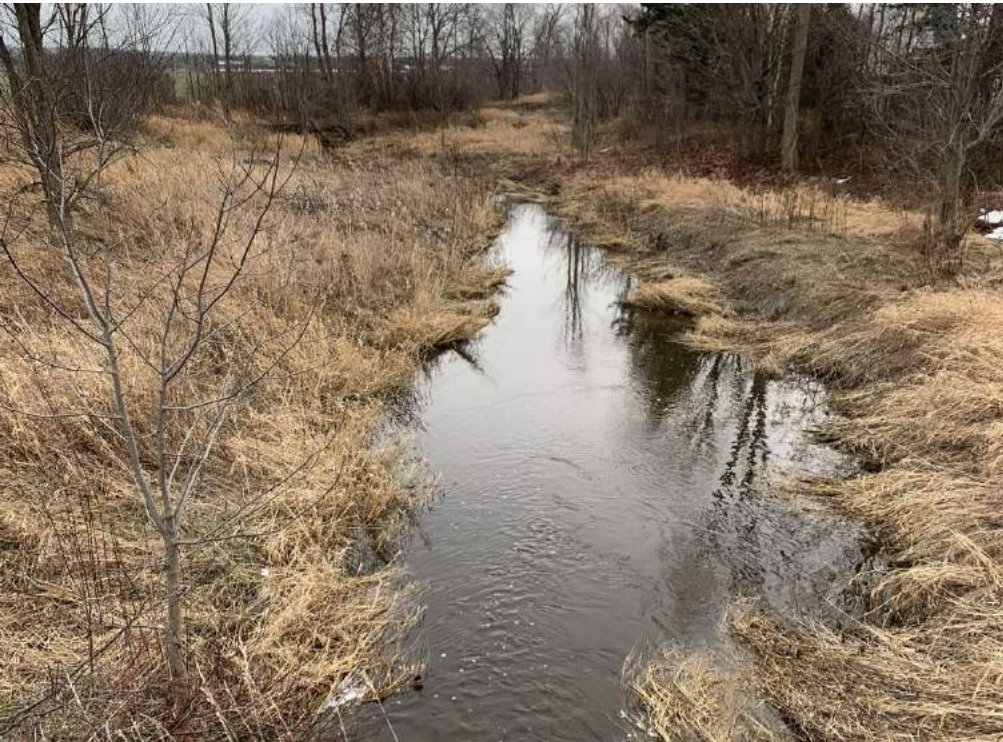
Photo 10-3: View of watercourse downstream

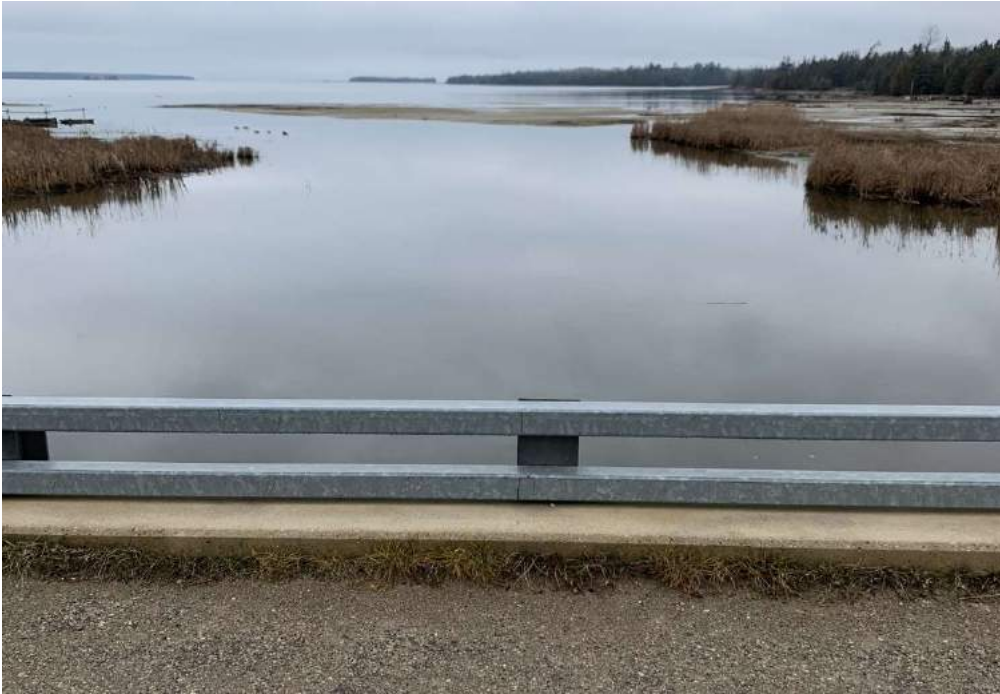
11-8: View of watercourse downstream

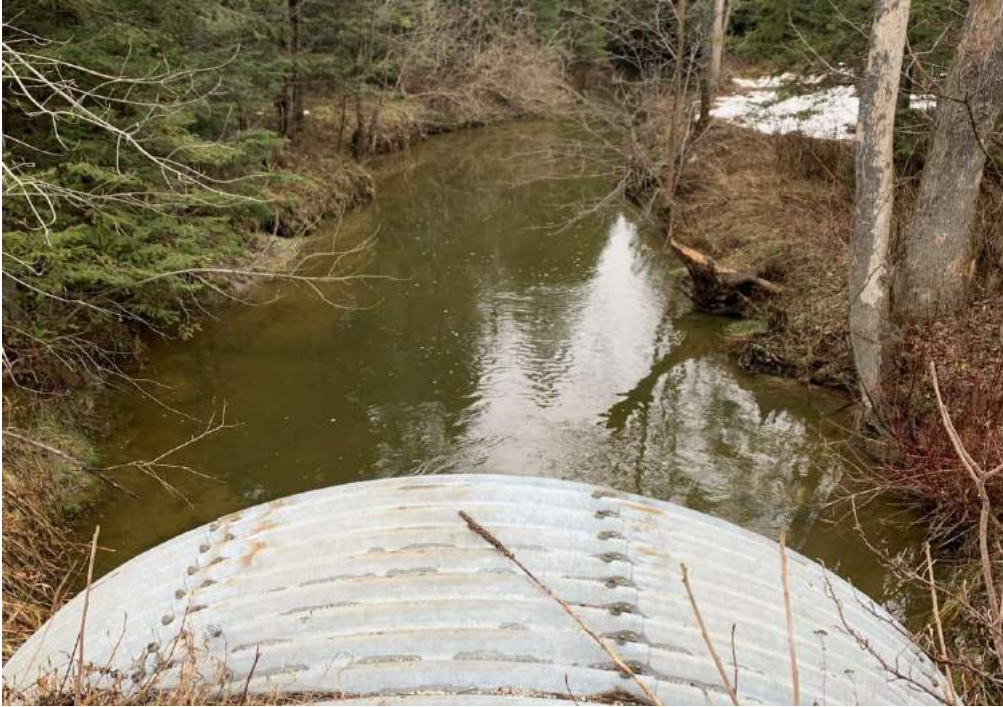
Photo 12-6: View of watercourse downstream

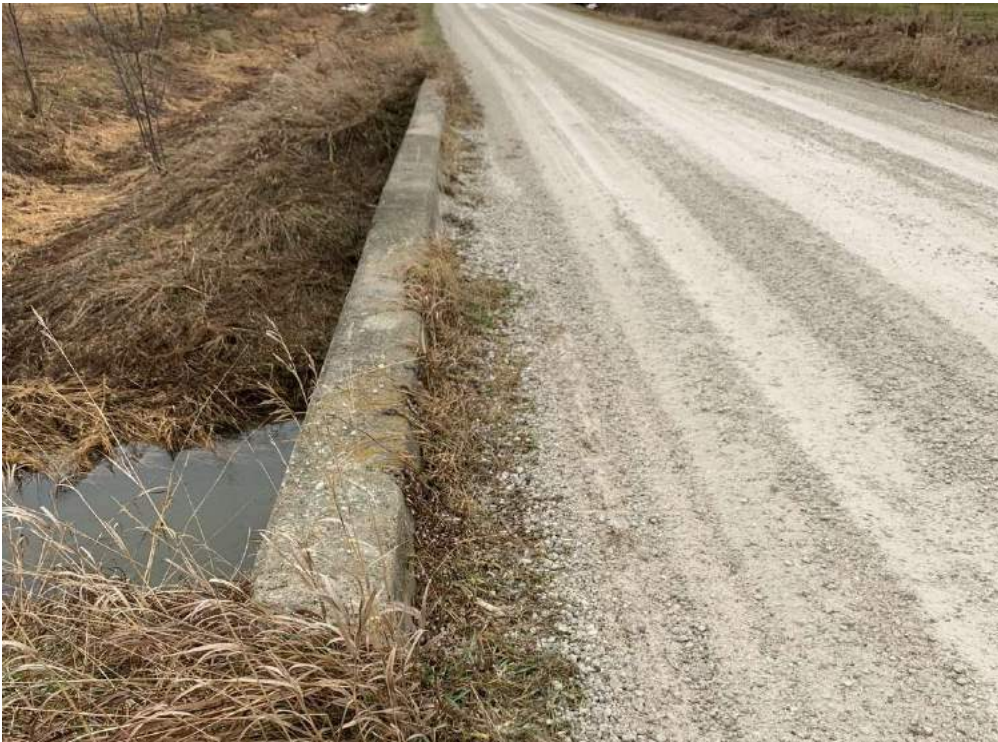
Photo 13-3: View of curb

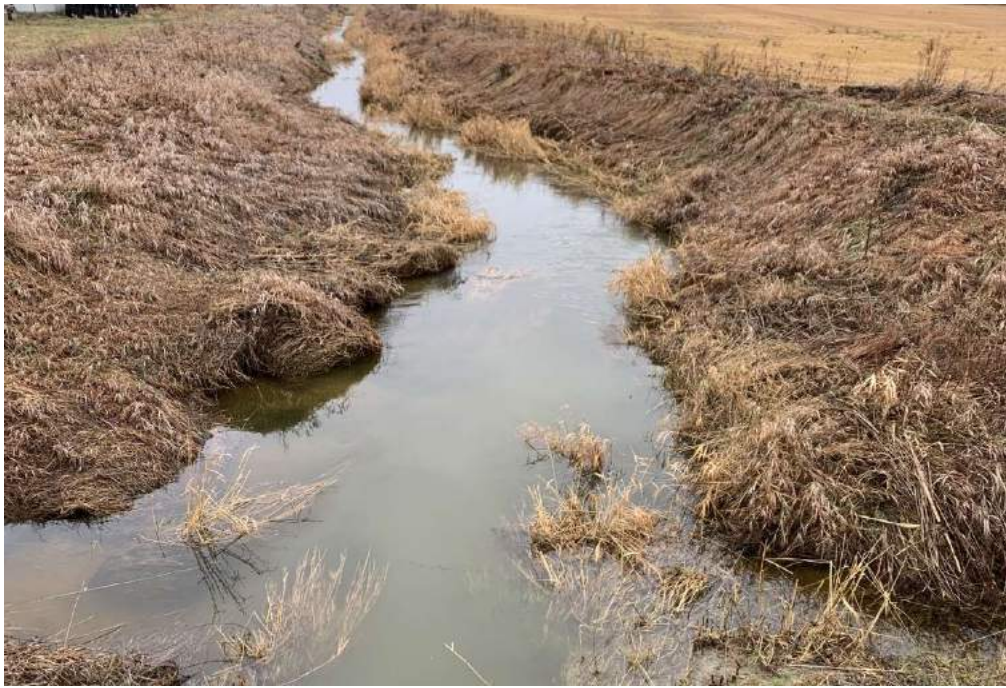
Photo 13-10: View of watercourse downstream

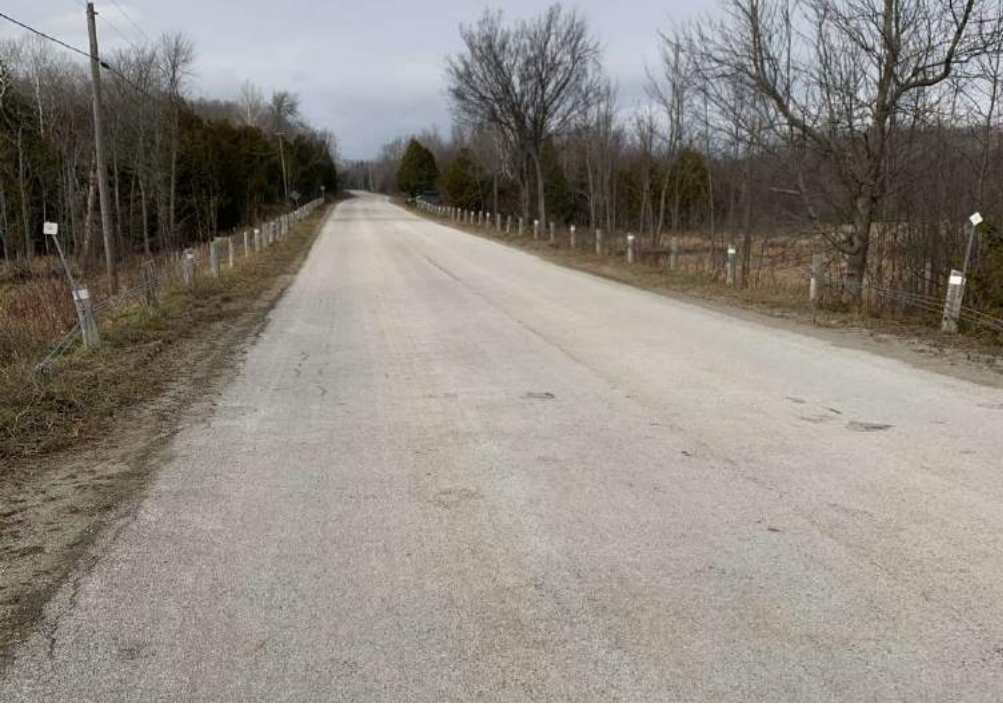
| <b>Comments:</b> | The surface treatment is in good condition with minor wheel path rutting observed. | | | | | | |

Photo 14-2: View of structure wearing surface

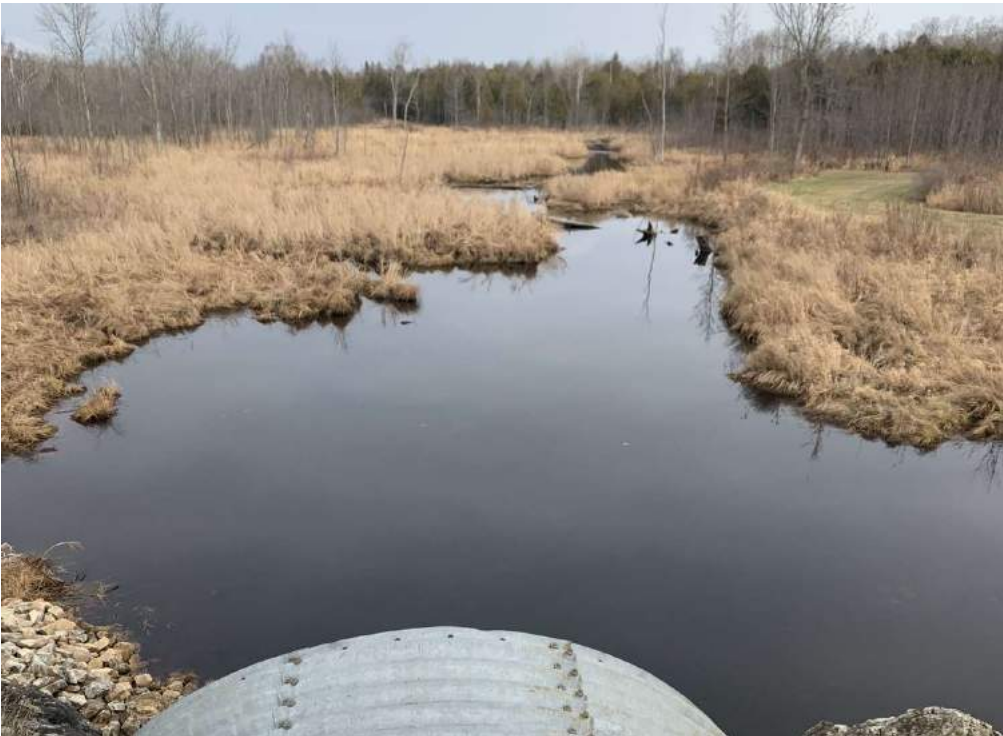
Photo 14-3: View of watercourse downstream

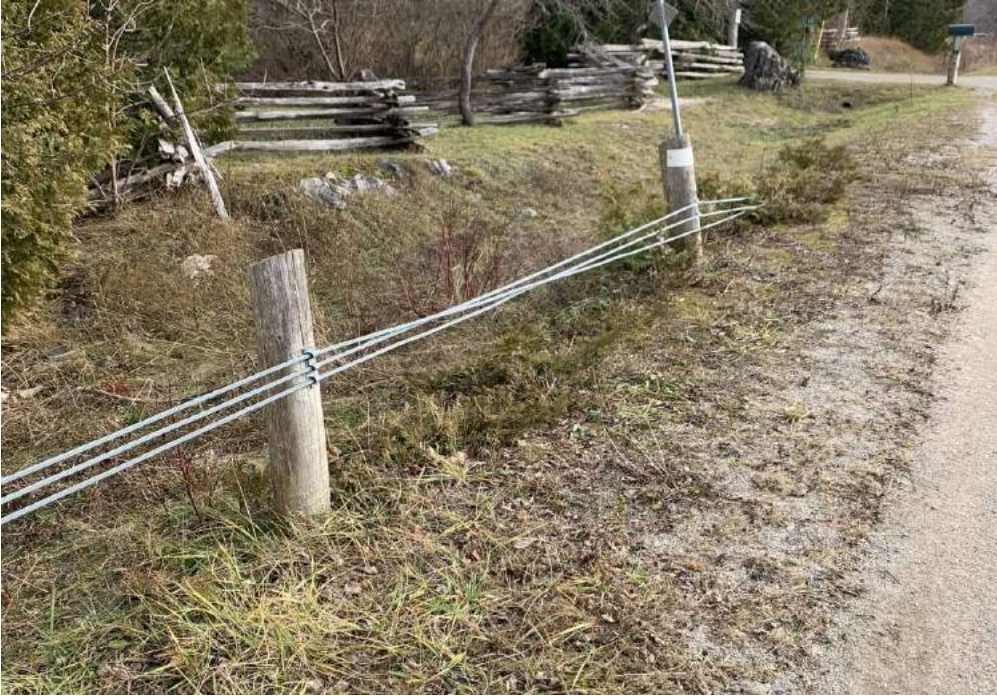
Photo 14-8: View of barrier (typical)

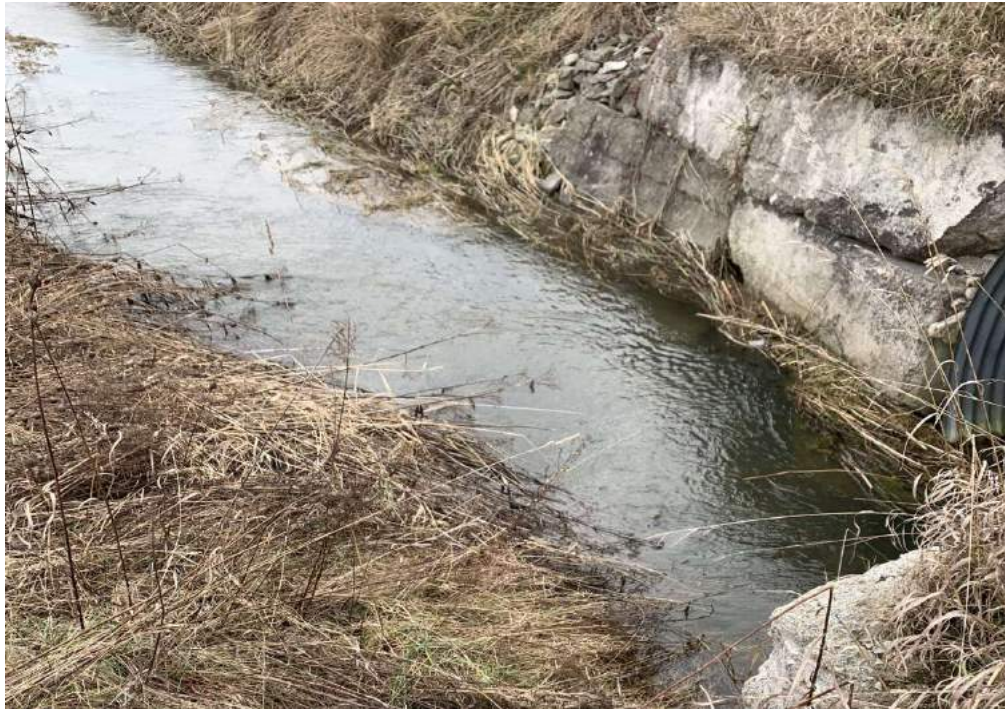
Photo 15-6: View of watercourse downstream

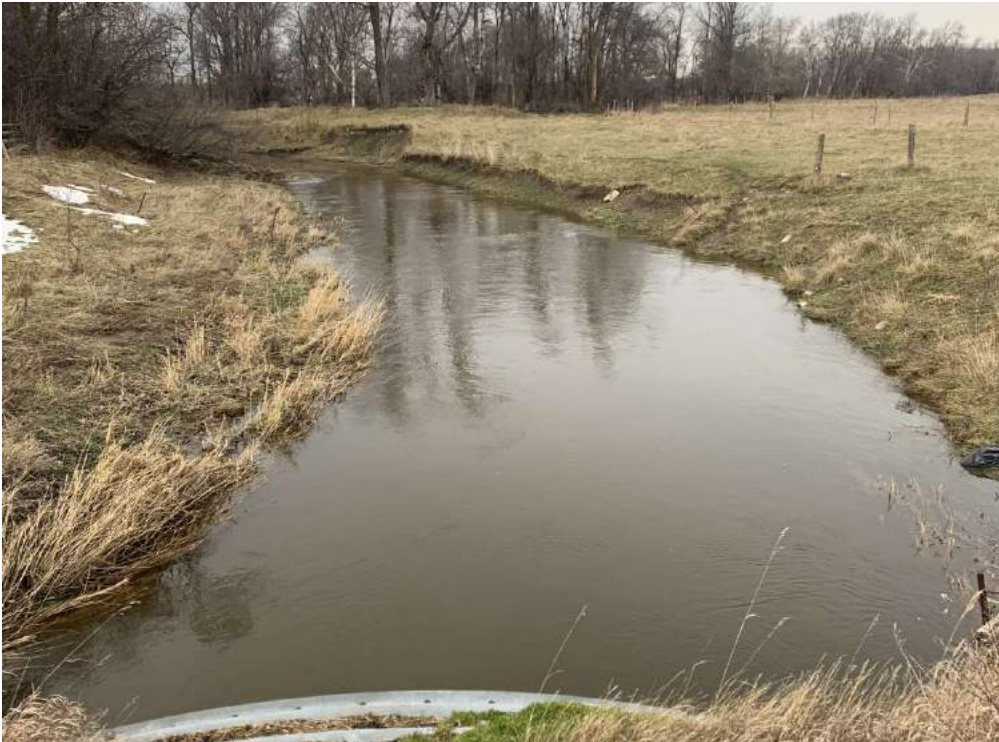
Photo 16-5: View of watercourse downstream

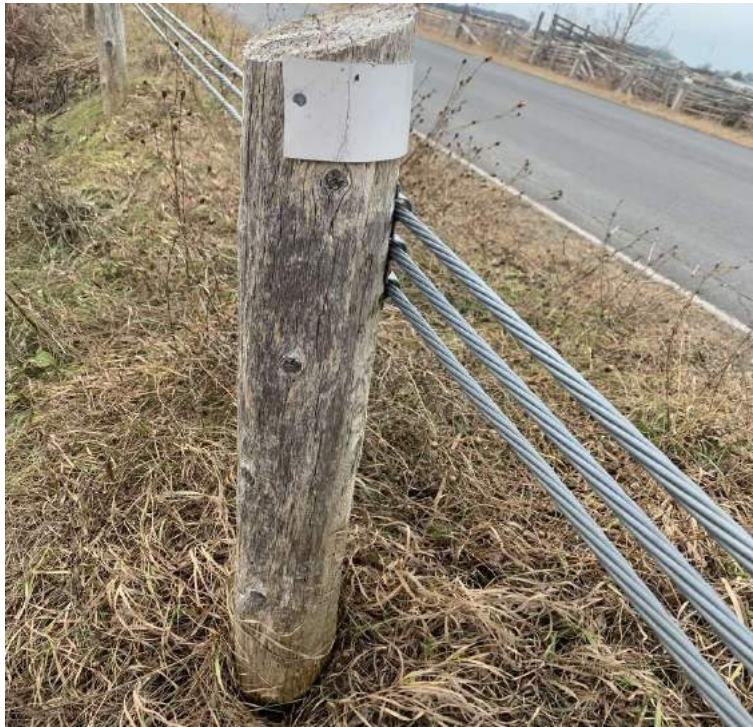
| <b>Comments:</b> | The three cable guide barrier is in fair overall condition. Some of the wooden posts are experiencing moderate rot and should be replaced for vehicle safety. Loose cable on south side. | | | | | | |

Photo 16-9: Wooden post (typical)

| <b>Recommended Work:</b> | None <input type="checkbox"/> 6-10 Years <input type="checkbox"/> 1-5 Years <input checked="" type="checkbox"/> < 1 Year <input type="checkbox"/> Urgent<br>Replace the rotten barrier posts. Re-attach and tighten loose cables. | | | | | | |

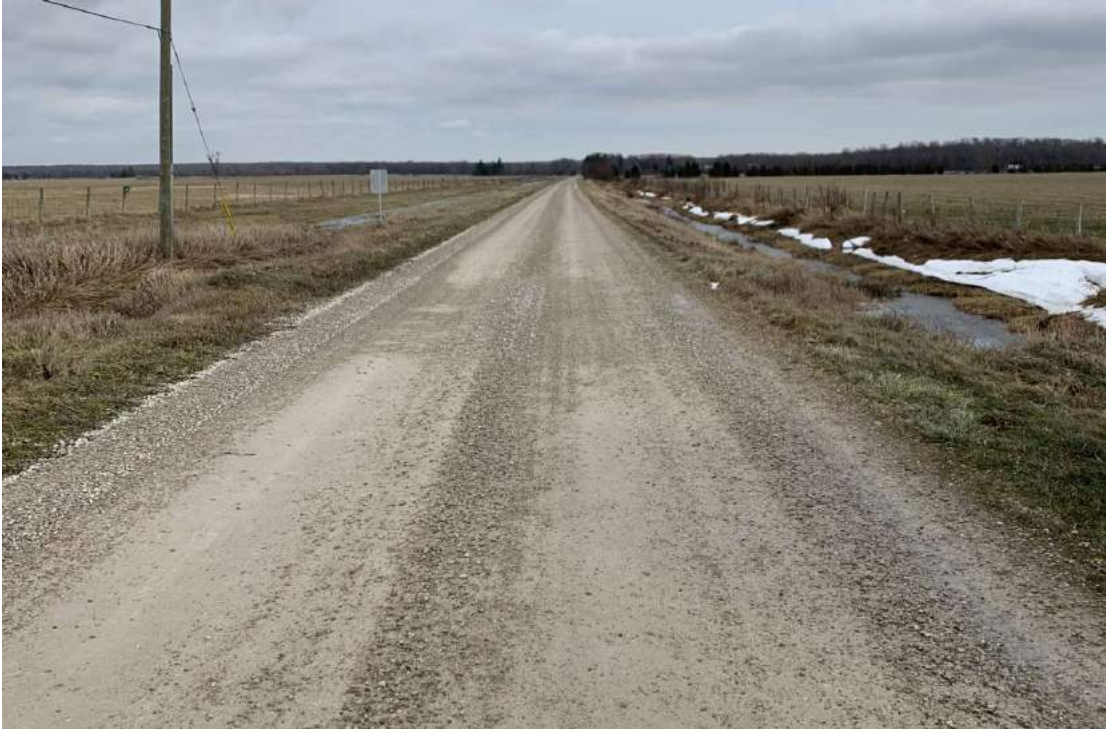
Photo 18-2: View of structure wearing surface

| | Continue annual grading of the wearing surface. | | | | | | |

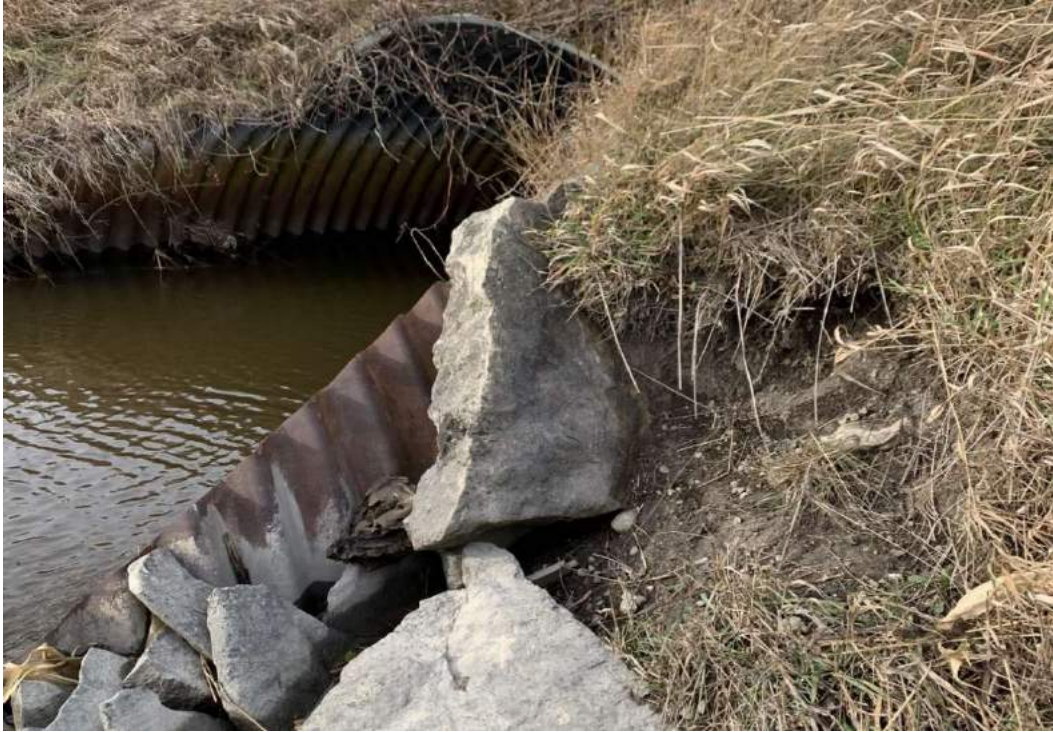
Photo 19-6: Structure embankment
